The role of geological conditions in the disintegration of historical structures on the escarpment of the Lower Vistula Valley, on the example of Chełmno (Poland)

Ewa Labak-Mechowska*, Michał Dąbrowski

Nicolaus Copernicus University in Toruń, Poland

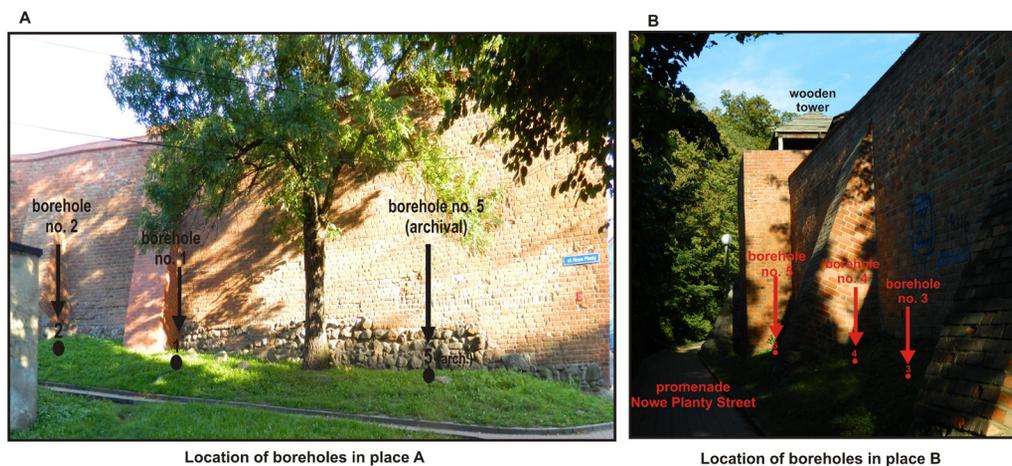
Fig. 2. Location of study boreholes in designated places

Until 1267, Chełmno was surrounded by an earthen rampart (Góra, webpage). After this year a brick wall was built, reinforced with about 30 towers. Almost three hundred years later the walls were built up higher, to their current height (Czacharowski 1999). Unfortunately, a few years ago two fragments of the historical fortifications collapsed (a stretch of wall and a buttress). Additionally, other parts of the walls have for some years been systematically repaired due to brickwork coming away. Figure 2 shows the place where the but-

stress and brickwork came away from the wall, and indicates the points at which bores were drilled.

The study was conducted by authors on both sides of the buttress on the corner of Wodna Street and Nowe Planty (Fig. 2 – place A). The drilling was done to a depth of 3.5 m (borehole 1) and 3.7 m (borehole 2). The ground to the right of the buttress (borehole 1) is dry, and the bored out sandy silts and clays are stiff. On the left of the buttress (borehole 2) the bored out soils are moist; these are clays and sandy silts which, below 2.2 m, have a soft consistency. After analysis of the ground around the wall it is unclear why such differing groundwater conditions occur over such a small stretch. It may be the loose, uncompressed and moist slope of the escarpment having been covered with younger soils or embankments. This area requires further examination in order to determine the cause of the differences in conditions.

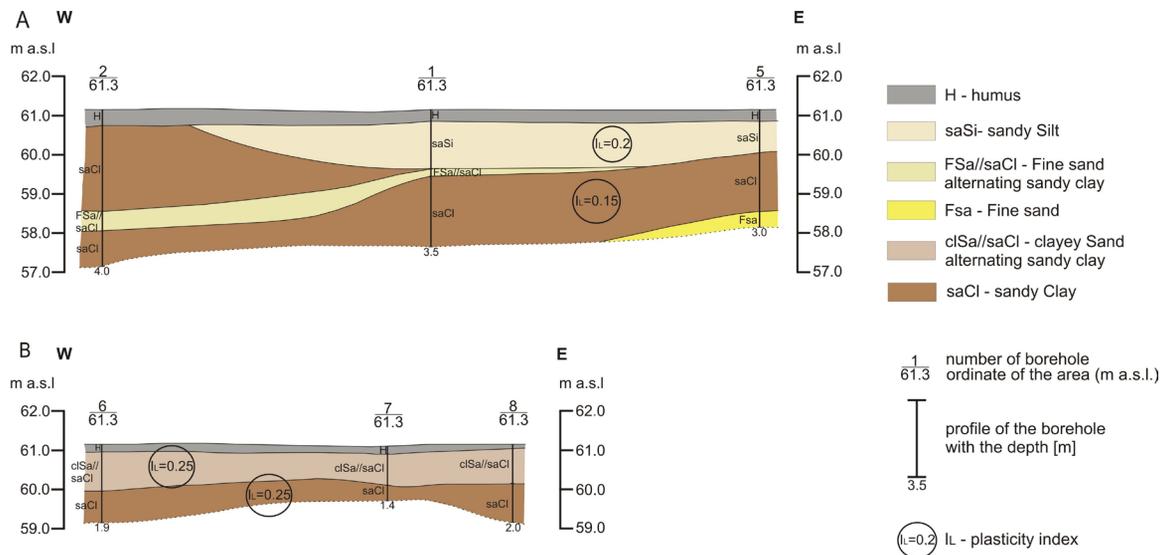
Fig. 5. Geotechnical cross-sections (A and B) of the indicated study area (location in the Fig. 4B)

The soils of the analysed subsoil (by the detached buttress) were loose and cohesive sediments represented by: stiff sandy silts; fine sands interbedded by layers of sandy and stiff clay (borehole 1); and medium stiff and soft sandy clays (borehole 2). During the analysis, the occurrence of groundwaters was not recorded to a depth of approximately 4 m. The load-bearing subsoil to the area in question is of fine sands and sandy silts. Clays were found at a depth of 0.3 m, which is confirmed by the geo-radar profiles. In the second area (where the brickwork came away) boring yielded stiff sandy clay interlayered with clayey sand and sandy clays. In both cases no non-construction embankments were identified. On the external side of the walls (Fig. 2) there is soil (to a depth of 0.3 m).

of their foundations. The best ground for building foundations is native mineral soils (Pisarczyk 2001). For the area in question these are represented by medium-density fine sands. Unfortunately, these exist only as lenses occurring between layers of clay. Moreover, these deposits occur at depths ranging from 2.5 to 3.5 m, so significantly deeper than the wall foundations (foundation depth is 1–2 m). At the depth of the wall foundations there are sandy silts and clays (sometimes interbedded with fine sands), which are usually firm and can bear high loads. It is only at borehole 2 that the clays found at a depth of approximately 3 m are soft. Clays are found at a depth of as little as 0.3 m. The shallow position of these deposits means that long-lying rainfall can result in pockets of standing groundwater between the base of the foundations and the native ground. In the long term this leads to a decrease in strength parameters. Repeated deep freezing of the wet subsoil on the escarpment slope leads in the long term to solifluction movement of the surface and building layer. Water stored in clays expands under the effects of low temperatures (the active layer of the study area is 1 m deep). This leads to a weakening of the walls and their buttresses, which caused the detachment of the buttress.

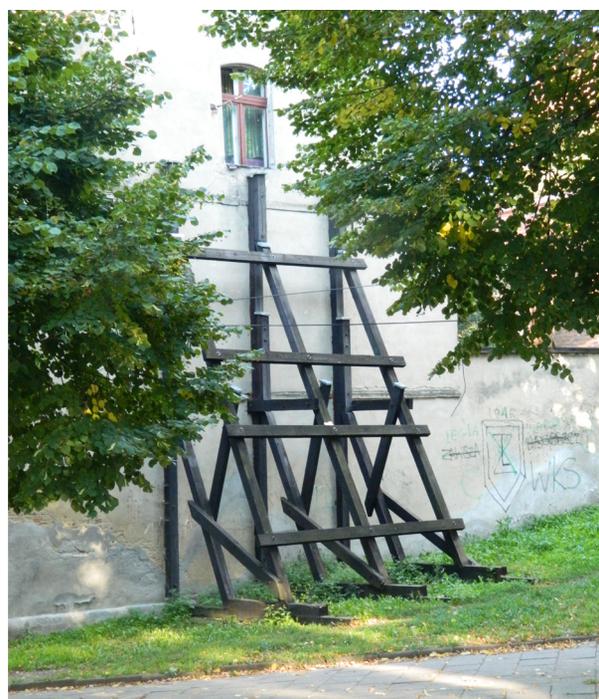
Fig. 7. Wooden supports for a residential side wall

In the vicinity of the studies, the results of slow mass movements are visible (creeping soil). Opposite the fortifications (on the external side) there is a building which is supported by a special wooden constructions (Fig. 7), because the building wall shows small cracks.

The base of the skeleton construction is secured in a concrete slab. It was therefore not possible to conduct direct analysis of its subsoil. Manual drilling was only conducted to a depth of 0.9 m next to the support and at a distance of approximately 2 m, because drilling was made impossible by large brick fragments. The underground analysis was therefore of the unbuilt-upon embankment (unmonitored). In this area a geo-radar profile was also made. This

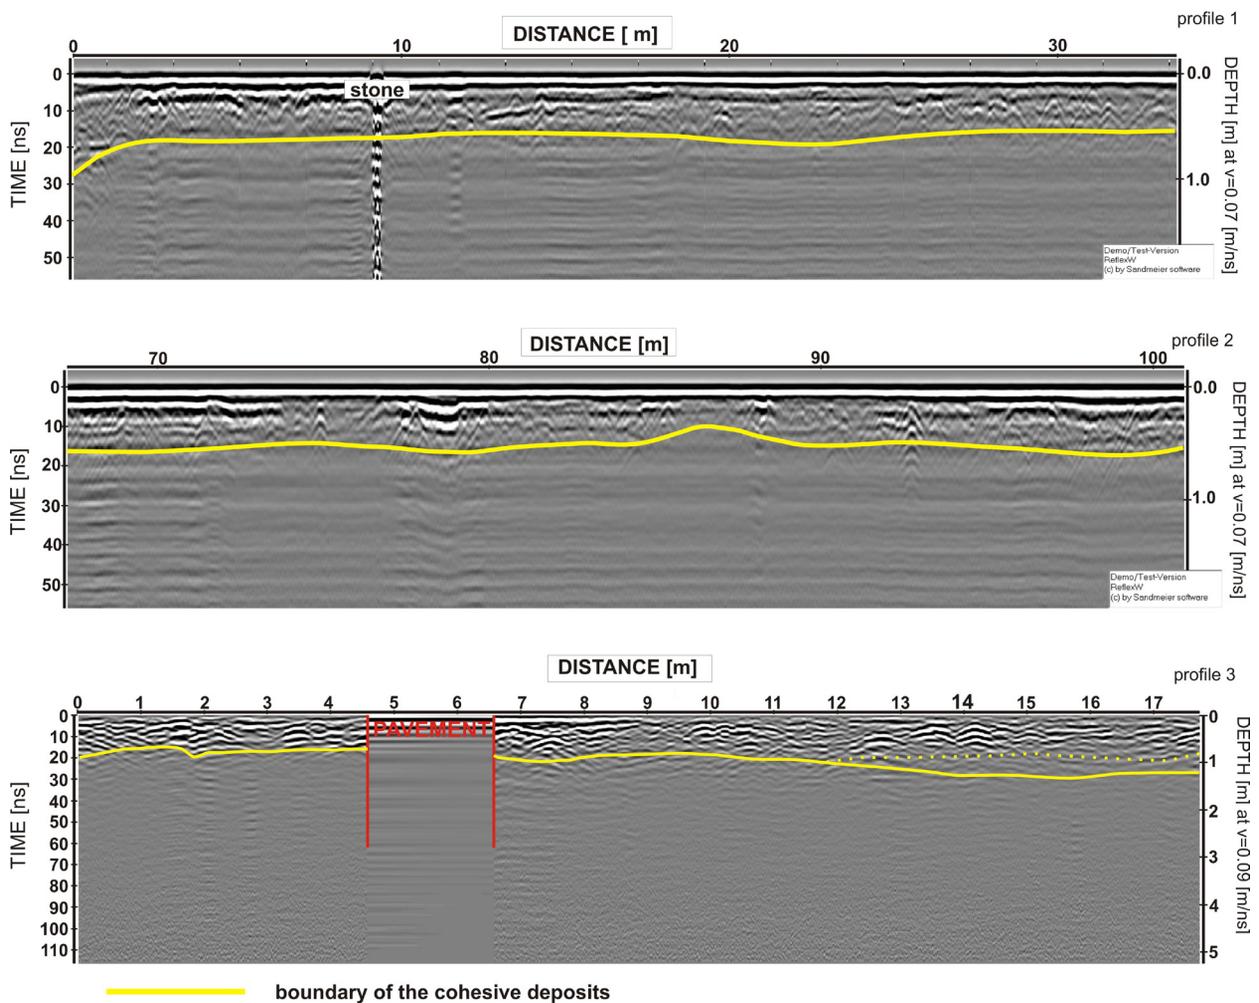
Fig. 8. Penetrating radar profiles (location in Fig. 4)

profile clearly shows a structural boundary (at a depth of approximately 1 m). This is probably associated with a layer of glacial till. It is associated with the occurrence of clear horizons at this depth in the geo-radar profile.
