Vernacular architecture and traditional rural landscape in new socio-economic realities - a case study from Central Poland

Abstract. The article presents the results of the research survey of the old rural constructions in the Koło Basin (Central Poland) and its closest vicinity, conducted by the authors in the period 2011-2013. From the beginning of the 19th century until the late 1960s, the population of that region tended to use for construction limestone, instead of wood which for centuries was the most common building material on Polish lowlands. Using the local deposits of limestone, excavated near Różaniatów village, various structures were built, with the parts of the building most endangered by degradation made of ceramic bricks (for corners and window/door frames) or glacial erratics (for wall base), thereby forming structures with specific architectural and aesthetic features, unique to that region. The survey was conducted in 165 villages of the region, cataloguing more than 2,000 such structures – residential buildings, farm facilities, industrial buildings. Many of these buildings display a similar elevation style of same-coloured stones, making them one of the most

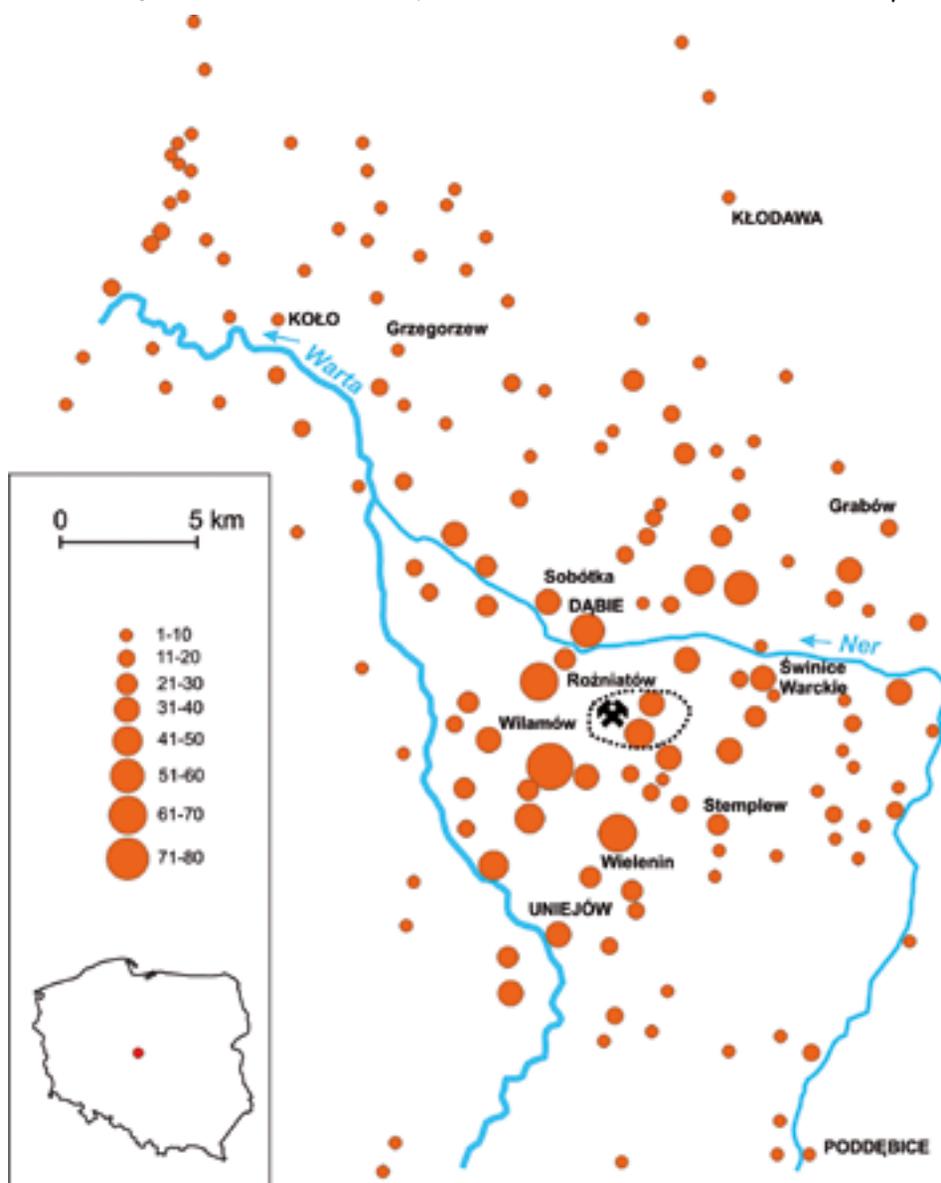
Fig. 2. Distribution of limestone buildings and their number in the locations analysed

The article presents the results of research into the region-specific technology of rural construction in the Koło Basin. The survey, conducted by the authors in the period 2011–2013, included 165 settlements in an area of about 1,100 km² (Fig. 2).

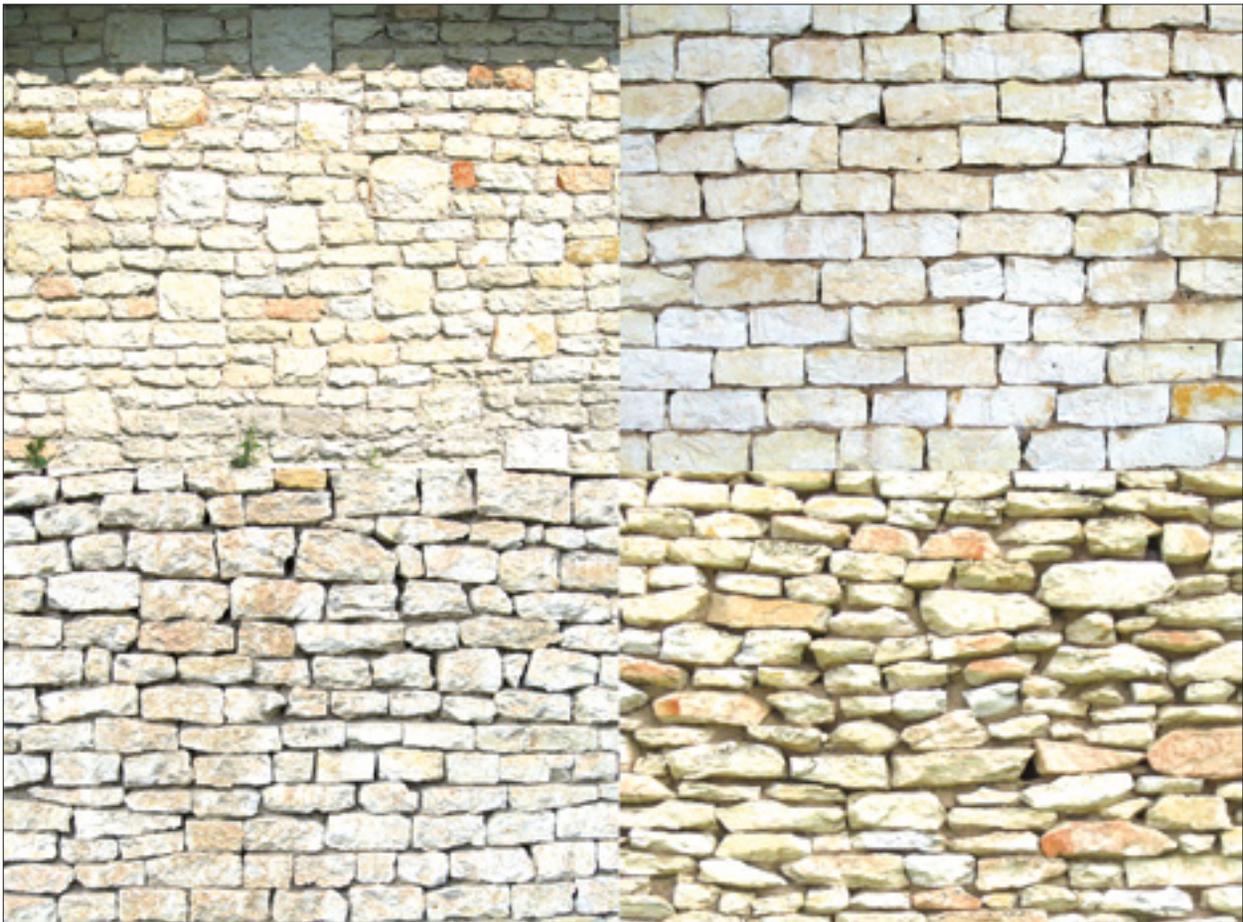
Fig. 3. Examples of limestone walls

Structures with walls built solely from limestone silica are very rare, occurring almost exclusively in the closest vicinity of the place of exploitation. Structures in which ceramic bricks served as a supplement are more numerous. Their application was due to both practical and aesthetic reasons. Bricks were used to make sections of the wall which required greater durability such as frames of windows and portals. In the case of lintels bricks were formed in a segmental arch. They were also used for ventilation holes, quoins and cornices. The proportion of bricks in the construction increases with the distance from the limestone mine, especially to the north and to the north-east of the region where small upland brickyards operated basing their production on local clay deposits. In these areas bricks were the favoured material for the entirety of front and back walls, while the warmer limestone was

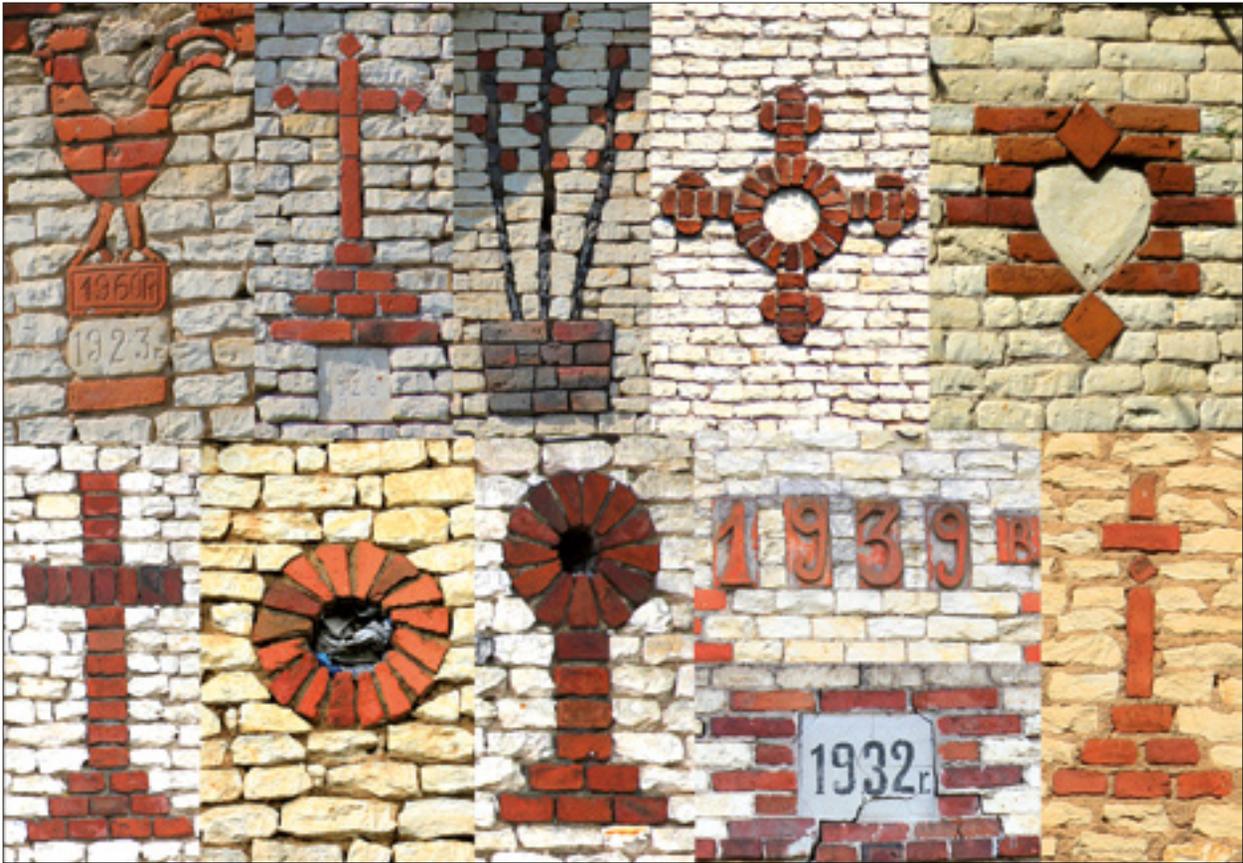
Fig. 4. Ornamental brick details on limestone masonry buildings

used for gable walls. The colour contrast obtained by putting together the creamy-yellow limestone silica with the red colour of thermally processed brick was also used as a means of decoration in the form

of geometrical patterns, very often crosses, found especially in pre-war buildings (Fig. 4). Another supplementary material were glacial boulders used in foundations and shallow underpinnings.

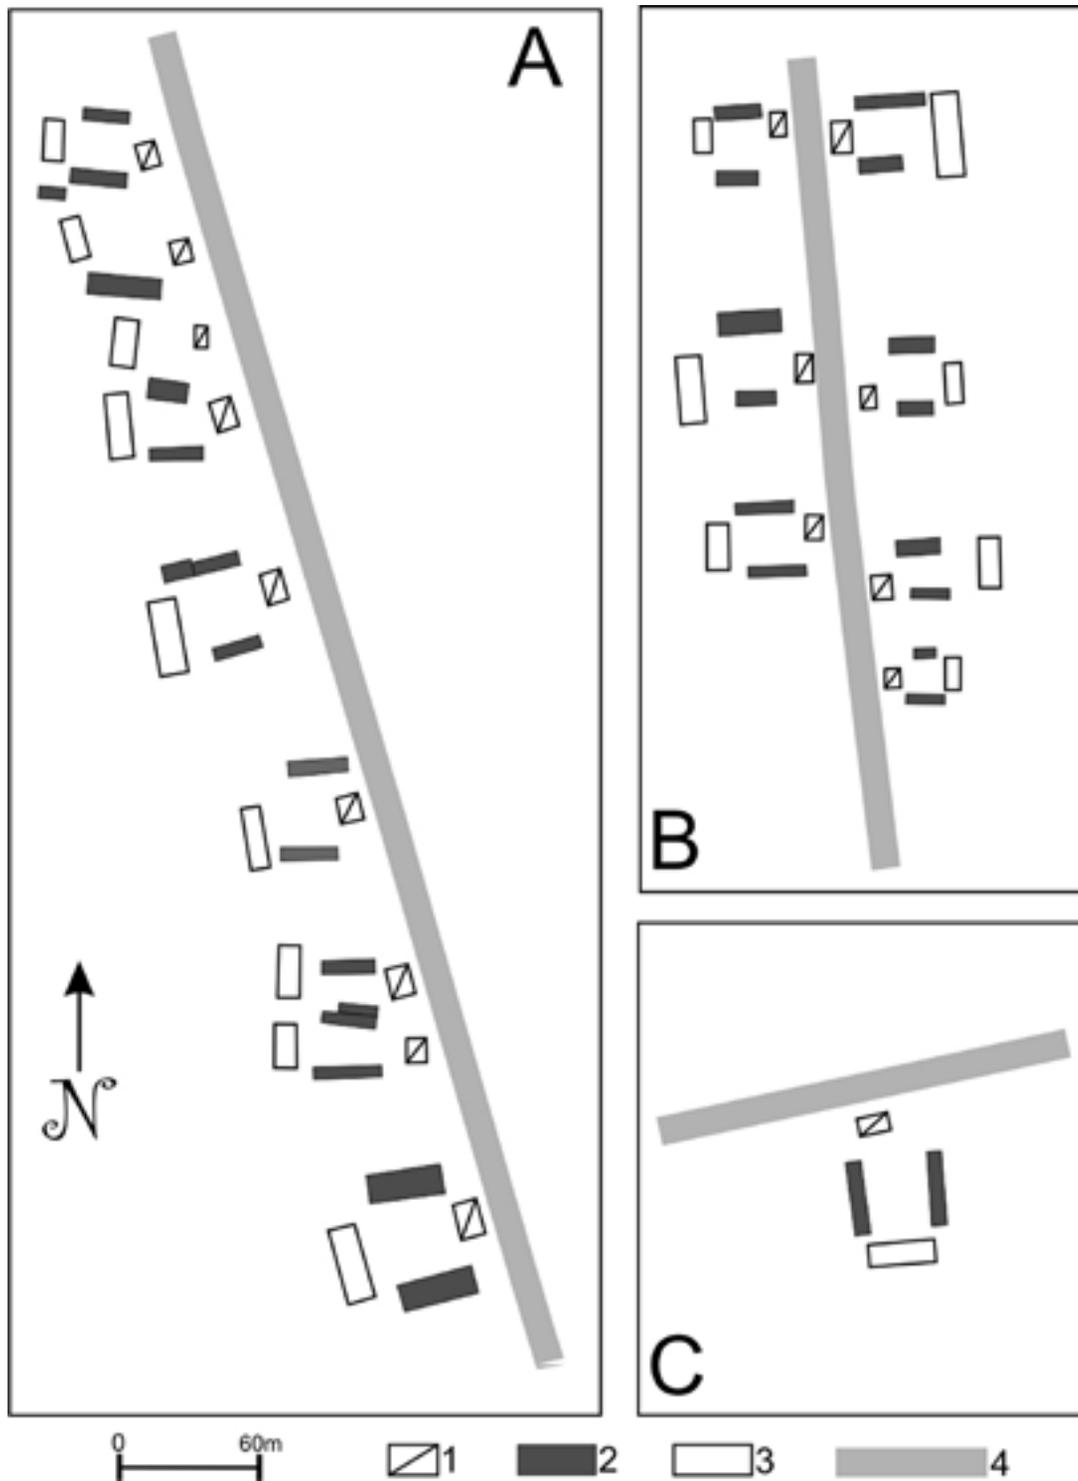
Fig. 5. Examples of typical settlement layouts: A – a linear settlement on one side of the road, B – a linear settlement on either side of the road, C – a single farm on quadrilateral layout; 1 – a residential house, 2 – a farm building, 3 – a barn, 4 – a road

The farms were built mostly using the quadrilateral layout (Fig. 5) which included: a residential house in its front (facing the road), two farm buildings perpendicular to it on both sides and a barn (made out of limestone or wood) closing the property from the side of the field. The central part contained a vast yard hardened with cobbled pavement. Large farms had also minor homesteads erected in their close vicinity for hosting hired farmworkers, and were usually made up of two buildings – a residential quarters and a utility building.

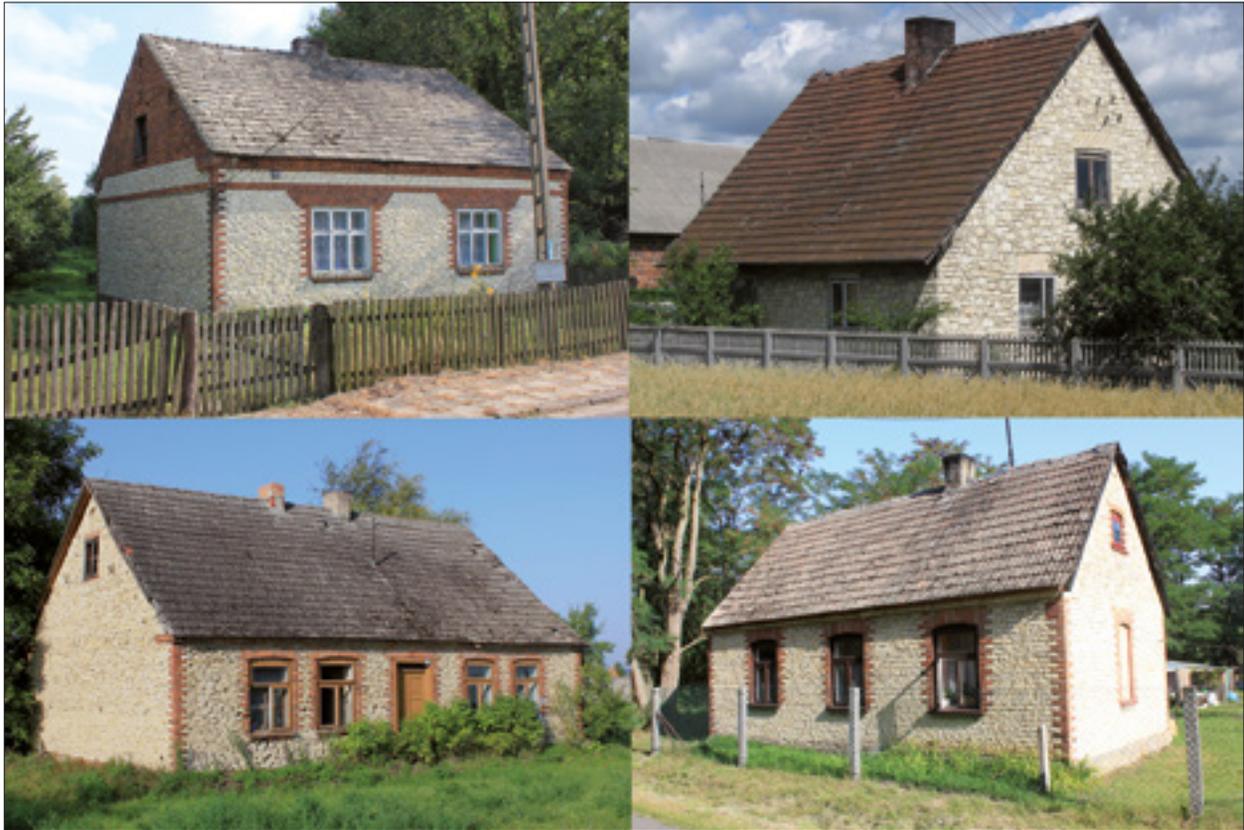
Fig. 6. Typical examples of residential limestone houses

A typical stone residential structure found in that area is a free-standing single-floor building with a double-pitched roof with a slope at around

45° angle (Fig. 6). The dominant architectural forms are simple – only in a dozen or so cases structures possess a high attic cut into the roof slope. Hous-

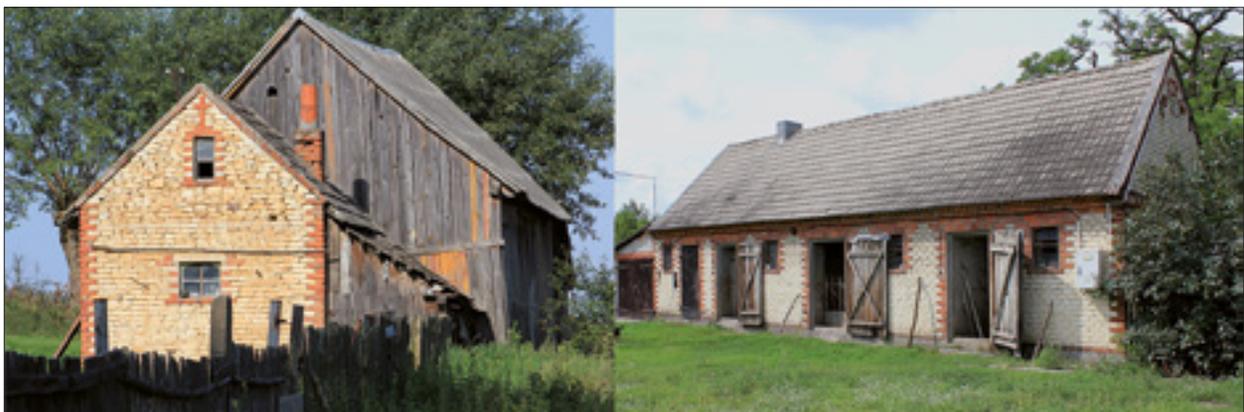
Fig. 7. Examples of farm buildings

Farm buildings, except for barns, show a very high variation in terms of surface, cubature and shape of the architectural form (Fig. 7). Larger structures comprised stables, pigsties, chicken coops, a coach house, etc. Free-standing structures of that kind had double-slope-pitched roofs, just

like the residential structures, unless they were located on the border of the plots, in which case they were built with a single-slope-pitched roof. Due to a large variety of shapes and placements of doors and windows in those buildings, their front walls significantly differ from one another.

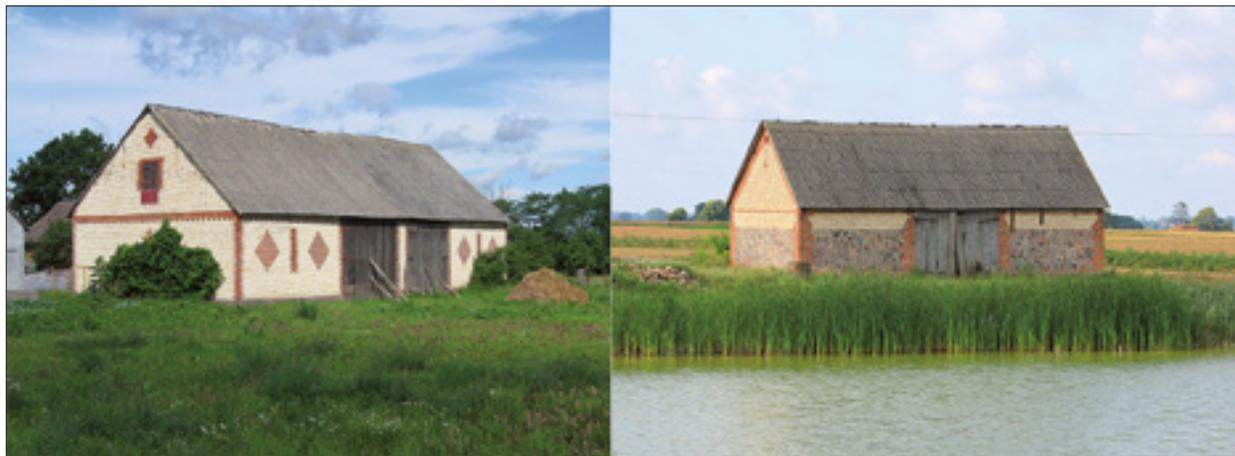
Fig. 8. Barns

Barns usually display simplicity of the architectural form, which creates an impression of massiveness (Fig. 8). They usually differ in the sizes and

number of gates. In some cases buildings have also an inner compartment for animals or a residential quarters.

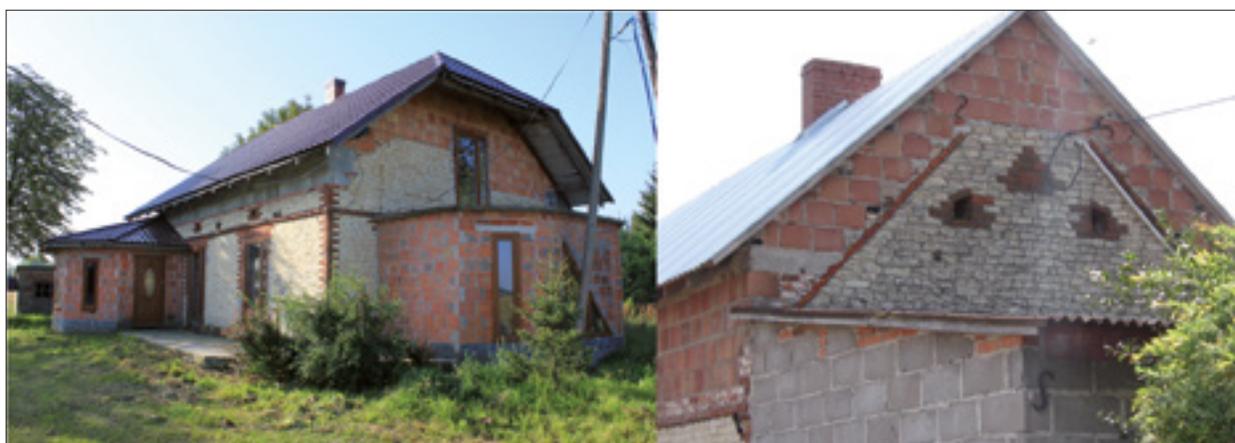
Fig. 9. Examples of old limestone building extension

Another frequent cause of degradation lies in unprofessional and provisory repairs, especially when missing elements are replaced by or expansions are made using other materials (Fig. 9). Particularly, when the owner of such a building experiences inflow of funds for construction purposes, the primary action most often taken is insulation and plastering of the walls, depriving them of their architectural uniqueness.

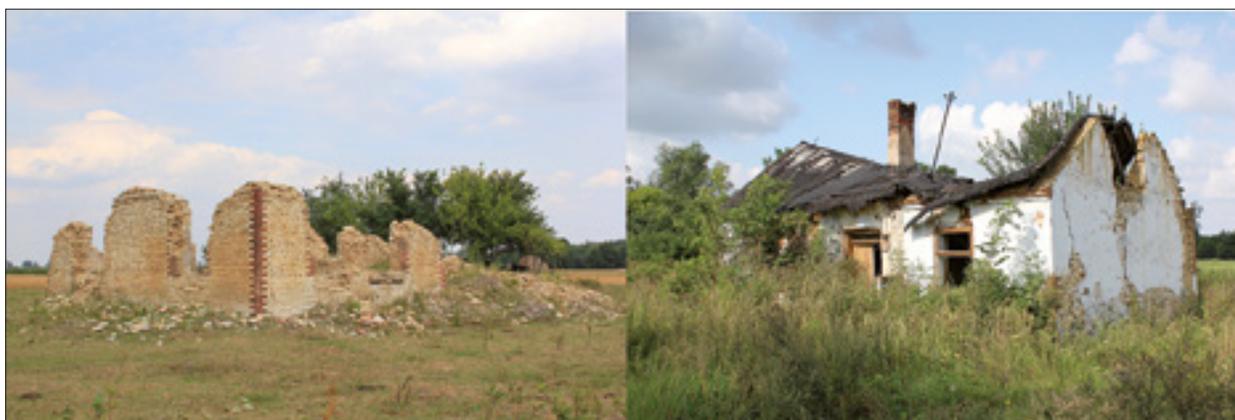
Fig. 10. Residential houses ruins

production – stables, barns, etc. On the other hand, the commune, like most rural areas in Poland, is undergoing depopulation (Szymańska, 2009), leading abandoned homesteads to rapid deterioration (Fig. 10).

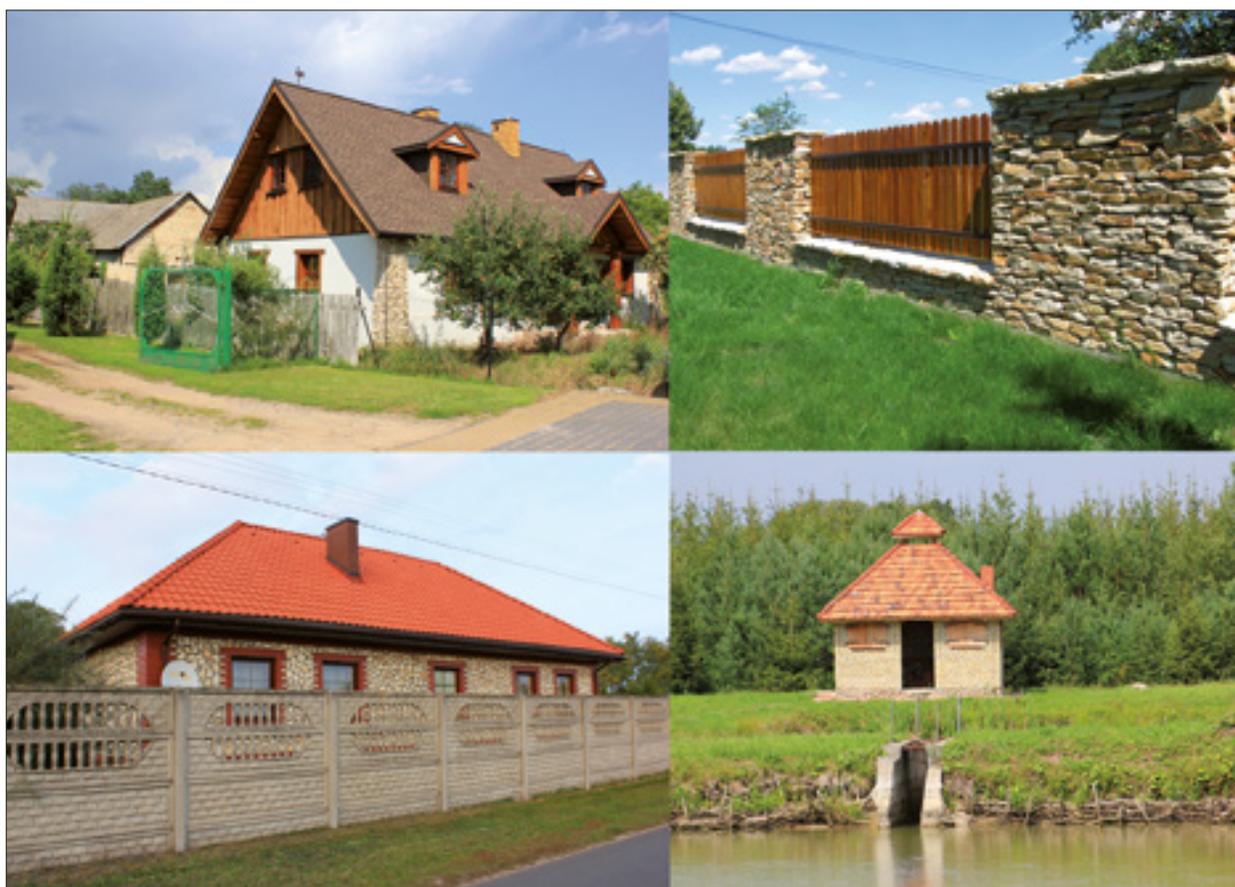
Fig. 11. Examples of contemporary use of stone material in new farm constructions

Meanwhile, interestingly, limestone is still being exploited in Roźniatów, although at a much lower scale than before, and could successfully be used in construction of modern rural structures which relate back to the regional traditions (Fig. 11). Modern techniques of chemical protection of surfaces of porous materials would surely allow fulfilling modern requirements of functionality, as defined for the building materials. It might even result in producing better longevity effects than those of many elevation veneers currently applied.

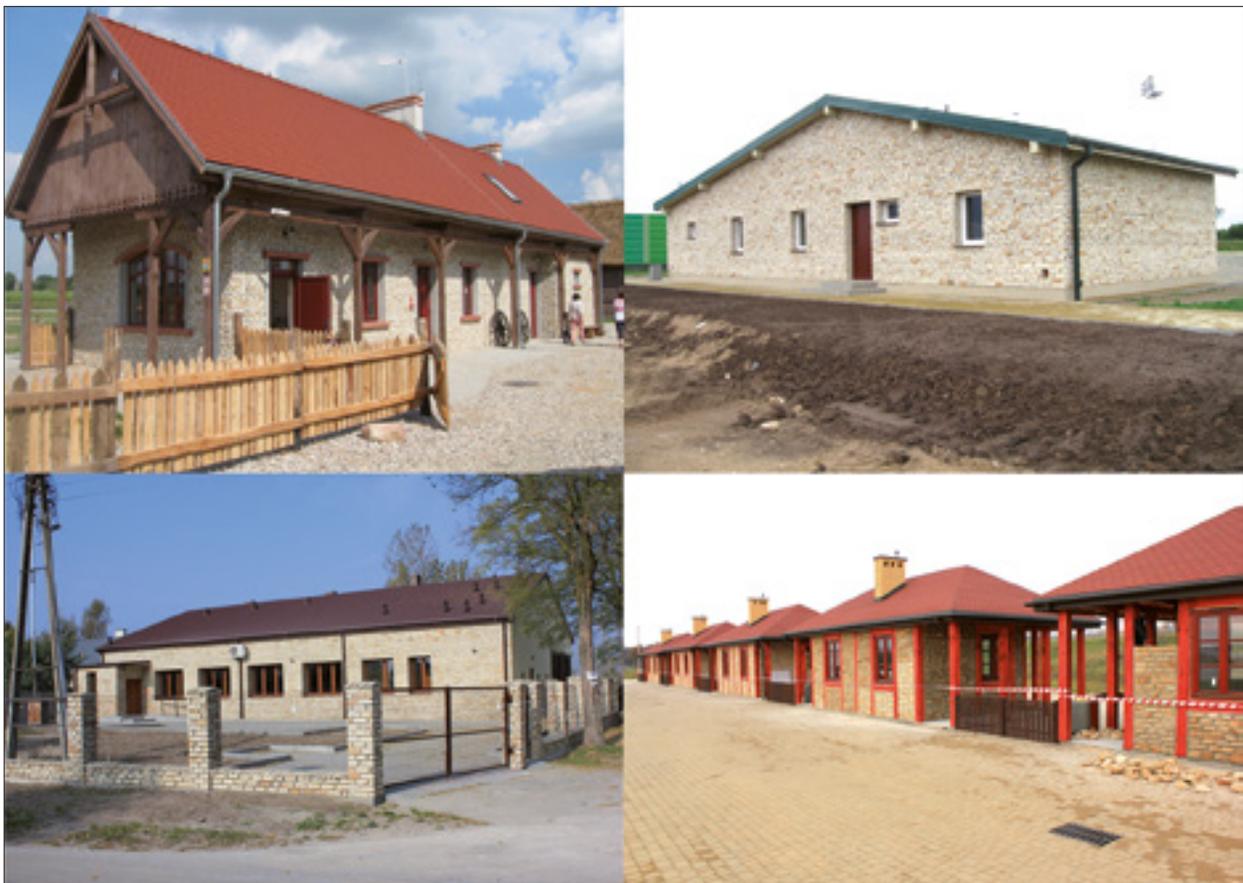
Fig. 12. Examples of contemporary use of stone material in new public buildings

buildings, such as public offices, schools, libraries, community centres, restaurants, inns, etc., which are financed from public funds, are conducted using the local building materials (Fig. 12). Yet even before that happens, it is indispensable to first of all include the most valuable, in terms of architecture and engineering, structures made from local limestone in historical preservation programs. Regional architecture could be also one of the important elements of socio-economic development, of this area, next to the health resort recreational values (Mokras-Grabowska, 2009; Poczta, 2013).
