**Wooden sacral architecture in Greater Poland.
An interdisciplinary case study of the church in Domachowo**

Abstract. Sacred wooden architecture in Poland is a huge and still unrecognised research problem. It covers a number of issues of interdisciplinary character: from the properties of building materials and carpentry techniques, through construction and architectural-spatial solutions, to cultural and natural conditions. Hence, the best way to study this problem is interdisciplinary research. The necessity of cooperation of representatives of various scientific disciplines became the basis for creating a team to study the wooden church of St Michael the Archangel in Domachowo, so far dated to 1568. As researchers representing various disciplines (including archaeology, history, art history, history of architecture, architecture, architectural conservation), we cite sources and research that allow us to formulate a thesis that the past of the Domachowo church dates back to the 14th century. Moreover, we present the research and methodological problems inscribed in the aforementioned church building, understood as a whole. Such a multifaceted approach allows us to redefine the

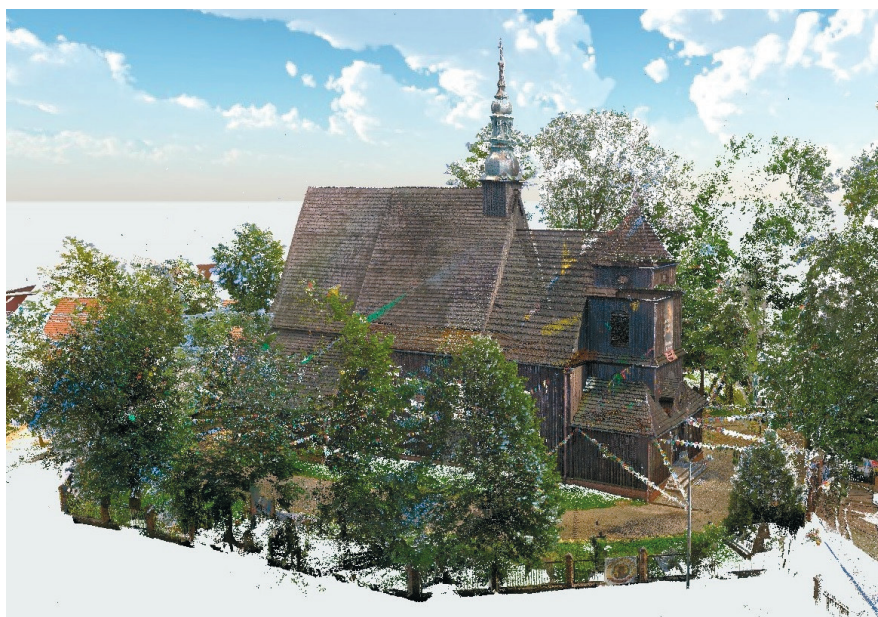
Fig. 1. Domachowo, Krobia municipality, Gostyń county. Onsite documentation. 3D inventory of St. Michael the Archangel Church: building and vicinity (edited by Artreal Sp. z o.o., Lublin)

Simultaneously, in July 2020, under a grant from the Archdiocese of Poznań, an inventory was carried out to document the existing condition of the building. The church was scanned using a 3D FARO® FocusS scanner. Using information

obtained from a 360-degree point cloud, the building was modelled in virtual space with 1.0-mm accuracy. This provided for documenting and making 2D architectural drawings of the church. The virtual model was made in natural colours measured in RGB standard during the scanning process. The output material was a point of departure for subsequent analytical and designing studies regarding the architecture and construction.

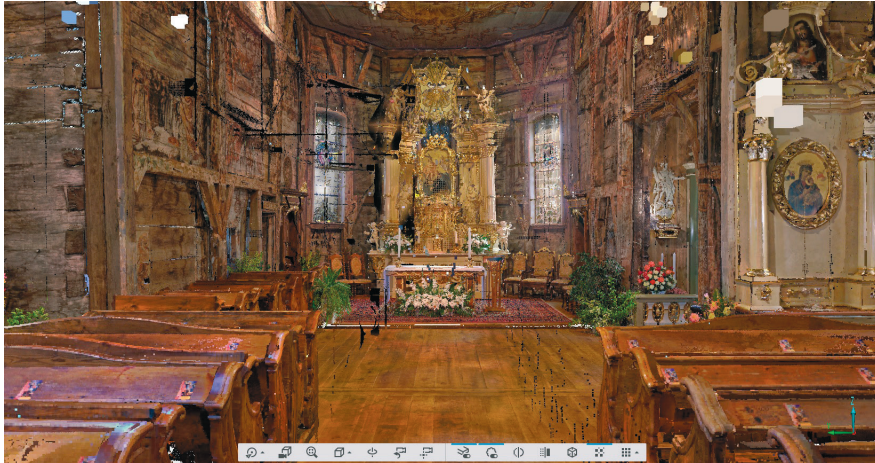
Fig. 2. Domachowo, Krobia municipality, Gostyń county. Onsite documentation. 3D inventory of St. Michael the Archangel Church: interior and vicinity (edited by Artreal Sp. z o.o., Lublin)

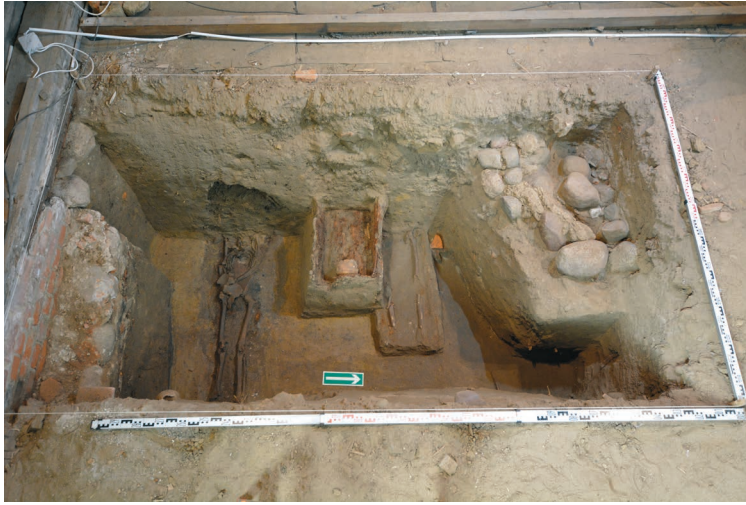
Fig. 4. Domachowo, Krobia municipality, Gostyń county. Excavation 1/2020. Western profile (photo by A. Róžański)

Considering the scholarly belief in the continuity of a holy place, the continuity of the altar, the first excavation of 3.5×2.0 m was made in the chancel on the N–S axis, intersecting the longitudinal axis of the church. Unfortunately, the archaeological image of the stratigraphic layers did not differ from those known to the authors both from literature and direct experience. The removed wooden floor revealed a 14-cm layer of light-grey dusty humus, and underneath it, almost to the undisturbed soil, a 145-cm 'funeral' layer formed during intensive burial activity in the church. As this paper is not intended to be an archaeological study, it suffices to conclude that no traces of objects or buildings predating the erection of the present church were found in the excavation. Among the archaeological artefacts that can be used for the purpose of dating, two decorative elements of the church floor from different periods were discovered: a handmade gothic flooring brick (x=46, y=130, z=285 mm) dated to the late 14th or early 15th century, and three ceramic floor tiles (188×188×27 mm) dated to the 16th century.

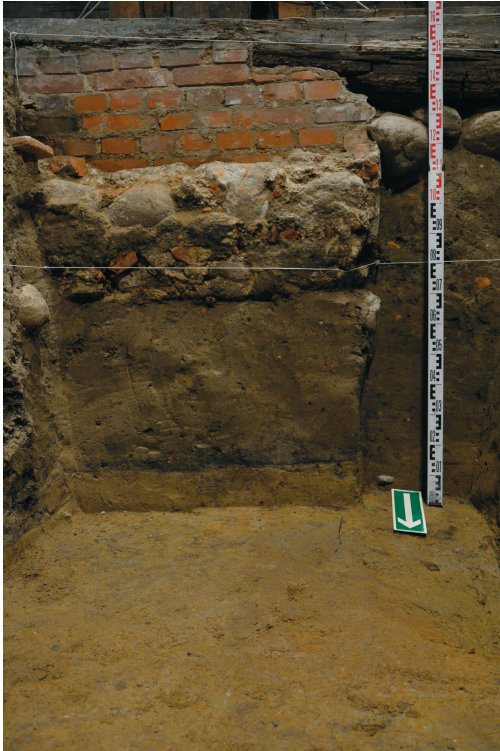
Fig. 5. Domachowo, Krobia municipality, Gostyń county. Excavation 1/2020. Southern profile (photo by A. Różański)

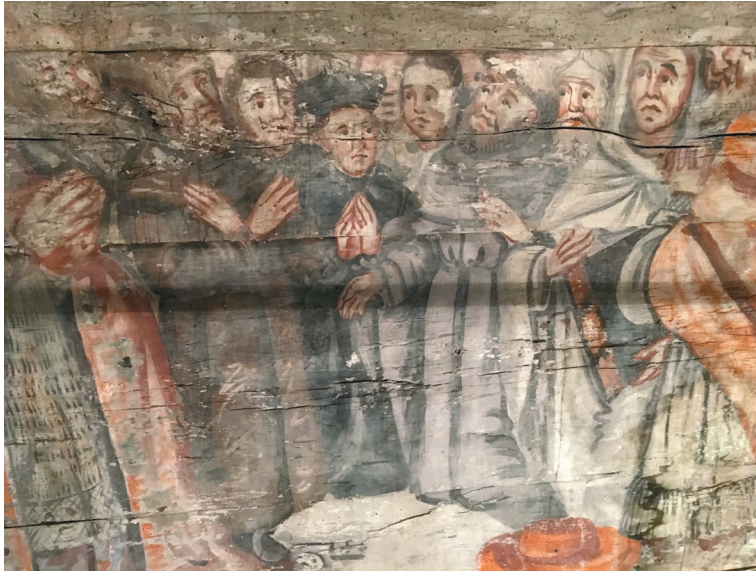
Fig. 6. Domachowo, Krobia municipality, Gostyń county. Uncovered discovered Polychromes in St. Michael the Archangel Church; northern wall. Figural scenes (photo by P. Marciniak)

The painting layer discovered during the conservation project covers the log construction and is determined by the frame construction. It shows figural scenes relating to both the Old and the New Testaments. The frame construction outlining the scenes is also covered with a polychrome of an ornamental and illusionistic character. The painter's intention was to make the vertical elements imitate superposed columns illuminated from the east through the window. Under the abovementioned painting layer, there is yet another, older one hidden behind elements of the frame construction. This means that the painting must have been created earlier. Not much of this layer has survived. Many features are illegible, and their continuity on the southern wall is obscured, since the wall has been punctured by the arcades. Nevertheless, the outlines of the figures are discernible, as are the marks left between each of them by *zacheuszki* (small candleholders symbolising the Twelve Apostles). On the northern wall,⁵ the first figure from the east is wearing

a tunic. It has a long beard and a nimbus adorning its head. The second figure, also with a nimbus, is very different, with a youthful face, in a fur-lined coat, holding a chalice (St John?). Another figure, whose outlines are in the nave, holds the cross of St Andrew. These attributes, as well as the presence of the abovementioned *zacheuszki*, lead to the conclusion that the subject matter of the oldest painting layer included depictions of the apostles: six each on the northern and southern walls, both in the chancel and in the nave.

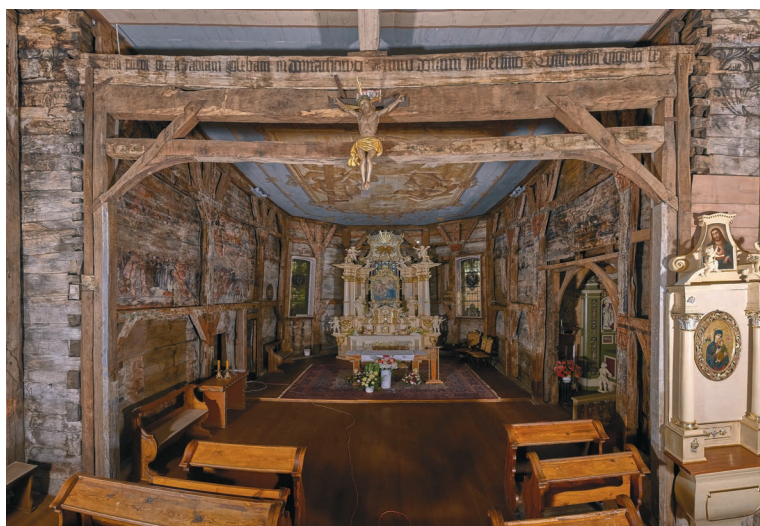
Fig. 7. Domachowo, Krobia municipality, Gostyń county. Polychromes in St. Michael the Archangel Church. Figural scenes; visible sodium light image (after Kłyszcz, Majewska 2020)

In 2020, during basic interventive conservation the discovered paintings were disinfected and protected against further damage. In addition, the conservators cleaned the preserved paint layers, and the wooden sublayer. They created full photographic documentation of the state of preservation before, during and after conservation. Furthermore, photographic documentation was made of the whole paintings and the details in visible sodium light, ultraviolet light (UV) and infrared light (IR). The composition of pigments was analysed using XRF X-ray spectrometry, and samples of the paint layers were chemically tested to identify the composition of the pigments and binding agents (Kłyszcz, Majewska 2020).

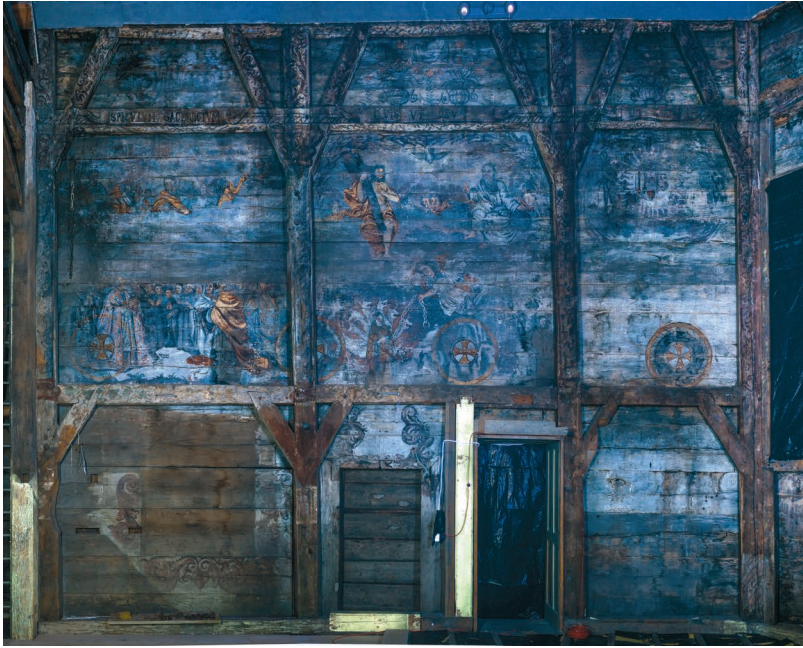
Fig. 8. Domachowo, Krobia municipality, Gostyń county. Polychromes in St. Michael the Archangel Church. Figural scenes; UV image (after Kłyszcz, Majewska 2020)

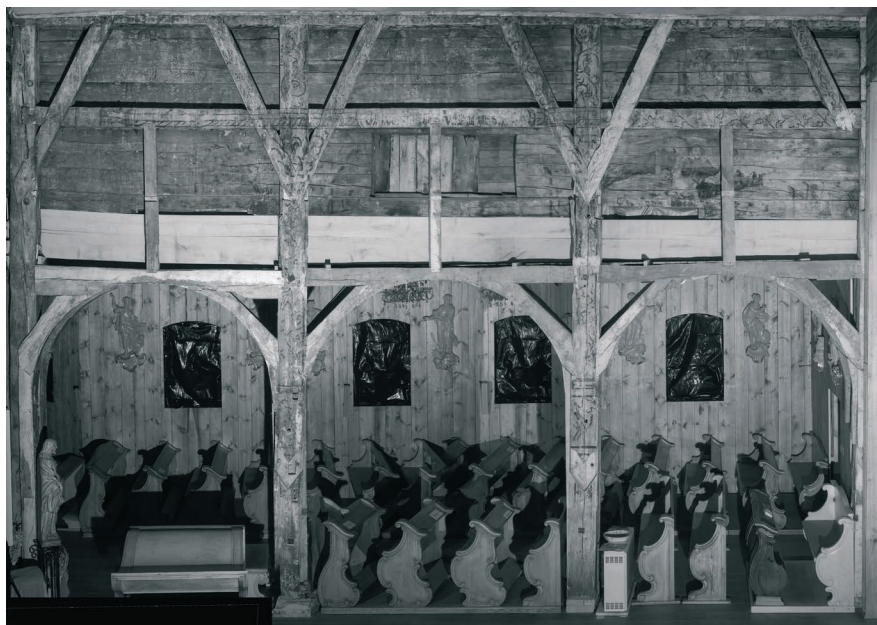
Fig. 9. Domachowo, Krobia municipality, Gostyń county. Polychromes in St. Michael the Archangel Church. Figural scenes; IR image (after Kłyszcz, Majewska 2020)
