**The defensive enclosure of the small knightly castle
in Witków (Silesia, Poland)**

Abstract. The paper presents the architectural transformations of the defensive enclosure of the small castle in Witków. This complex is one of the best-preserved examples of a medieval seat of knights in Silesia. Unfortunately, the literature to date has only discussed its tower house with gothic polychromes in greater detail. Using source references, descriptions from early modern *urbaria*, and the results of architectural research and archaeological excavations, the authors discuss the emergence and transformations of the defensive enclosure. The medieval complex, including a curtain wall, a gatehouse and a gate, was established in the early-15th century. The renaissance reconstruction, including the introduction of four regularly arranged towers, is related to the castle having been taken over by Fabian von Schönäich, and the works are confirmed by the date 1557 visible on a stone windowframe. There was another significant construction campaign in the latter 17th century, probably in connection with the condition of the buildings on the site deteriorating.

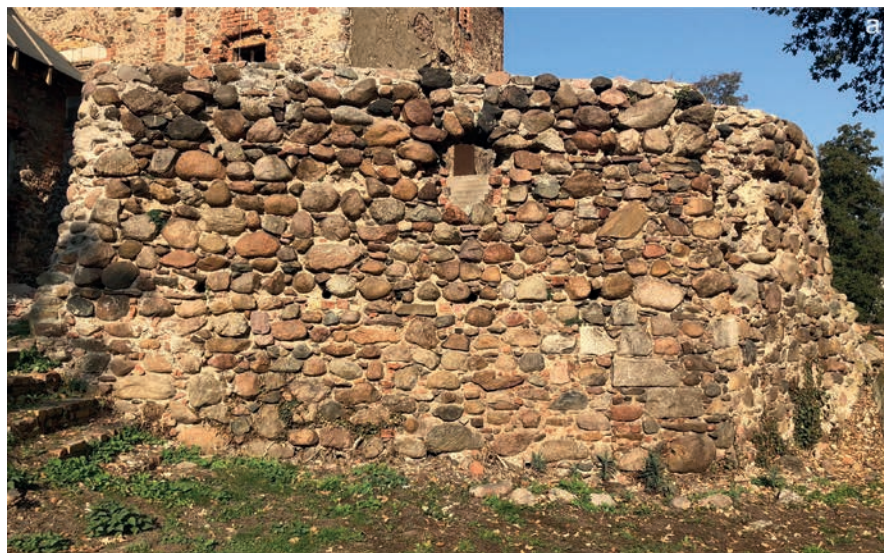
Fig. 2. Castle in Witków (site 6), Szprotawa commune, Lubuskie voivodship. Preserved southern part of defensive walls (a) and location of wood sample for radiocarbon dating (b) (photo by A. Legendziewicz and M. Kaczmarek)

The knight's castle in Witków was erected on a roughly oval plan of about 30 m across, with a centrally placed four-storey tower on a rectangular plan of about 10 m by 11 m. It is surrounded by a *plateau* on top of the mound. The border of the castle comprises the partially visible walls of a defensive perimeter with four bastions. In the south of the enclosure, there is a single-storey gatehouse with a basement built on a rectangular plan and part of a stone curtain wall that marks the location of the former gate (Figs. 2–4).

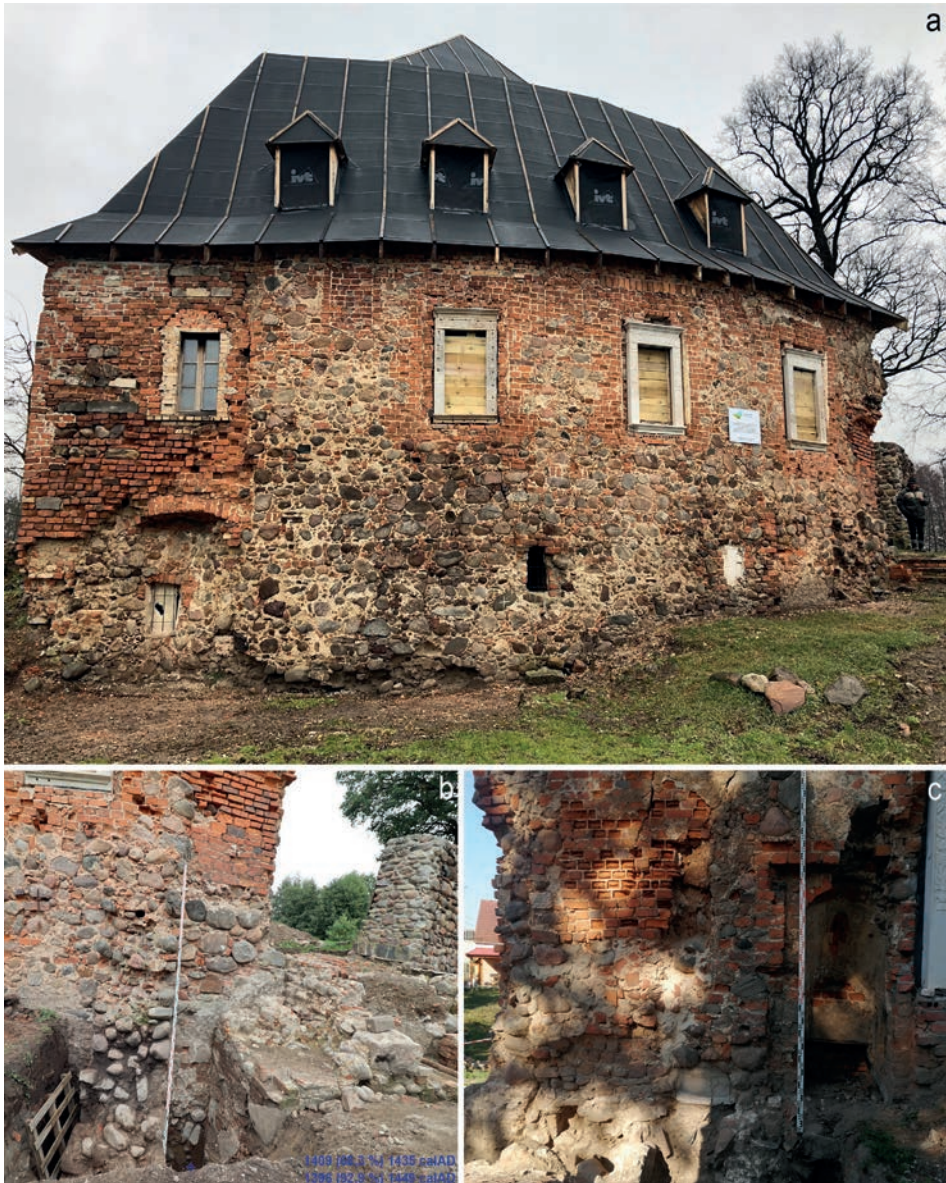
Fig. 3. Castle in Witków (site 6), Szprotawa commune, Lubuskie voivodship. Gatehouse (a) showing remains of defensive wall (b; location of sample for radiocarbon dating marked in blue) and adjacent gate tower (c) (photo by A. Legendziewicz and A. Michalak)

by a wall at the opening of the gate passage. On the southern façade, in a belt beneath the eaves of the present roof, within the section delimited by the pillars between the windows, three arrowslits were found. They begin 5 m above the present-day adjacent ground (about 3 m above the courtyard). Their openings are about 80 cm wide and about 100 cm high. They are probably the remnants of a defensive porch/gallery that comprised a defensive level in the building adjacent to the gate (Figs. 3, 7).

The work on the building's southern façade at the gate included introducing three rectangular window openings. They measured approximately 1.3 m × 2.0 m and are enclosed in stone frames with profiled windowsills, of which a fragment from the middle window is preserved *in situ*, while the rest, together with the frames, were reconstructed during conservation works in 2020. Its edge was about 3.5 m above the present adjacent ground. Above the windows, frieze panels were fitted, one of which is preserved, while there is a painted inscription above the easternmost one and the lower edge of another above the middle one (Fig. 3: a, Fig. 8).

The changes to the western part of it were more important, with the renaissance staircase being enlarged and rebuilt. On an extension to the building's southern wall, a triangular pillar was built upon which a one-brick-thick segmental arch was erected, and the walls of the ground floor were erected. About 1.5 m of the oblique renaissance wall was pulled down, leaving its eastern part where it joins the gothic building. Two windows were carved out in the basement – partly in the renaissance wall. The opening on the first floor is a segmental arch, just like the new entrance in the northern corner of the eastern wall. The facing of the building in the corner at the gate opening was also levelled, and part of the northern façade was rebuilt (Fig. 3: a, Fig. 8).

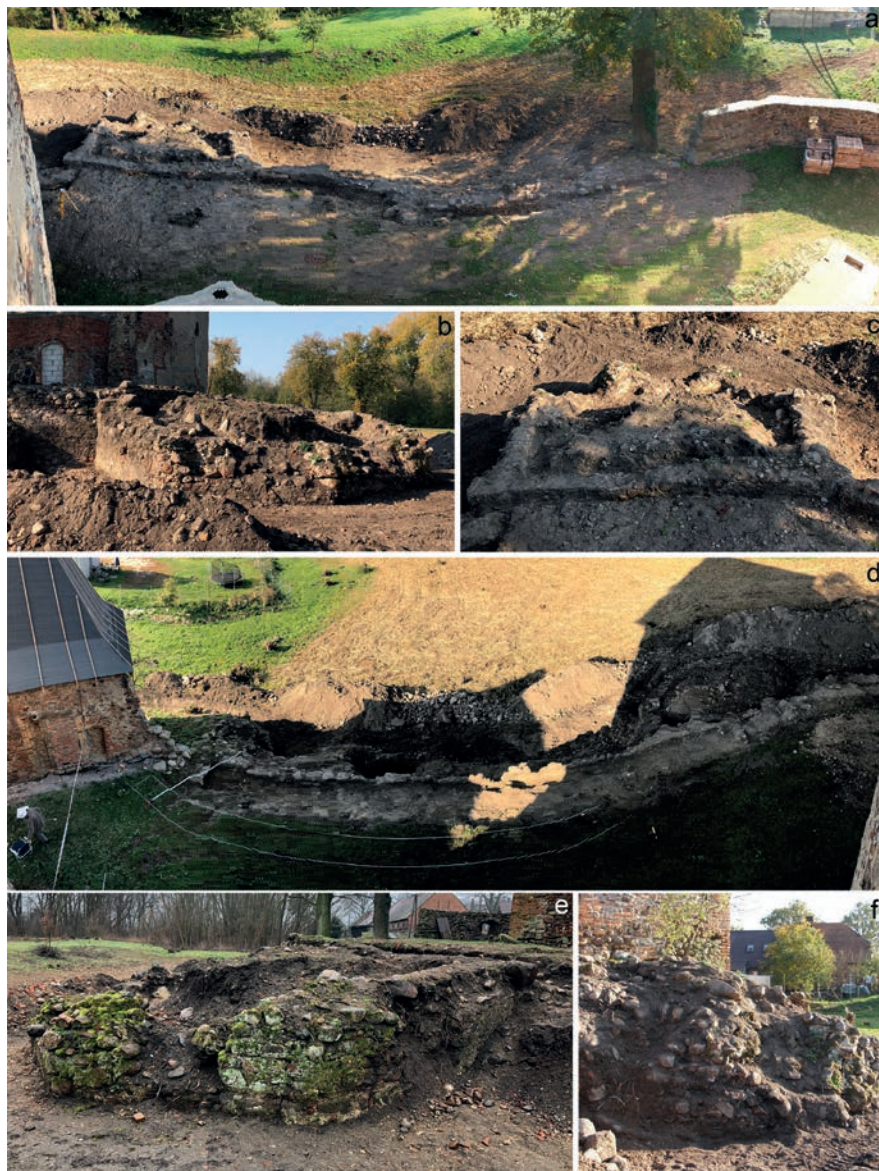
Fig. 4. Castle in Witków (site 6), Szprotawa commune, Lubuskie voivodship. Remains of eastern (a–c) and western (d–f) enclosure of defensive walls and hexagonal towers (photo by A. Legendziewicz)

The defensive perimeter consists of four sections whose boundaries are delineated by the remains of the bastions and the gatehouse. The western section has a damaged coping/cap and is partially lacking its outer facing; it stretches from the bastion in the south-western corner and the west façade of the gatehouse to the north. From the polygonal tower, the outline of the perimeter walls can be seen as heavily corroded fragments, which in the eastern section were used as part of a building's ground floor. The perimeter walls of the bastion in the north-west corner are preserved up to the level of the wetland surrounding the mound, except for small sections of about 1 m long adjacent to the curtain wall itself. In the middle between them, there are stone stairs leading to the bastion from the plateau level (Fig. 4).

the north-eastern bastion and the wall fragment with the arrowslit has retained its face intact from the base of the mound to the courtyard level (Fig. 4).

The defensive enclosure was reinforced with four polygonal bastions. Their locations are marked by fragments of walls added to the perimeter in the south-east, north-east, north-west and south-west corners. Those on the northern side are in the best condition. On the other hand, the two bastions on the southern side are preserved partially or only as an embankments (Figs. 4, 6).

The most information was obtained from the investigation of the north-eastern bastion, which is the only one to have a wall on its courtyard side. Probably a collapse of the perimeter's curtain wall due to subsidence was caused by damage. The bastion was built with two storeys, on a roughly rectangular plan of outer dimensions of 9.5 m × 8.5 m, with the corners cut on the longer side. In the opposite wall, on the courtyard side, an entrance topped with a segmental arch half a brick thick lead into the bastion. The upper part of the arch was exposed in excavations. The lower storey, now backfilled, probably had one arrowslit in each wall. Their form remains unknown, but they were probably slotted, with chamfered jambs providing a wide angle of fire. The existence of an upper storey is indicated by the wall offset on the inside, probably serving for ceiling beams (Fig. 4).

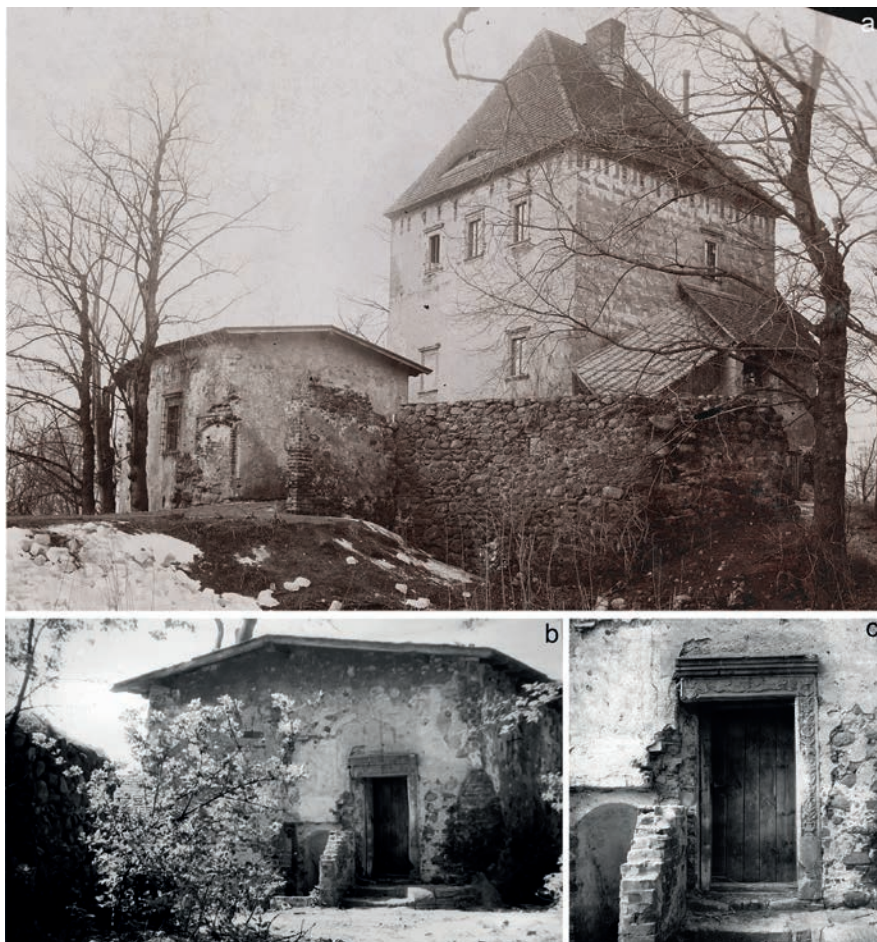
Fig. 5. Castle in Witków (site 6), Szprotawa commune, Lubuskie voivodship. Photograph from the south of the castle in 1913. Foreground: remains of south part of defensive wall and eastern wall (from the archives of Provincial Conservator of Monuments in Zielona Góra)

The first documented interest in the tower dates to the early 20th century, when the first, greatly incomplete architectural inventories were made (Fig. 5) (Nowakowski 2008, p. 564). Architectural research on the complex was carried out in 1960 by Zbigniew Radacki, who also devoted some attention to the preserved and then-legible sections of the defensive curtain walls, the gatehouse and the gate, dating their construction to before 1500 AD (Radacki 1961, pp. 14–16). Later studies were mainly based on the results of that work (Chorowska 2003, pp. 148–149; Nowakowski 2008, pp. 556–564; 2017, pp. 459–461; Kowalski 2010). The first archaeological research, which was carried out in 1978 and then continued in 1983–1986 (Dąbrowski 1979; Sachs 1983a; 1983b; 1984; 1987), focused mainly on the vicinity of the tower itself. The results have still not yet been fully elaborated and published (Michalak 2010), although individual items from that research indicating the high material status of the site's inhabitants have steadily been published (Szczurek 1985; Kałagate

two on the north side are best preserved. It is possible that the castle reconstruction took place after the death of the last member of the Warnsdorf line of Witków and after the castle was taken over by the imperial general Fabian von Schönäich in 1552. It perhaps took place in 1557, as may be indicated by that date having been carved on one of the stone frames on the gatehouse. The lower north-eastern storey was probably reconstructed in the Baroque period by the introduction of window openings. This may have been part of the construction works related to the takeover of the Witków property by count von Redern in 1659 or by count von Proskau in 1687. The curtain wall of the medieval defensive enclosure was probably gradually demolished in the 19th century, as evidenced by archival iconography (Fig. 5).

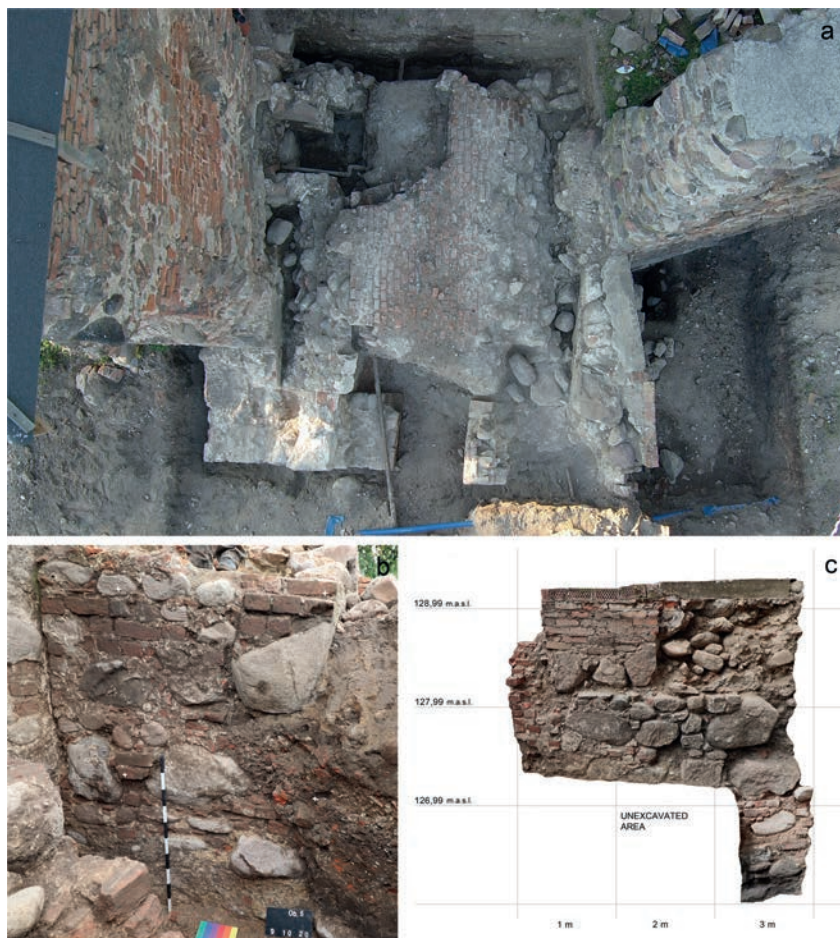
Fig. 8. Castle in Witków (site 6), Szprotawa commune, Lubuskie voivodship. Remains of gate tower (a) and its western (b) and eastern walls (c) (photo by B. Gruszka and A. Michalak)

On the west side of the gate, traces of a partially destroyed buttress were found that was added to the perimeter in the Gothic period. Its poor state of preservation makes it impossible to clearly define its function (Fig. 8: b)².

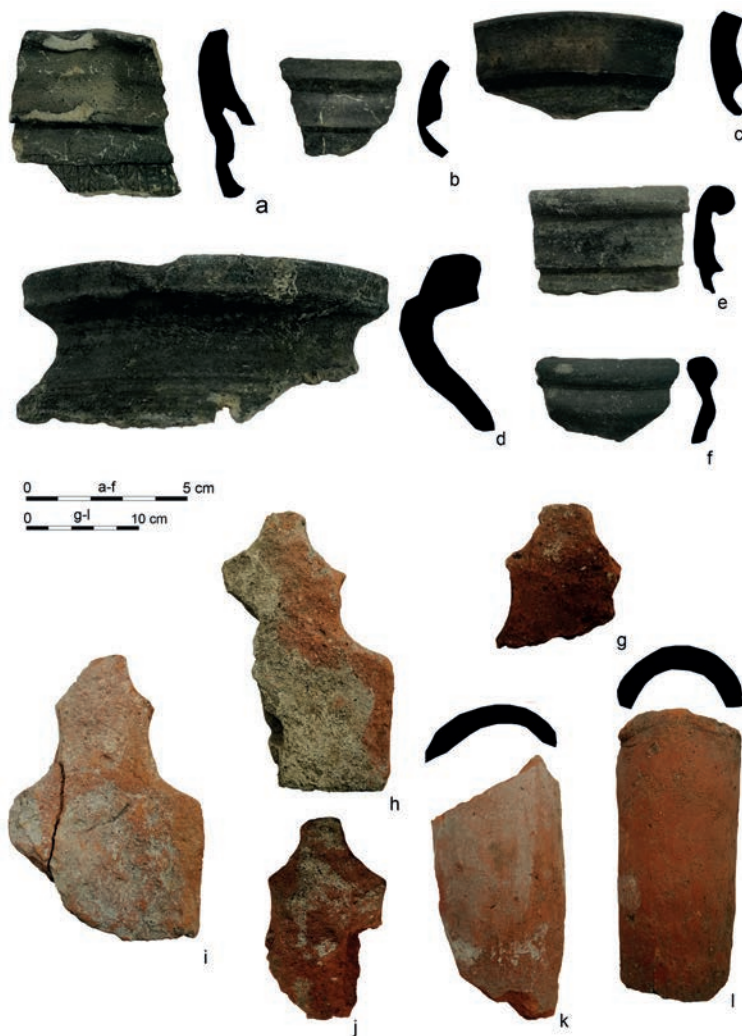
Fig. 9. Castle in Witków (site 6), Szprotawa commune, Lubuskie voivodship. Archaeological materials from the 15th-century phase: a–f – earthenware pottery, g–l – ceramic ribs from the vault (development by A. Michalak)

the obtained fragments. Among the pots, a form with a semicircular, thickened edge and a clear notch for a lid stands out (Fig. 9: d). In Poland, this type is dated from the 14th to 15th centuries. In Witków, fragments of this type have been found before (Kałagate 1994, p. 163, Fig. 2: 1). In general, these materials include numerous vessels equipped with a lipped edge (Fig. 9: b, e), as previously found in late-medieval materials from research on the tower in Witków (Kałagate 1994, Fig. 2).

A dozen or so items of construction ceramics can also be associated with this phase, including ceramic fittings – double-concave vaulting ribs – from the decoration of the ostentatious dome of the tower's ground floor (Fig. 9: g–j). In addition, the excavation yielded fragments of ridge tiles and monk-and-nun tiles from the roofing of the tower or gatehouse (Fig. 9: k, l). They were found loose in the excavation near the west side of the gate, where they had probably been thrown during renovation works around the mid-16th century.

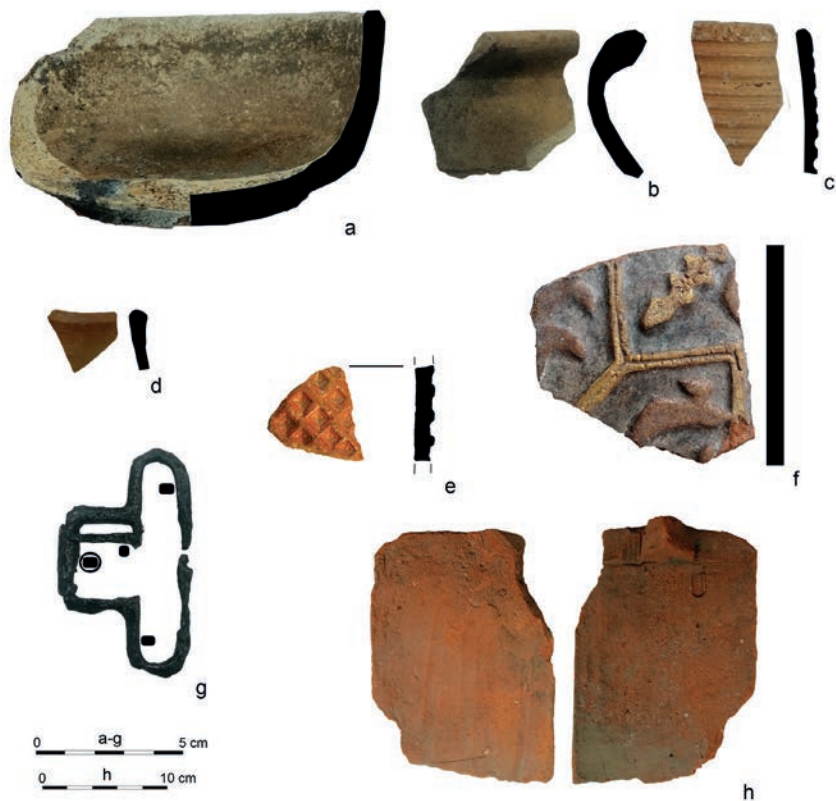
Fig. 10. Castle in Witków (site 6), Szprotawa commune, Lubuskie voivodship. Archaeological materials from the 16th-century phase: a, b – earthenware pottery; c, d – stoneware; e – imitation of Falke stoneware; f – glazed ceramic floor tile; g – T-shaped buckle from horse harness; h – ceramic roof tile (development by A. Michalak)

We should also mention an ornate floor tile of glazed ferric clay (Fig. 10: f). A T-shaped buckle probably also dates to the 16th century (Fig. 10: g) It was found in the roof layers of the gate. Based on ethnographic analogues, it can be judged to be a saddle girth buckle (Egan 2004, pp. 59–61).

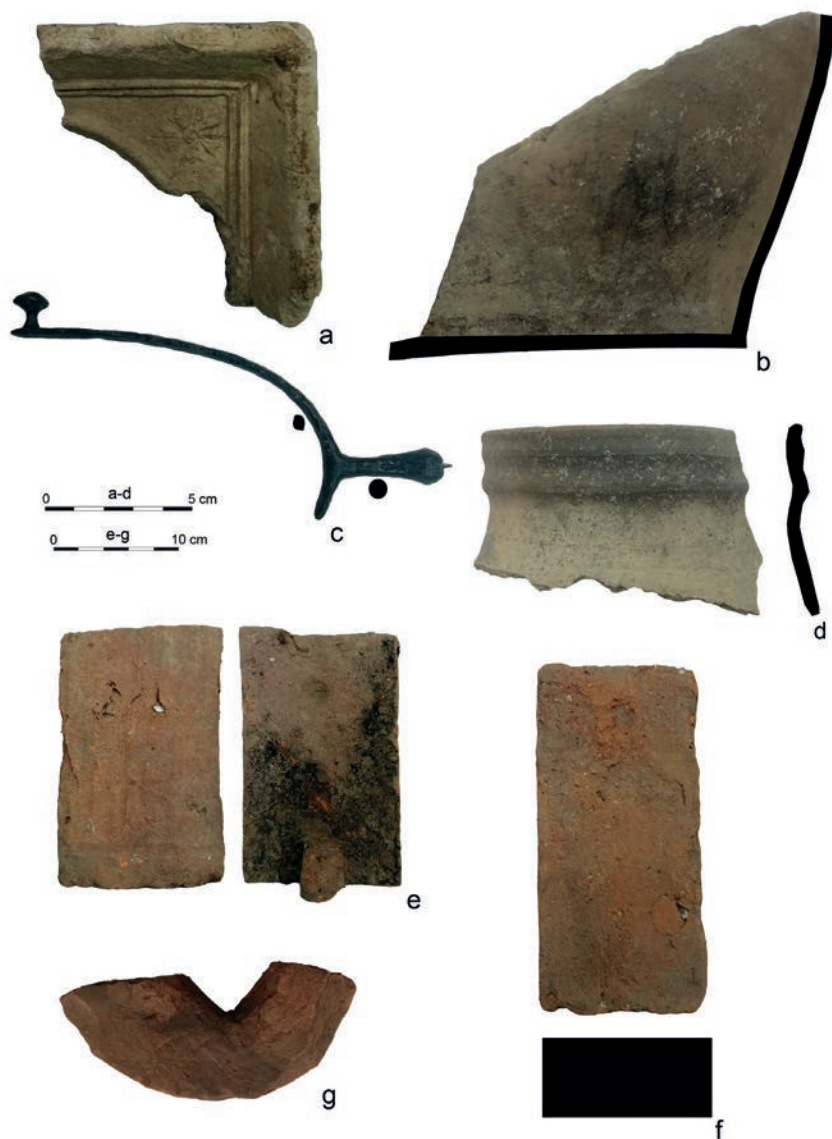
Fig. 11. Castle in Witków (site 6), Szprotawa commune, Lubuskie voivodship. Archaeological materials from the 17th-century phase: a, b, d – earthenware pottery; c – iron spur; e – ceramic roof tile; f – brick; g – whetstone (development by A. Michalak)

The acquired movable cultural objects (mainly ceramics) that can be associated with this phase of the castle's use was largely found in backfill layers, so it tells us little. As well as thin-walled brick-red and cream-yellow vessels (Fig. 11: b) glazed inside and out, fragments of basin tiles were also discovered. Most of the ceramic stove tiles are unglazed. Most can be dated to the 17th century (Fig. 11: a). Of the identified items, a spur with a U-shaped heel band that is almost flat seen side-on and is equipped with a star-shaped rowel and rounded chap guards (Fig. 11: c). Based on analogies, it can probably be attributed to the 17th-century (Beneš *et al.* 1995, Fig. 6: 2). Large amounts of lime mortar, sometimes painted, and building ceramics (including bricks and plain tiles; Fig. 11: e, f) were also recorded in the excavation at the gate.
