**The second left-bank castle in Wrocław in the light
of the latest archaeological and architectural research**

Abstract. The paper presents the results of archaeological and architectural research on the premises of the former Babiński Hospital at John Paul II Square (plac Jana Pawła II) in Wrocław (Poland), during which the relics of the unfinished second left-bank castle, dating back to the end of the 13th century, were uncovered.

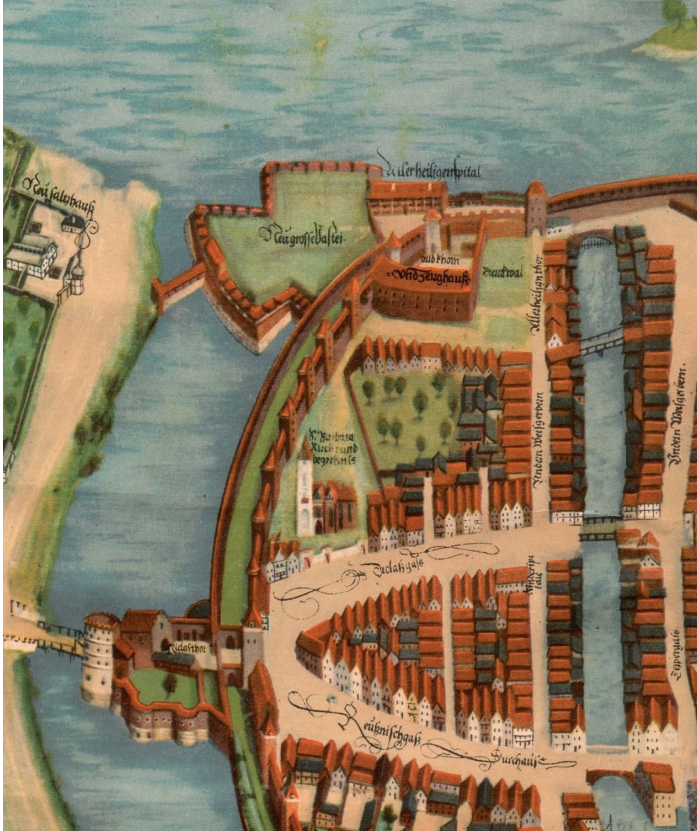
Fig. 4. Wrocław. A fragment of the plan of the B. Weiners showing the area in question (after Weiner 1929)

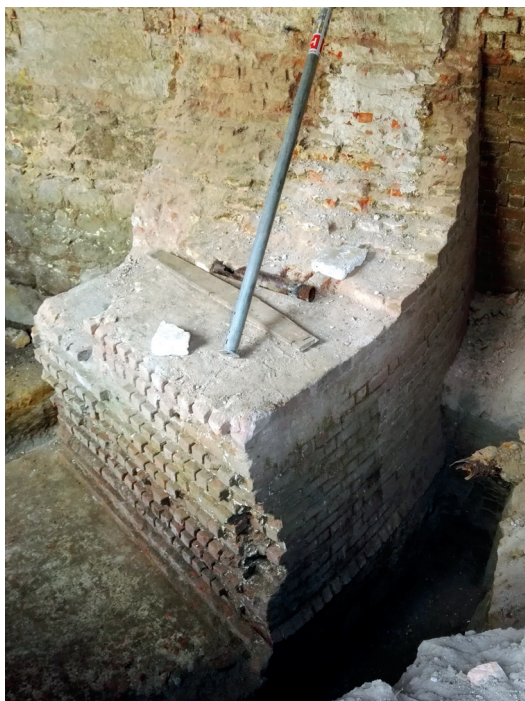
Fig. 7.
Wrocław. Arched wall: view from the south-west. In the lower-left corner of the photo the foundation is visible (photo by P. Kmiecik)

of a arched, brick wall with tothing, an inner face with a vertical bond, and an external (southern) face with vertical deviation of an angle of approximately 7 degrees, was found (Fig. 7). It was built as solid-finger, hand-made, brick masonry measuring approximately 29 x 14 x 9 cm in a Flemish bond. A lime-sand, sand-grey, strong mortar with a large amount of lime binder was used for the construction. It also contained a noticeable amount of the so-called lime lumps (micrite aggregates). This suggests lime burning in non-homogeneous conditions (Gašior *et al.* 2015, p. 215). This is a characteristic feature of medieval construction. Some of the headers visible in the face of the wall are clearly darker than the rest of the material, but no geometric schema can be observed in their arrangement. The joint of the inner (north) face is smoothed, which suggests that this part was intended for backfilling. The vee joint was used in the inner face of the wall. From the inside, in the line of the later defensive wall, tothing was found, suggesting the planned construction of the inner wall of the element almost perpendicular to the described perimeter wall, running towards the north (Fig. 8). In the lower part, on the outer side (south), a cornice made of simple, ceramic, special bricks was found. The width of the wall at its base (level 114.6 at the ground level 117.8–118.0 m a.s.l.) is about 3.2 m, at the level of the preserved coping – 2.97 m, and at the height of the pavement about 2.50 m. The height of the preserved part from the foundation level to the preserved coping

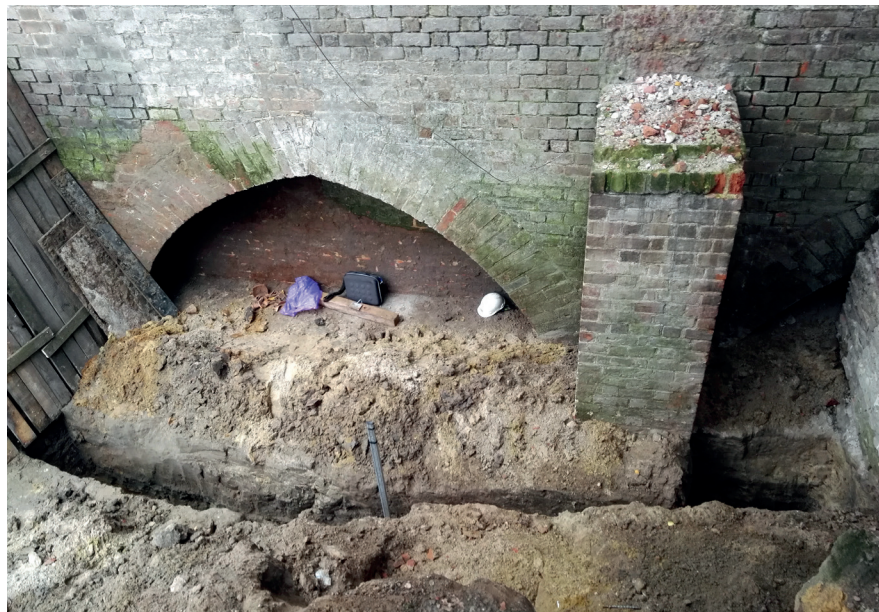
Fig. 8. Wrocław. The north end and the beginning of the middle span of the bridge seen together with the buttress. On the right side, the arched wall protected from mechanical damage (photo by P. Kmiecik)

was 2.1 m, and the total height read out from the trace of the scattered fragment was 5.2 m to the level of the pavement. The battlement height is not possible to be measured precisely due to the latterly made end bearing for ceiling beams that occur at this level, but with a certain approximation it can be assumed to be about 1.7 m, which gives the total height of the wall from the foundation level as about 7 m. On the inner (northern) side in profile there is a visible trench reaching the bottom of the masonry construction. The whole structure was founded on erratics supplemented with bricks on lime and sand mortar with visible fragments of lime (Kąsinowski 1970, p. 61). The foundation was made in a narrow trench, placed at a level of about 112.9 m a.s.l., with the coping at a level of 114.6 m a.s.l. The foundation line continues the curvature of the wall, but continues beyond the west wall of building no. 8. However, no traces of the continuation of this structure were found in the exploratory trenches established there. The coping of the preserved part of the wall coincides with the original floor level of the present building, so it can be assumed that at least the last demolition works on this part must have been related to the construction of a hospital facility. The width of the foundation at the wall's coping level is slightly wider than the base of the masonry wall and is about 3.5 m.

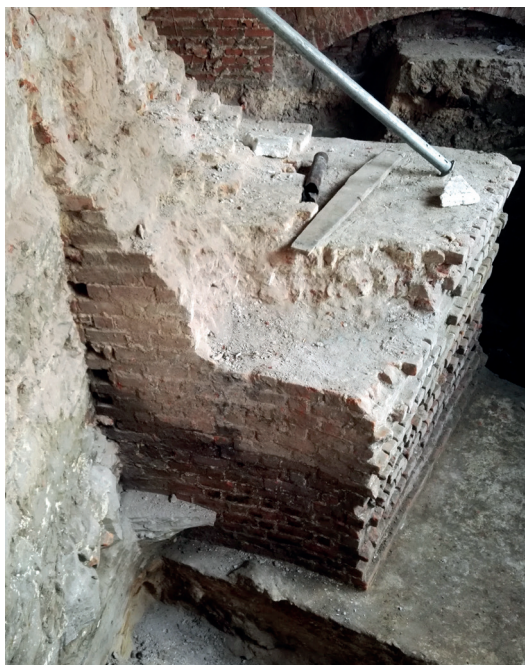
Fig. 9.
Wrocław. Arched wall: view
from the north. Remains of concave
toothing visible on the left
(photo by P. Kmiecik)

Also noteworthy is the concave toothing found in the arched wall directly opposite the bridge wall, in a place where you would expect some sort of a gate building (perhaps another tower).

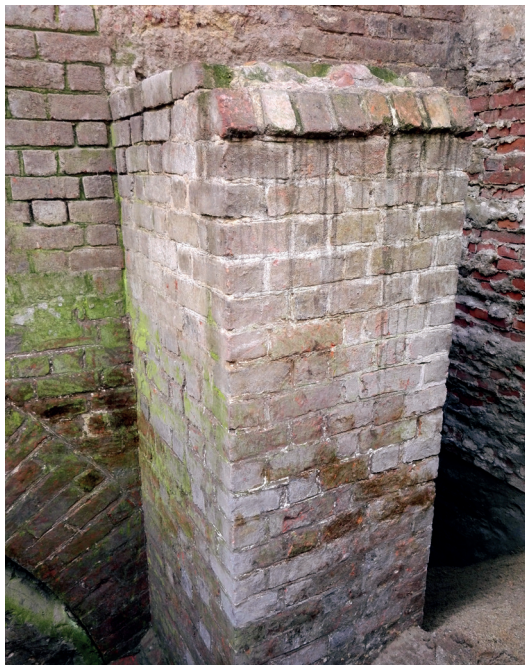
Fig. 10.
Wrocław. The buttress: upper
offset and arch connection are
visible (photo by P. Kmiecik)

South of the arch wall, below the found masonry cornice in a roller arrangement, in the line of the later city wall, a blinded two-centred arch span was found, originally interpreted as an element of a culvert or a bridge (Fig. 9). Below the second scraped element, a buttress was found, the size, shape and location of which corresponded to those found by J. Romanow on the eastern side of the same wall (Informator 1982, p. 277). It was made of solid brick with dimensions of approximately 29 x 14 x 9 cm on the mortar identical to the one found in the arched wall. In the external wall face, right next to the preserved coping, an offset profiled with ceramic special bricks was exposed. From the analysis of the preserved mortar fragments above, it can be assumed that its original slope length was at least two bricks (Fig. 10). In the lower part of the buttress, in all dimensions, there is an offset made of ceramic special bricks, similar to those found on the arched wall. Both the pillar and the buttress were set on a foundation made of granite blocks, with a plan identical to the lower part of the brick part (Fig. 11). To the south of

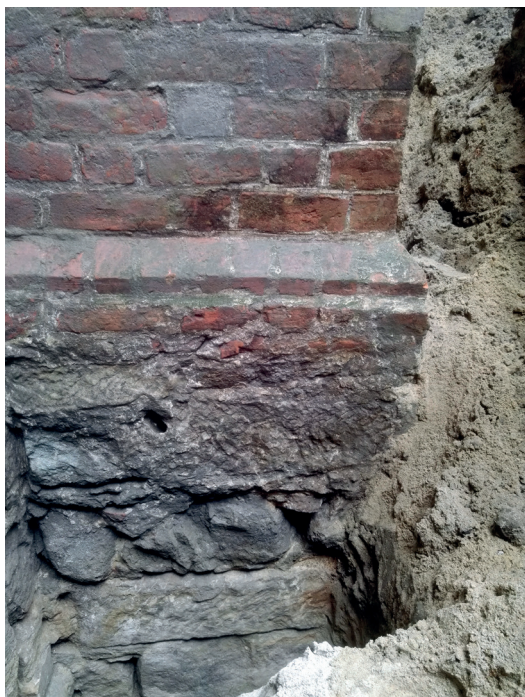
Fig. 11.
Wrocław. Lower part of the
buttress. Visible foundation
technology and profiled offset
made of brick fittings (photo by
P. Kmiecik)

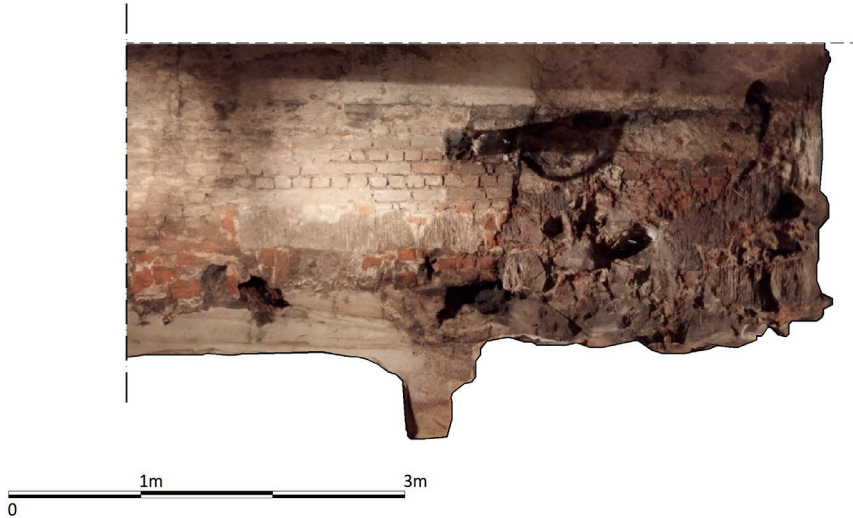
Fig. 13. Wrocław. View of the south wall of trench no. 6.III. A scraped wall with a sloping face is visible on the right (photo by P. Kmieciak)
