## OLGA ANTOWSKA-GORACZNIAK

Cemeteries of the Church of Our Lady *in Summo* in Ostrów Tumski in Poznań from the second half of the 15<sup>th</sup> towards the late 18<sup>th</sup> century – variety of funeral practices\*

Keywords: Poznań, church cemetery, cemetery wall, ossuary, Middle Ages, Modern Times.

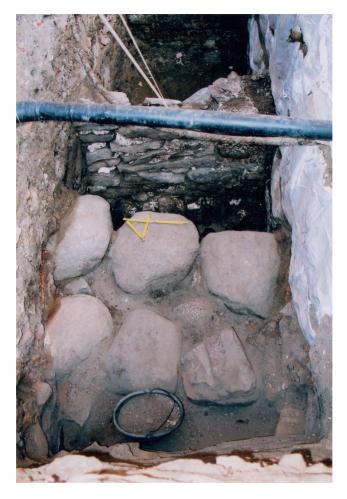
Fig. 3. Continuous foundation on the west side of the church – trench 54 (photo by A. Sikorski)

The field works yielded records of numerous foundations and relics of the abovementioned cemetery wall built shortly after the mid-15th century. The structure was found to have an uneven foundation, for which, in the western and northern parts, also older foundations were reused. It is not surprising then that there is a mention dated back to 1529 about the need for a new wall between the church and the Psaltery (Nowacki 1951, p. 328). It could be assumed that at that time, it might have been renovated, but at the level of the preserved foundations no clear evidence of the scope of these works has been observed. These two parts were laid on a continuous foundation comprising large boulders and fragments of brick rubble with clay, covered with earth (Fig. 3). On the other hand, the south-western, southern, and south-eastern parts were constructed on a point foundation with brick arches one-brick tall, with bricks arranged as stretcher - header - stretcher (Fig. 4: 1, Fig. 5). The width of this foundation varied from 1.5 to 2 m, and at the height of the brick arches, it measured about 1 m. These relics were identified at a total length of about 33 m. The span of the brick arches, as recorded, ranged from about 3.3 m to about 3.8 m, with a height of about 0.7/0.85 m. The arches were carelessly made, crooked, and slightly triangular with a crown at the top. From the outside, a system of narrow buttresses was applied for extra support against the slope of a small hill. They were positioned fairly regularly at intervals of 4-5 m. Within the area in question, relics of three buttresses and one corner buttress were identified in trench 16 (due to technical difficulties, it was not possible to identify the cemetery wall in trench 75, where one more buttress might be expected). The written sources frequently refer to the Church of Our Lady as in Summo, thus the hill must have been clearly visible in the landscape. The wall above the foundations was made either of stones and bricks, or bricks only. A Gothic motif was rarely observed. The brick structure of the wall was often interrupted by large boulders with flat surfaces. The stone-and-brick cladding of the lower parts of the wall refers to the stone-and-brick plinth of the church, and perhaps it served this exact function. This aboveground part was up to about 0.8 m wide. On the north side of the church, there was a wall much as 0.95-1.15 m tall, previously preserved in a much better condition, today known only from descriptions provided by the works conducted in 1946. It was made of bricks "with the same bond as that of the

Church of Our Lady [...] and the Psaltery [...]" (Żak 1959, p. 101) – that is, a Gothic one-stretcher motif. In written sources referring to the construction, it was noted that the wall was erected to the height of 10 cubits (Nowacki 1951, p. 328), that is, almost 6 m! This height corresponds with defensive walls rather than the fence of the cemetery. Therefore, it should be assumed that either the note is inaccurate or that the metric value included the foundation. The latter would mean that about 2.5 m of the foundation sunk below the ground level, and that the above-ground wall was about 3.5 m tall. From the north, within trench no. 60, a foundation was registered, meant for a less deeply based and definitely narrower brick wall, made using early modern brick (Fig. 4: 5).

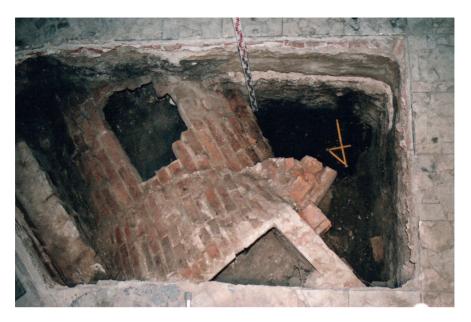
Fig. 6. Crypt in the north-eastern part of the ambulatory – trench 69 (photo by A. Sikorski)

Other crypts or masonry tombs were identified inside the collegiate church in the eastern part of the ambulatory and in the central nave (Fig. 4: 4). To the north of the ambulatory, there is a preserved toothing of an older, perhaps late medieval crypt built of "finger" bricks, while a completely preserved early modern crypt with a barrel vault and an 'entrance' with steps leading downstairs from the north-west side was constructed on it (Fig. 6). This "entrance" likely served as an opening to put more coffins through rather than a proper entrance that would allow one to enter conveniently. A kind of a cover was recorded - a door made of sheet metal. Four graves have been identified in the crypt, one of them being a burial of human bones placed in a coffin with no anatomical order (a double? - two skulls). The best-preserved tomb in the crypt belonged to a priest in a chasuble with preserved remains of a stole (grave 136). On the basis of the collected materials, the time of the construction of the crypt could be estimated at the second half of the 17<sup>th</sup> century. The breach in the vault of the crypt was probably caused by a construction disaster and the collapse of the vaults in the eastern part of the church in the 18<sup>th</sup> century, replaced with newer ones in 1727 (Kurzawa 2003, p. 365). The crypts were still visible during the inspection of the church in 1841, preceding the 19th-century renovation. It was at that time that a decision was made that "the vaulted rooms located in it along with the bones of the dead should be buried" (Kurzawa 2003, p. 367). Eventually, the crypt/crypts was/were put out of service, filled with soil, and covered with a floor during the 19th-century renovations.

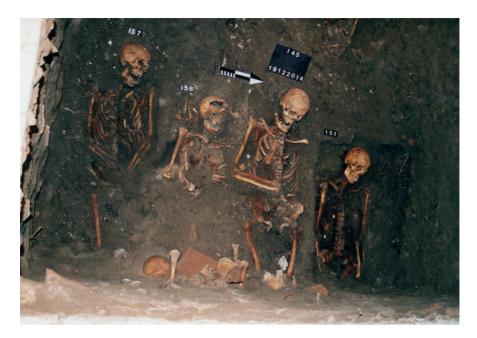
Fig. 7. Burials from the northern aisle – trench 78 (photo by A. Sikorski)

difficult in terms of putting together those from various trenches in the same area. Hence, it was only later possible to combine two different grave numbers or delete randomly duplicated numbers. Now, despite these obstacles, some regularities relating to the cemetery might be suggested. All skeletal burials within the church were oriented along the E-W axis, with heads to the west (with the exception of grave 137 in the central nave where the head was oriented to the east). It should be added that the Church of Our Lady was not built in line with the designated directions, but with a deviation of about 20° on SE-NW, and the burial pits were oriented according to the building. However, burials in the modern crypt on the north-eastern side of the ambulatory differ from this arrangement, where their orientation was adapted to the longitudinal axis of the crypt. In the church cemetery, a greater variety of burials was noticed. On the northern, western, and eastern sides of the shrine, the tombs were located along the E-W axis, usually with heads towards the west (exceptions; tombs 13, 18, 89), while in the southern part, the dead were buried either along the E-W axis (deviation on SW-NE) with heads towards the west (exception grave 4), or along the S-N axis (deviation on NW-SE) with heads northwards (exception grave 32). This may suggest two different phases in which the cemetery was in use - the older one with a traditional medieval arrangement of skeletons and the younger one (17th-18th centuries). For the younger phase, in the south-eastern part of the discussed area, three rows of burials were recognised, probably separated by narrow alleys. Moreover, two graves on both sides of the portal, in front of the south entrance to the church belong this phase. A detailed division into phases of use of the cemetery inside and outside the collegiate church will be possible after the analysis of stratigraphy and materials obtained during the excavations. As far, the study confirms the custom of choosing a burial place on the east side of the church, where the highest density of graves has been observed. Also, a desirable space was the interior of the church, where a particular density of graves was found in both aisles: in the central and southern part of the southern aisle and in the entire studied space of the northern aisle (Fig. 7).
