# ANDRZEJ LEGENDZIEWICZ<sup>1</sup>, ELŻBIETA GRODZKA<sup>2</sup>, DARIA DOBRASIAK<sup>3</sup>

# The alderman's seat in Głuchołazy and its transformations from the 14<sup>th</sup> century to the beginning of the 19<sup>th</sup> century\*

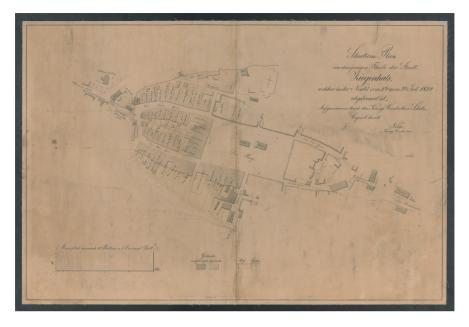
Fig. 2. Głuchołazy, plan of the town after the fire on the night of 2–3 June, 1834. The alderman's seat is described as *Vogtej* (courtyard), *Stadtgericht* (west wings) and *Schule* (south wing) (AP Opole, file no. Op. IX/26)

The archival iconography was also analysed, which consists of: a lost picture of the view of the city from 1634, a painting depicting the city fire of July 1834 – in the collection of the Museum in Nysa, and a plan of the city after the fire on the night of 2–3 July 1834 (Fig. 2) (AP Opole, file no. Op. IX/26).

The building complex of the alderman's seat was partially destroyed as a result of a fire that broke out on the night of 2–3 July, 1834 (Fig. 2) (AP Opole, file no. Op. IX/26).

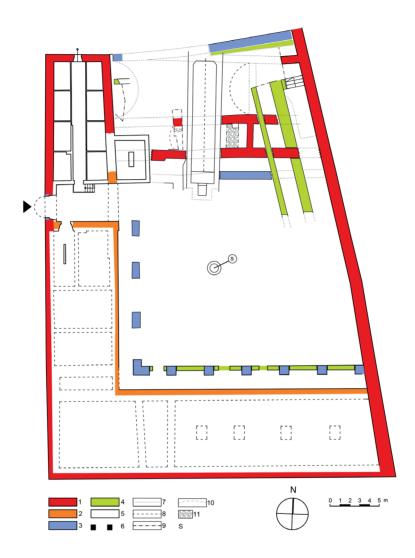
Fig. 3. Głuchołazy, the alderman's seat, plan of the basements with chronological stratification of the walls. Key: 1 – first half of the 14<sup>th</sup> century, 2 – around the middle of the 15<sup>th</sup> century, 3 – around 1603, 4 – the second half of the 17<sup>th</sup> century, 5 – 19<sup>th</sup> and 20<sup>th</sup> century, and also unrecognized walls, 6 – stone frames, 7 – reconstruction lines (walls and vaults – hypothetical), 8 – reconstruction lines (walls and vaults), 9 – borders of inspection excavations; 10 – reconstruction lines of gothic vaults, 11 – stone pavement, S – well (developed by A. Legendziewicz, E. Grodzka, D. Dobrasiak)

the market square. The complex was surrounded by stone walls connected to the city wall (Figs. 3, 4).

The Renaissance reconstruction carried out by the alderman Henrich Adelsbach was probably carried out in the first half of the 17<sup>th</sup> century (Kutzer 1928, pp. 131–134). The form of the building after these works is known from a lost picture of the view of the city from 1635. It shows a three-winged, three-story building arranged around a courtyard. The eight-axis front facade is decorated with a two-storey attic ridge. Its crest consisted of nine elements, behind which there was probably a butterfly roof. During the excavations in the courtyard, fragments of slate slabs were discovered, which may indicate that they could have been used as a roof covering. On the ground floor of the western facade, there was a semicircular gate opening leading to the courtyard, which was framed with stone blocks (Figs. 3–5).

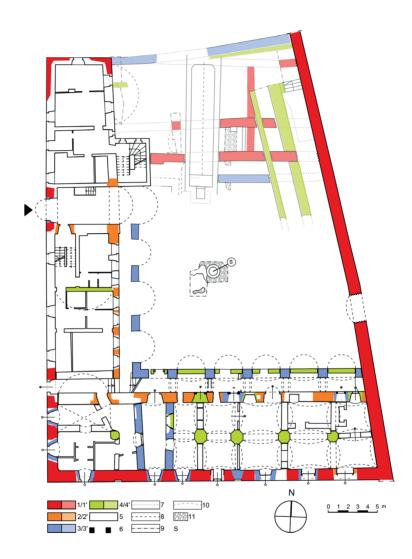
Fig. 4. Głuchołazy, the alderman's seat, ground floor plan with chronological stratification of the walls. Key: 1/1' – first half of the 14<sup>th</sup> century (basement and ground floor walls), 2/2' – around the middle of the 15<sup>th</sup> century (basement and ground floor walls), 3/3' – around 1603 (basement and ground floor walls), 4/4' – the second half of the 17<sup>th</sup> century (basement and ground floor walls), 5/5' – 19<sup>th</sup> and 20<sup>th</sup> century, and also unrecognized walls, 6/6' – stone frames, 7/7' – reconstruction lines (walls and vaults (hypothetical), 8/8' – existing vaults and arches, 9/9' – borders of inspection excavations, 10/10' – reconstruction lines of gothic vaults, 11/11' – stone pavement, S – well (developed by A. Legendziewicz, E. Grodzka, D. Dobrasiak)

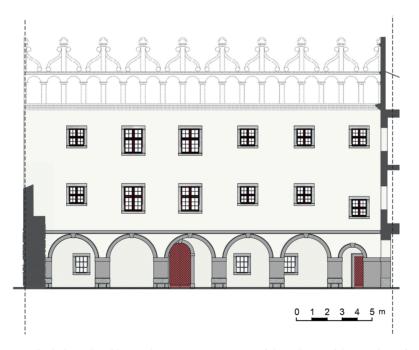
Fig. 6. Głuchołazy, the alderman's seat, reconstruction of the colours of the northern facade of the southern wing (the form of the attic – hypothetical) (developed by A. Legendziewicz, E. Grodzka, D. Dobrasiak)

1.2 to 1.4 m from them. At the bottom of the walls, arcades were introduced: from the south – six, from the west – four, and probably five from the north. They were probably semicircular arcades that opened onto a cobbled courtyard. Their shape is known from the ones that have been preserved in the southern wing. Evidence of the others are their foundation walls. Archivolts, with a span of about 3 m and edges decorated with bands, were supported on rectangular pillars with cubic imposts. The arcade in the southern wing, and probably in the others wings, was covered with a beam ceiling (Fig. 6).

The colour scheme of the facade of the courtyard was formed in accordance with the rules in force during the Renaissance in Silesia, as well as analogously to other buildings funded by bishops in the cities of the Duchy of Nysa (Chorowska, Legendziewicz 2023, pp. 165–166). The stone detail was painted grey and black, and it stood out against the smoothed background plaster, which was whitewashed in the colour of Roman white. In addition to the new colours, a stone pavement was also laid 283.54 m above sea level in the courtyard. The floor was introduced under the arcade, in the passage hall, and around the well in the middle of the courtyard (Fig. 6).

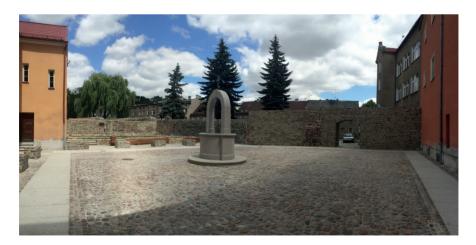
Fig. 7. Głuchołazy, the alderman's seat, general view of the courtyard towards the north-east (photo by A. Legendziewicz)

Both walls were made with the use of broken stones from the demolition, which were laid quite carelessly. The binder was a weak lime-sand mortar that was sandy-white in colour (Fig. 7).
