**MAREK BOGDAŁA¹, MAŁGORZATA CHOROWSKA²,
KRZYSZTOF CZARNIAK³, WITOLD WANIEK⁴**

**The House and the utility buildings of the Cathedral Chapter in Wrocław
in the light of architectural and archaeological studies**

Abstract. Detailed architectural studies of the 14th-century House of the Cathedral Chapter in Wrocław conducted in the course of the current renovation works of the Archdiocese Museum complex shed a new light on the architecture of the building and the way it functioned in the Middle Ages. Parallel archaeological studies carried out in the basement of the building and in the courtyard revealed utility buildings, furnaces, a latrine shaft, and cobblestones from the medieval era and the subsequent period. The article presents the history of the construction of the buildings that comprise the chapter complex including the adjacent utility buildings divided into 3 medieval phases and 3 modern phases, as well as selected archaeological artefacts.

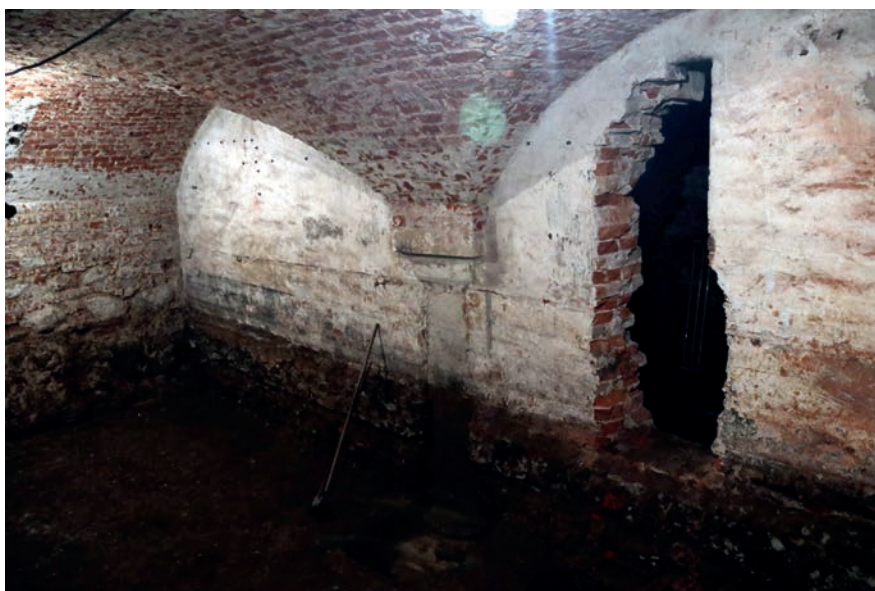
Fig. 2. Wrocław, interior of Piwnica Świdnicka in the underground of the House of the Cathedral Chapter. In the centre of the wall that serves as a secondary partition in the cellar there is a walled-in pillar (photo by M. Bogdała)

Originally, the cellars were accessible via as many as 3 ways. The southern one, running from the side of the cathedral, has been in use until the present day. The western one, from the side of Kanonia Street, was converted into a window in the 20th century. The third way was leading directly from the ground floor of the Chapter House via a narrow staircase corridor hidden in the depth of the west wall. The stone door frame leading to this corridor were bricked up ca. mid-17th century and for this reason, it had not been discovered until the renovation works in 2022. The corridor was narrow, with a brick barrel vault (Fig. 3). The brick steps were illuminated by an embrasure that is now walled over.

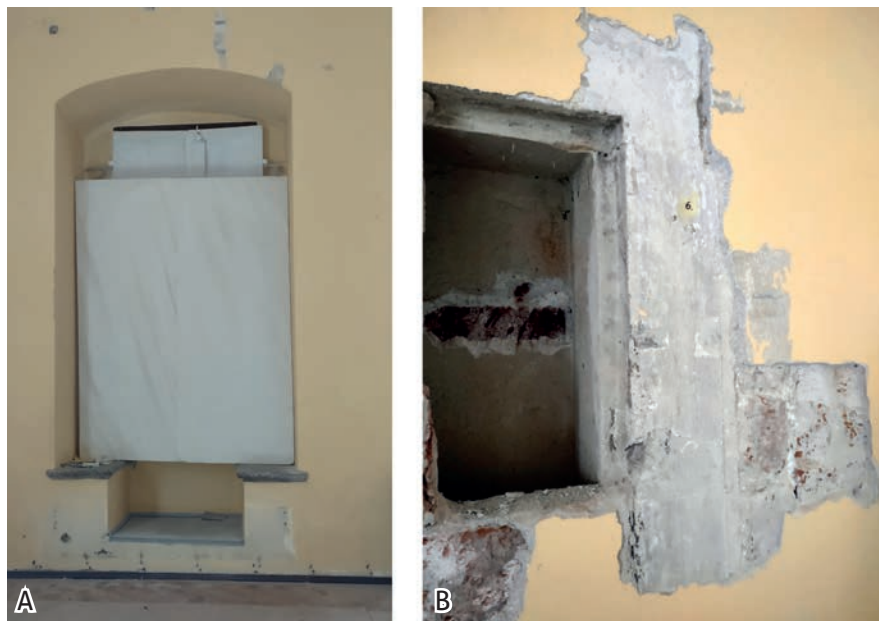
Fig. 6. Wrocław, House of the Cathedral Chapter, window openings on the first floor level:
 A – recess of the walled-in window opening with stone sedilia on the sides – north,
 B – walled-in entrance to the north (sanitary?) unit, prior to the conservation work
 (photo by M. Chorowska)

the interior of the Chapter House, this opening was framed with simple masonry with a recess for the door carpentry (Fig. 6: B). From the side of the annex, it was ogival, with the opening cut in the older wall and its soffit plastered with yellow-beige mortar⁵.

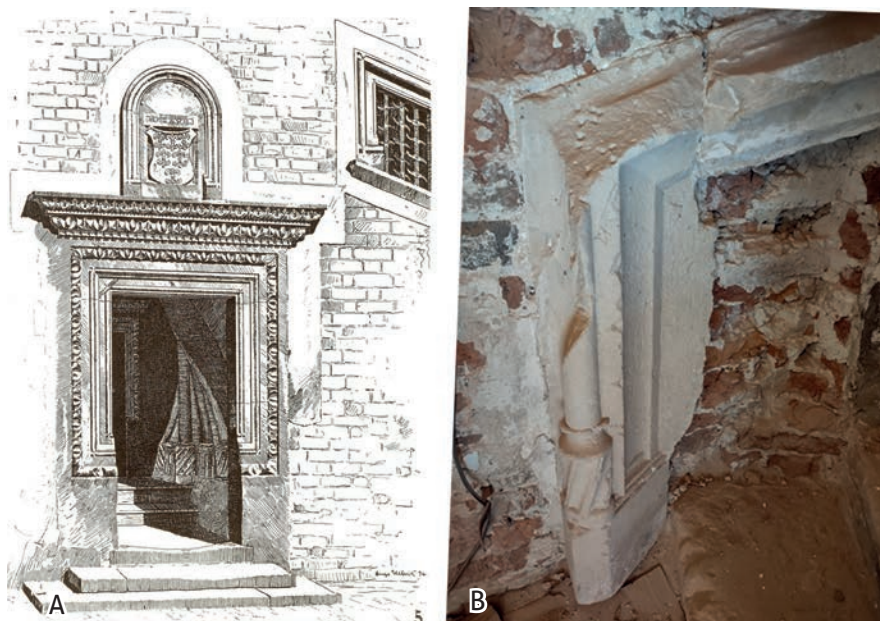
Fig. 7. Wrocław, pieces of masonry included in the southern staircase tower in the years 1518–1527. A – portal in H. Lutsch's drawings, B – the unearthed railing of the spiral staircase prior to the conservation work (photo by M. Chorowska)

Another just as equally significant refurbishment pertained to the 15th-century staircase tower. It was turned into the ceremonial main entrance to the Library on the first floor. The former “narrow stairway” was replaced by a spiral stone staircase with an ornamented handrail and a spiral pillar (Fig. 7: B). They were a highly effective solution consisting in the pillar in the form of an Amazon’s shield spirally enclosed by two shafts. One of them was turning into the inner handrail, whereas the other served as the framing of the pillar. The third shaft was vertical and determined the stairway spital axis. The shafts and the trochilus that separated them from one another were raising from five small bases decorated with colourful reeds and a motif of a twisted rope. Each tread-board was made as a monolith along with a section of the pillar. During the works conducted by fine arts conservator Waldemar Waszkiewicz, the lower part of the outer stairway handrail was also revealed, which was turning into a handrail of a cylindrical form⁶.

⁶ The damage to the newel and the handrail of the staircase took place in 1903 during works conducted in the building by Joseph Ebers, who adapted the interior of the old Chapter House to the needs of the Archdiocese Museum.

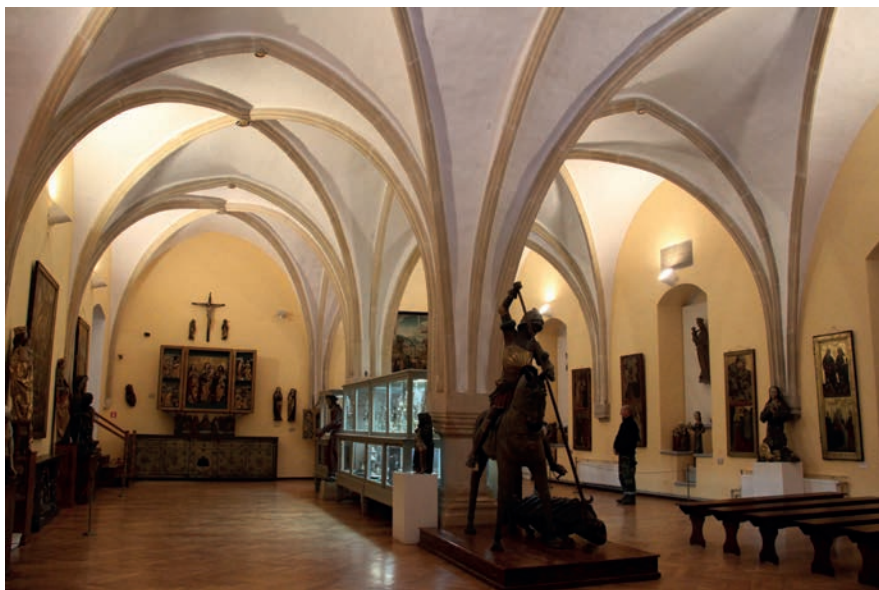
Fig. 8. Wrocław, the interior of the former Library on the first floor of the Chapter House before the renovation works (photo by M. Chorowska)

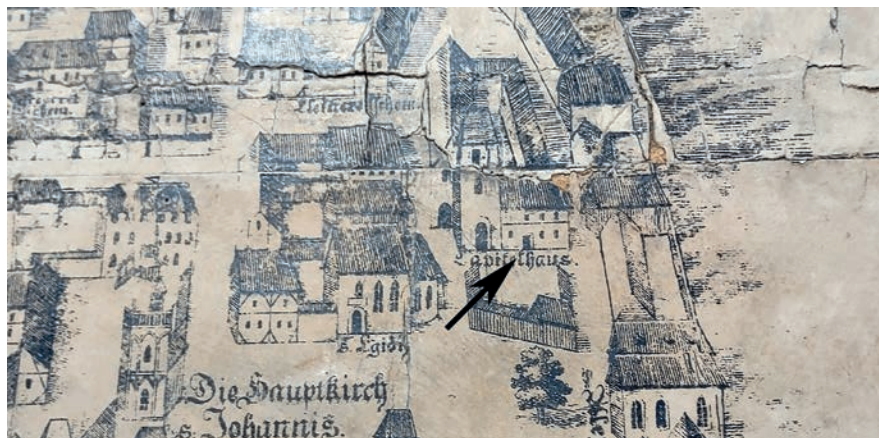
Fig. 9. Wrocław, fragment of a 1562 copy of the layout by Barthel and Georg Weiner, showing the property that is an appurtenance of the building of the Chapter including utility buildings (copy at the Faculty of Architecture of the Wrocław University of Science and Technology, building E-5)

In the 1562 axonometric layout by Barthel and Georg Weiner one can spot right next to the Chapter House and the staircase tower in the foreground the building of the Cathedral Office with a parallel roof ridge (Fig. 9). The version of that view of Wrocław in colour shows that it was a single-storey beam building. At present, this location is taken by a building that is one storey higher, with a beautiful late Baroque frame façade⁹, founded in 1756, when the chancellor of the chapter was baron Adam Josef Keller. During the architectural-archaeological studies conducted in 2022, its foundations were unearthed. They were massive brick arcades enclosing the older walls, partially late Gothic, from the first quarter of the 16th century, and partially from the 17th century. Thus, the chronology of this building was confirmed, dating it to the time before the 18th century.

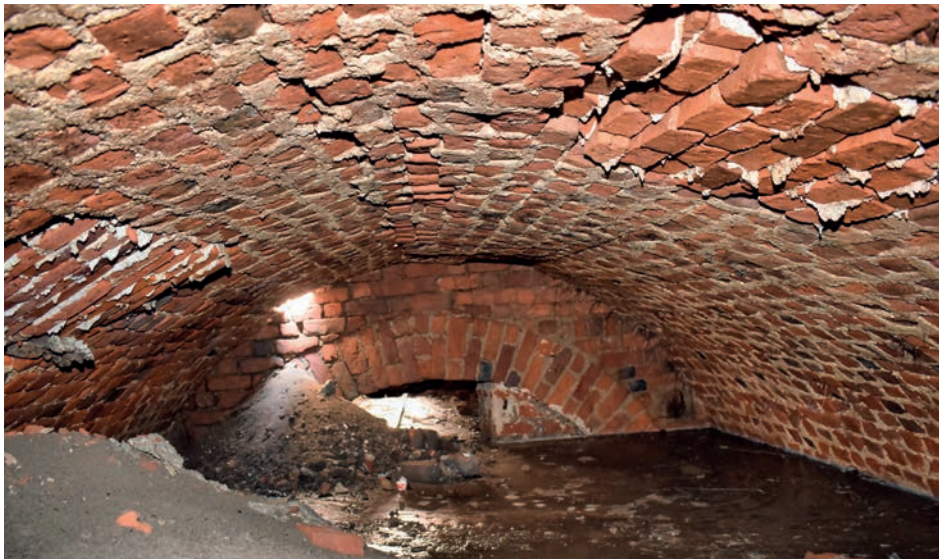
Fig. 11. Interior of the discovered cellar – as seen from the north (photo by M. Bogdała)

Among the unearthed buildings, the oldest ones were two narrow barrel-vault cellars situated one after another in N–S axis configuration. In the first stage, these cellars were separate brick “tunnels” independent of the clay-wooden buildings higher up in terms of their structure. Their interiors were enclosed from above and on the sides by clay barrel vaults that extend down (Fig. 11), whereas on the side of the tops, by screen walls that are not extended above the ceilings. The interior of the northern cellar was 4.4 by over 3.5 m big, whereas that of the southern one was 6.0 by over 3.6 m large. Initially, there was one entrance leading to these interiors, located on the south side. The cellars were connected by holes in the end wall. Their 15th-century chronology is supported by the used building material. In the next phase, the northern cellar gained an adjacent brick wall, 0.7 m thick, running in the north-south axis, as one more utility building was added. It had no basement and was supported by a pillar and flying buttress. Considering that on average, the thickness of the walls is 0.7 m, it can be assumed that it had two bricked storeys and two chambers on the ground floor.

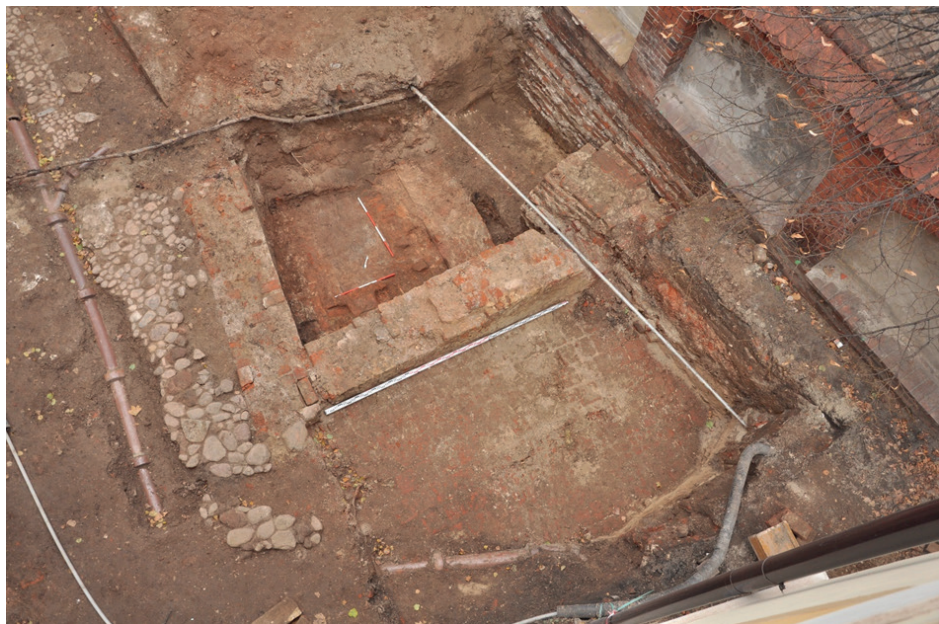
Fig. 12. Wrocław, utility buildings of the Chapter House – a general view on the discovered relics of the utility building in the northern part. 1 – cobblestones; 2 – hypocaust furnace, bottom of the firebox; 3 – clay-tiled floor; as seen in the north-eastern direction (photo by W. Waniek)

cobblestone level of the yard. It was built using bricks and hardened with kaolin clay (Fig. 12). The space between the three walls of the room and the firebox was filled with brick rubble and fragments of monk-and-nun tiles joined together using greyish lime mortar. Its pinkish discolorations show that it was in contact with fire. Below the foundations of the wall that separated the rooms with furnaces, there was a foundation from an older building whose role is unknown. Perhaps it was a wall that was enclosing the Chapter House complex back in the 14th century.

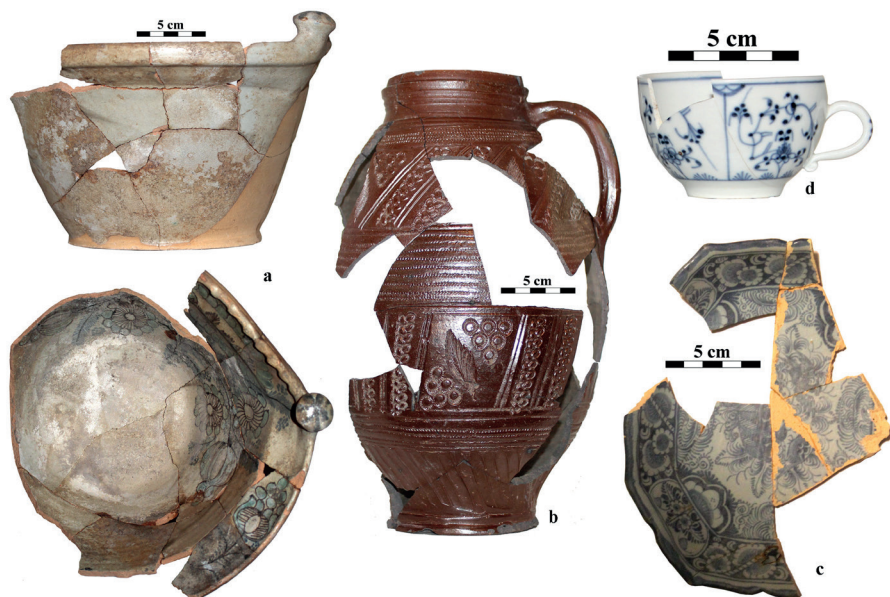
Fig. 13. Wrocław, selection of ceramics: a – aquamanile from the cellar of the Cathedral Office building (from the turn of the 17th century), b – stoneware jug from the northern part of the cellar of the Chapter House (17th century), c – faience, d – porcelain from the latrine shaft (photo by K. Czarniak)

the above-mentioned ones and the faience and porcelain vessels discovered there in terms of style (Fig. 13: c, d).

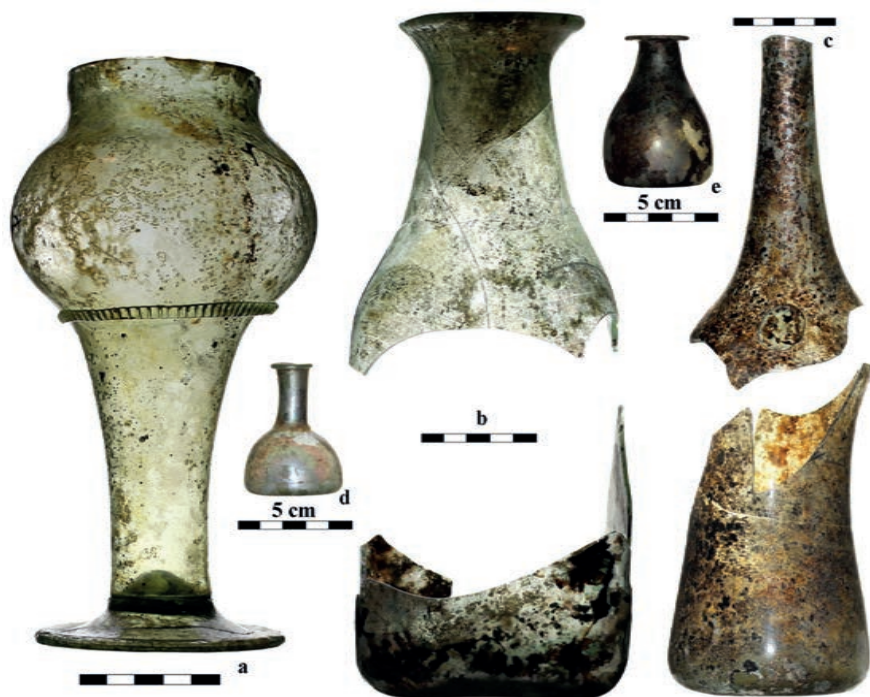
Fig. 14. Wrocław, Chapter House. Glassware from the northern part of the cellar (photo by K. Czarniak)

Glassware. The region covered by the study yielded a rich collection of glassware and fragments (744 pieces) of at least 398 products. The most representative are the materials unearthed in two abundant complexes, namely, the northern part of the Chapter House and the latrine. Furthermore, they somewhat show a chronological diversity. As for the glassware from the cellar, two main temporal horizons can be identified, too.

The older one is basically represented by glassware made of natural colour glass, celadon green, with some specimens made of raw material in dark green. Dating back to the 17th century, these products are connected to the operation of the above-mentioned inn. Among them, the most numerous are containers for eating or serving alcoholic beverages. There are numerous fragments of chalices and one specimen preserved in its entirety. It seems that this form could be a one-time order delivered for the inn. It comprises a spherical bowl with a short, distinct cup and a slender stem empty inside, fixed to a wide foot (Fig. 14: a). Most likely, a similar anatomy was shared by chalices that were significantly smaller and thus preserved fragmentarily, which were encountered in the same location. Their stems and bases show the same form, but their bowls were not preserved. Aside of these, there were also occurrences of fragments of beer mugs and glasses on tall stems. Fragments of characteristic tetrahedral carafes were also found (Fig. 14: b). A vast collection there is also made up by pieces of wine bottles with slightly concave walls and bottoms. At the neck of these bottles, there glass rings were added. Interestingly, they come with no traces of stamps (Fig. 14: c). The artefact collection from this timeframe is complemented by small medicine bottles rarely preserved in entirety and more often fragmentarily.

A younger chronological horizon within the discussed cellar is represented by relatively few artefacts made of sodium glass, which makes these specimens ideally transparent and of better quality. These often include particularly fragments of full-size glasses and similar yet smaller chaser glasses. These artefacts occurred within layers situated above, together with ceramic pipes, which allows us to date them back to the first half of 18th century.

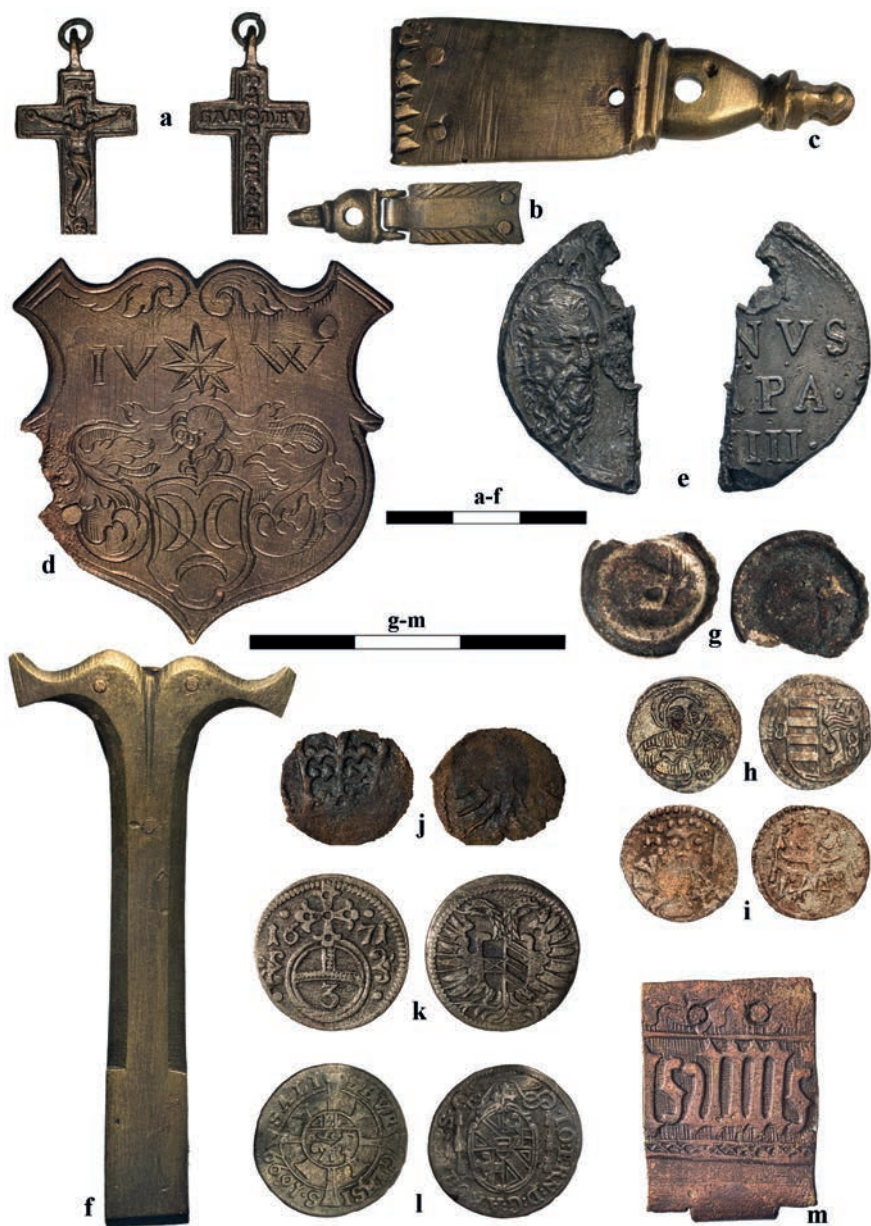
Fig. 15. Wrocław, metalware. a–f – building of the Office of the Cathedral Chapter, g–i – southern part of the cellar of the Chapter House, j–m – northern part of the cellar of the Chapter House (photo by K. Czarniak)

There is a numerous collection of coins dating back to the 17th century. They were present in nearly all the examined objects of the Archdiocese Museum. The most frequent find was Silesian Gröschlein of Emperor Leopold I (1658–1705). The rich coin collection of the mentioned emperor comes particularly from the northern part of the cellar of the Chapter House, which housed the inn (Fig. 15: k). Among the coins that were found there, attention is drawn to one Kreuzer minted by Johan Ernst von Thun, the Bishop of Salzburg in the years 1667–1709 (Fig. 15: l).

A somewhat wider timeframe can apply to the metal book cornerpieces and clasps. Based on the style, these artefacts can be often associated with specific workshops and the moment they were created in can be specified quite accurately (Adler 2010). The ones encountered during the works in question come from the time between the 15th century and the 17th century. The cornerpieces were unearthed mainly in the northern part of the cellar of the Chapter House and in the backfill of the foundations of the cellar of the Cathedral Office (Fig. 15: d, f, m). It was there that a half of a lead seal from papal correspondence was obtained from (Fig. 15: e). It belonged to Urban VIII (1623–1644).
