Appliance of realkalisation in the conservation of monuments made of reinforced cement mortar and concrete

ALEKSANDRA GRALIŃSKA-GRUBECKA

Department of Conservation of Architectonic Elements and Details
Faculty of Fine Arts, Nicolaus Copernicus University in Toruń
e-mail: aleksandra.gralinska@umk.pl

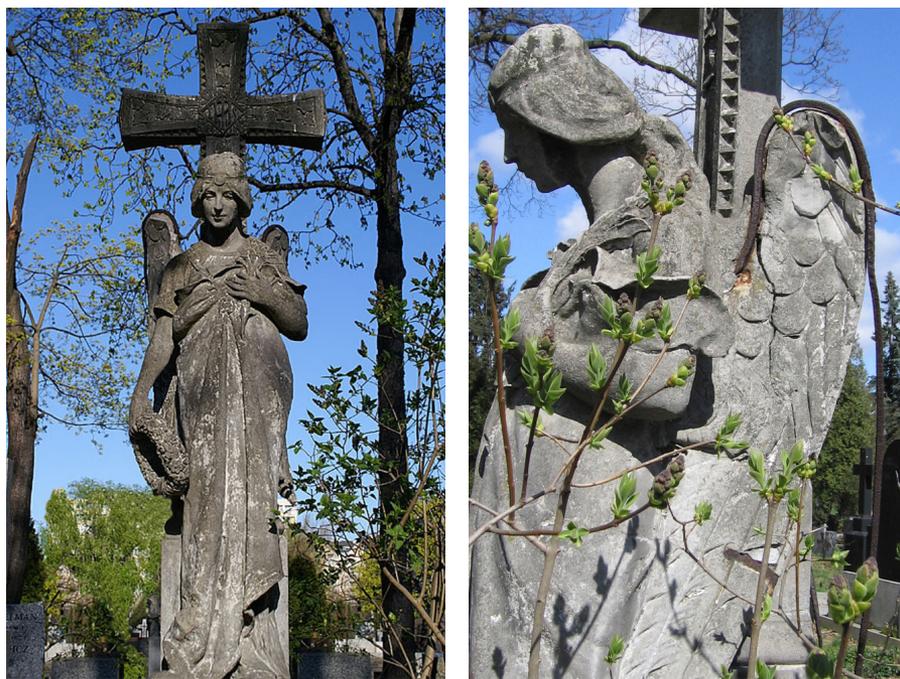
Fig. 1 and 2. Example of reinforcement corrosion caused by carbonation – the angel statue, dating 1895, from Augsburg-evangelical cemetery in Warsaw. Photo by M. Szulińska

solution, while electric charge flows in the form of electrons – from an anode to a cathode, through steel. As a result of electrochemical steel corrosion, a process of rusting begins. Its coating, having larger volume than steel, contributes to forming of significant internal strains whose relaxation manifests itself in micro scratches, cracks and, eventually, bursting of contiguous material (fig. 1–2). Corrosive transmutations usually begin from a surface of an object, slowly moving deeper and lengthwise, alongside scratches and cracks, constituting an inherent part of cement matrix.

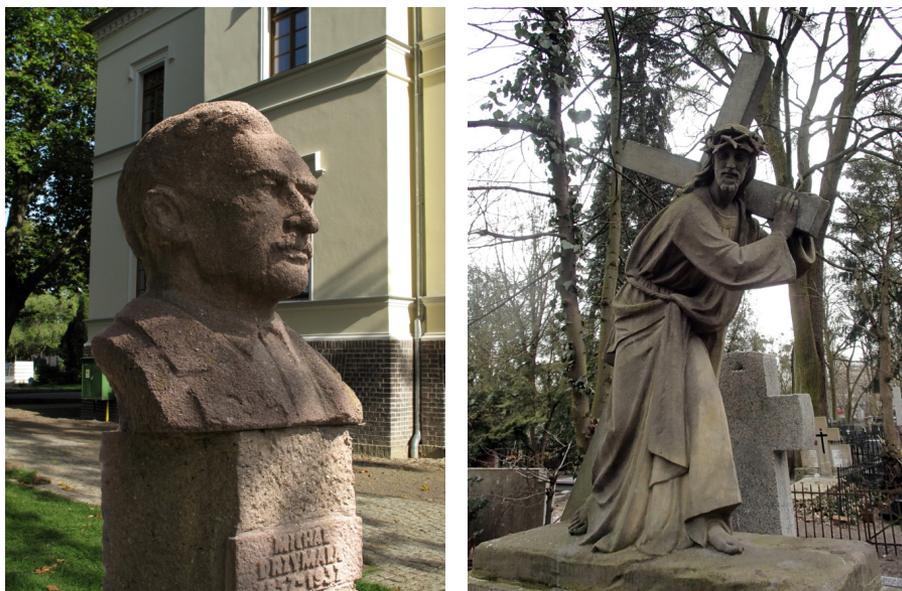
Fig. 3 and 4. The bust of Michał Drzymała by the sculptor Jerzy Sobociński (1971, National Museum of Agriculture and Agricultural and Food Industry in Szreniawa) and the statue of Christ from 1936 (St George's Cemetery in Toruń) are in a very good state of preservation after realkalisation procedure. Photo by A. Gralińska-Grubecka

Diffusive realkalisation was conducted by the author of this article while working on conservation of a cycle of busts (1971) by Jerzy Sobociński, the sculptor, in National Museum in Szreniawa³⁰, and the statue of Christ (1936) from the monumental St George's Cemetery in Toruń³¹ (fig. 3, 4).

Before the decision of performing this procedure was taken, there had been conducted petrographic research which had not confirmed presence of dangerous components. In the case of Christ's statue, the solution was inserted by means of intensive, long-lasting painting, aiming at impregnating it deeply. Furthermore, all of cracks present were injected with migrating corrosion inhibitor (MCI). At the last stage of restoration works, in need to minimize washing out of the realkalising solution, the whole statue was protected with hydrophobicizing impregnation.

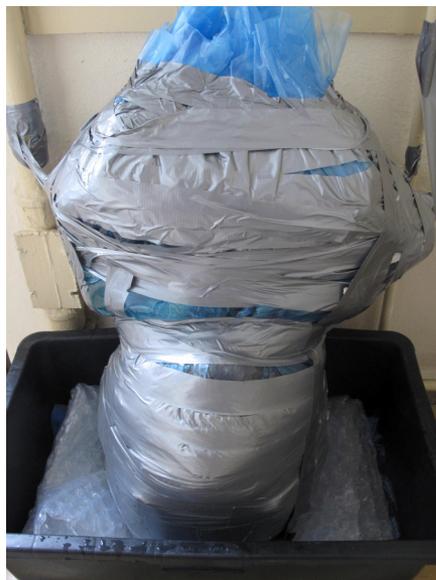
Fig. 5. Dezydery Chłapowski's bust during the procedure of diffusive realkalisation. Photo by A. Gralińska-Grubecka

In the case of busts, the sculptures had been dried before conducting the procedure. Then they were cover with three-layered thick polyethylene film (fig. 5). The sculptures were turned upside down and then filled with with realkalising solution, prepared immediately before impregnation and composing of a mixture of three hydroxides: of potassium, sodium and calcium. pH value of the mixture prepared was 13,11. After having impregnated the sculptures entirely, the solution was removed, while the busts were left to dry naturally (fig. 6).

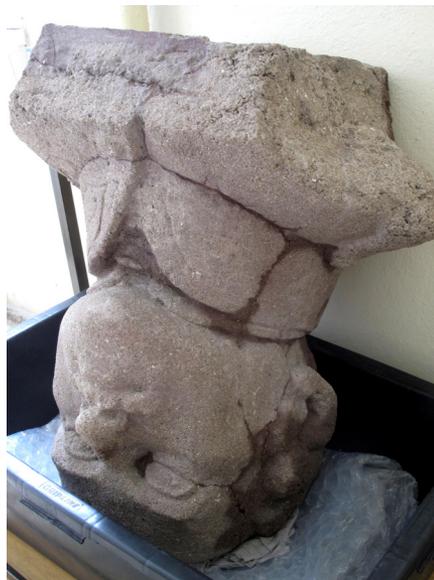
Fig 6. The bust drying out after the procedure of realkalisation had finished. Photo by A. Gralińska-Grubecka

An organoleptic examination with an unaided eye did not prove any signs of colour shift in sculptures. After the procedure, the pH level of an artificial stone was being controlled – it read 12,0 to 12,6 (desirable increase that was noted stretched from 0,56 to 0,82 depending on where the sample had been taken from). Six years have passed since the realkalisation procedures were conducted, and no recurrence of corrosion to the reinforcement has been observed. No loosening of the surface fragments of concrete has been observed either.

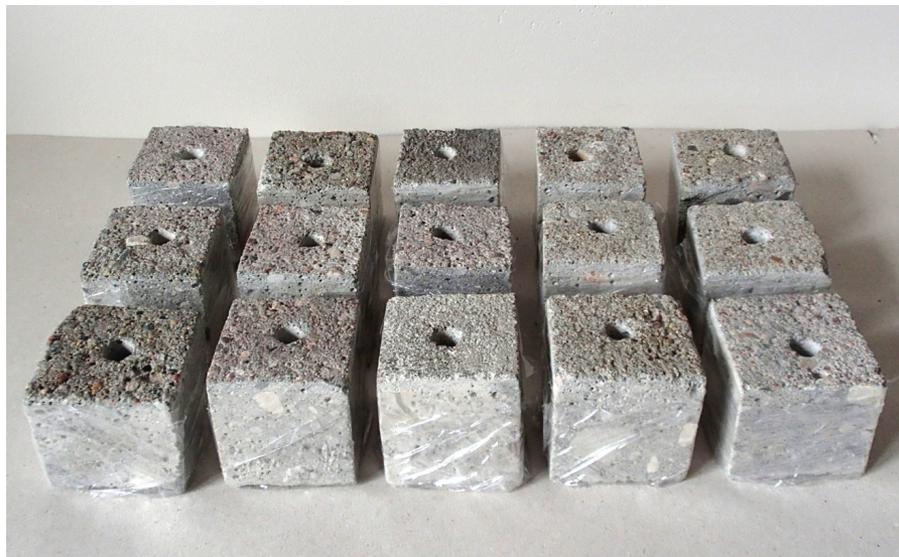
Fig 7. Samples drying after the procedure of diffusive realkalisation. Photo by A. Gralińska-Grubecka

After saturation, the samples were removed from the solution and left to dry freely in laboratory conditions. A part of cuboid samples was insulated with film, with an upper section of their surface left unprotected to enable water to evaporate (fig. 7). The appearance of the surface was being observed, especially the look of the unprotected upper part of evaporating (it was possible that hydroxides would migrate to the surface and an efflorescence would appear). After two months, pH level was examined again. Table no. 1 presents the results.

Among the results of diffusive realkalisation there have been observed: pH level increase in concrete and mortar within range of 0,27 to 0,82 pH units. The process of realkalisation went evenly within the whole volume of the material impregnated, migration of hydroxides to the surface while drying was not observed whatsoever.

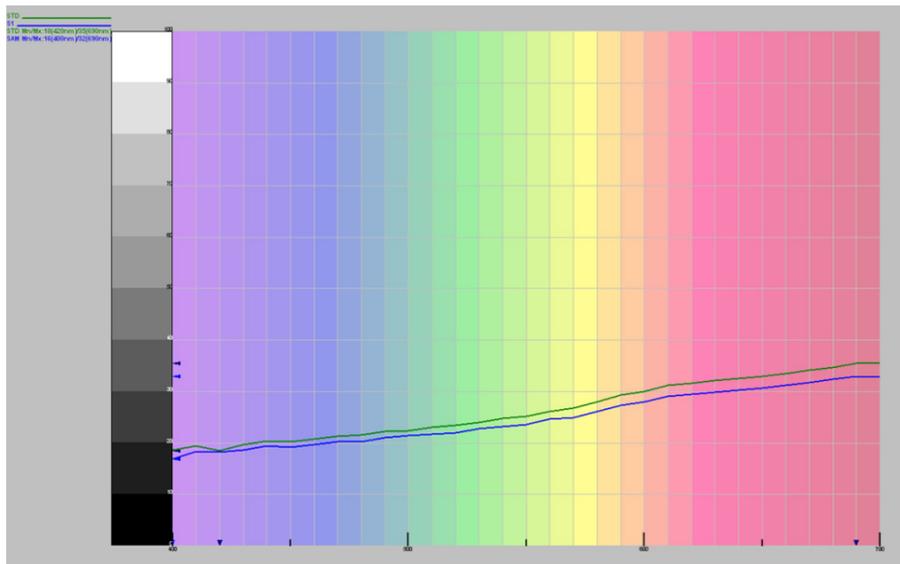
Fig. 8. Mensuration of concrete's colour from the bust of Daniel Janasz before and after the procedure of realkalisation, conducted with colorimeter. Drawn by A. Galińska-Grubecka

In order to examine how the procedure had influenced a colour of an artificial stone, the samples of the mortar taken from Michał Drzymała's bust and the samples from other objects were cut out and they underwent an examination with the usage of colorimeter MiniScan XE Plus³⁵. Following the examination, the samples were re-alkalised and examined again with a colorimeter after 12 months (tab. 1, fig. 8–11). That mensuration, as well as observation by an unaided eye, pointed out that realkalisation did not influence the colour of concrete examined. The chosen results representative for all 16 samples examined are presented below.

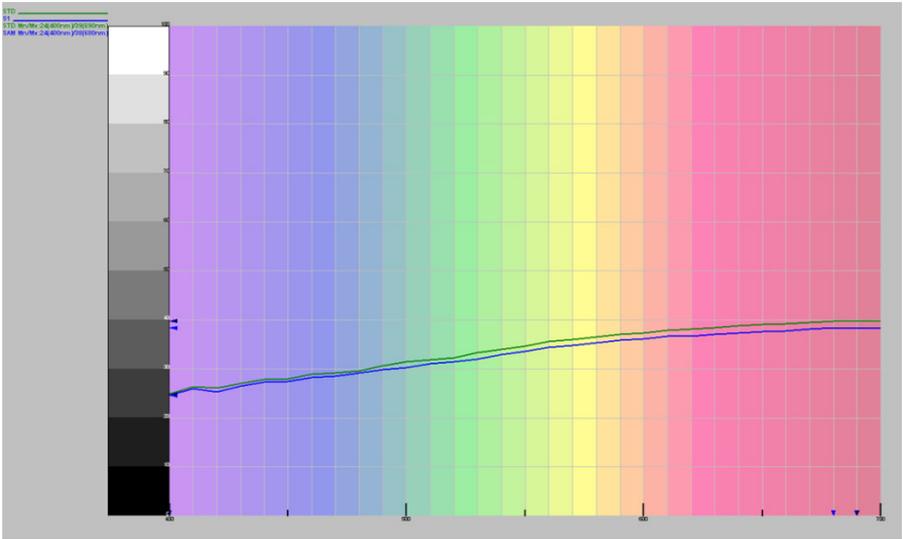
Fig. 9. Mensuration of concrete's colour in a sample from the beginning of the 40s before and after the procedure of realkalisation. Drawn by A. Gralińska-Grubecka

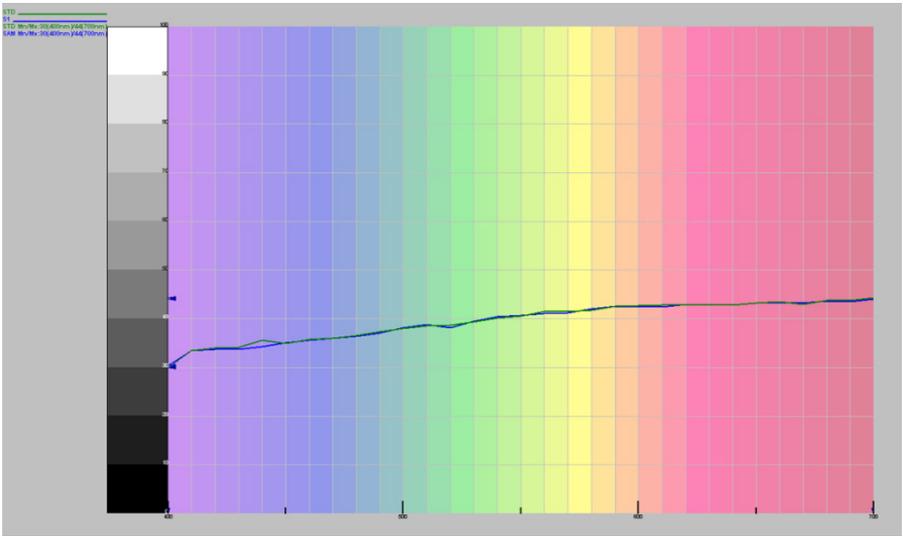
Fig. 10. Mensuration of concrete's colour in a sample from the beginning of the 40s before and after the procedure of realkalisation. Drawn by A. Gralińska-Grubecka

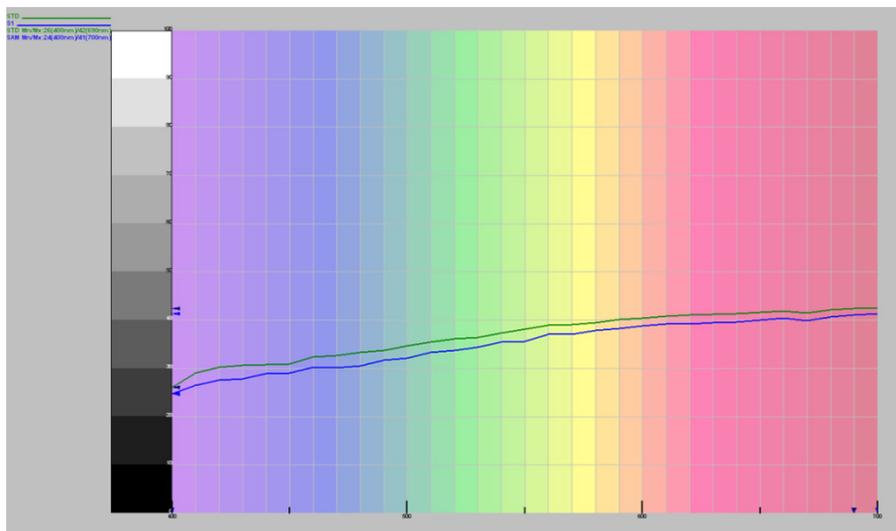
Fig. 11. Mensuration of concrete's colour in a sample from the beginning of the 40s before and after the procedure of realkalisation. Drawn by A. Gralińska-Grubecka
