# Hydrographic changes in a river system and their influence on the legal classification of watercourses, exemplified by selected tributaries of the San river

**Abstract.** The paper presents hydrographic changes in a river system and their influence on the legal classification of watercourses in Poland. As a case study, the watercourse Motwica, right tributary of the river San has been analysed. The main objective of this paper is an attempt to analyse whether the Motwica should be classified as flowing or standing water and the legal grounds for such classification in the Water Law Act. On the base of archival and contemporary cartographic materials' analysis it has been determined that the Motwica should not be classified as natural watercourse because its significant part flows in an artificial channel.

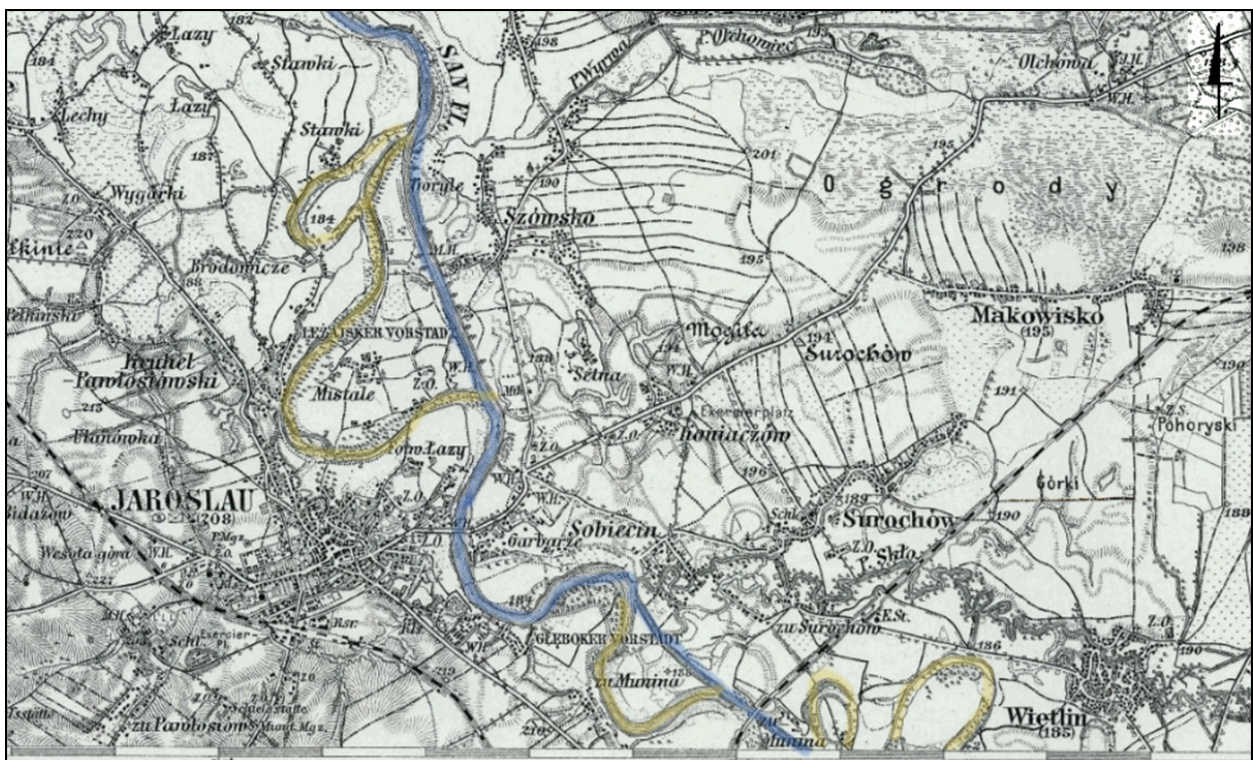
Fig. 5. Fragment of the rescaled 1878 Austrian map indicating the course of the San after engineering: blue line – new channel; yellow line – old channel

farming activities and as an attempt to possibly return the river to navigability. In this way, not only was the river shortened, but its gradient was also increased from 0.22‰ to 0.36‰. As Wład (1998) states, this work coincided with an overall drop in the level of the river's waters. The quickened flow and reduced amount of water caused vertical erosion and an approximately 2-metre lowering of the river surface level around Jarosław and Przemyśl. Therefore, from the perspective of returning the San to navigability, the engineering work was unsuccessful. The lowering of the water level in the river reduced water retention around the river channel and resulted in a significant lowering of water levels in the territory adjacent to the river. There was consequently a quick and total drying up of the San oxbow, including the oxbow to which the ditch was dug, later referred to as the Motwica. The way in which the channel of the San was straightened around Jarosław is depicted in the 1878 Austrian map (Fig. 5).

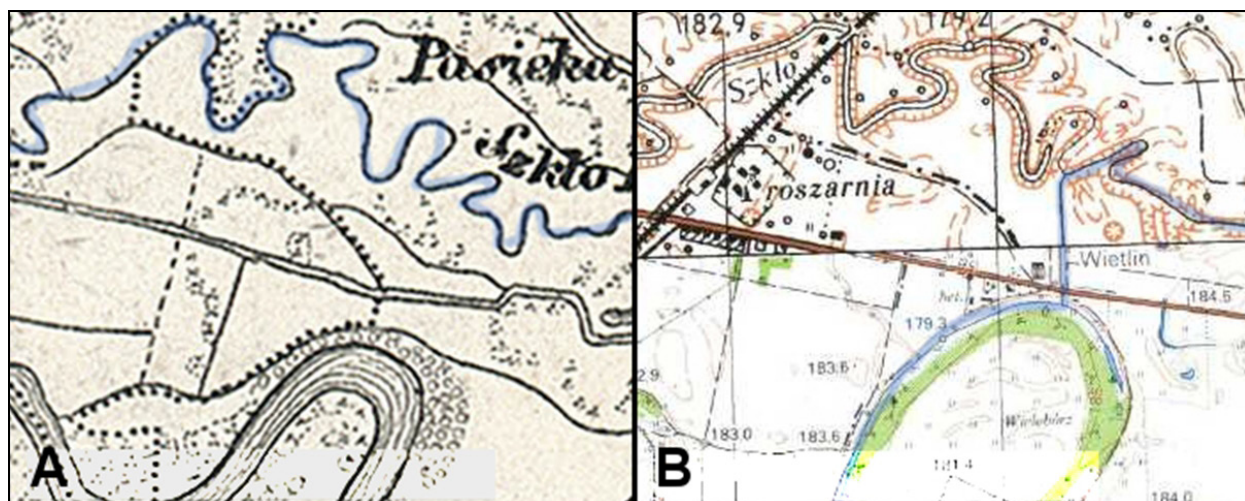
Fig. 7. Fragment of the 1855 Austrian map (A) and the 1980 raster map (B) showing the retained course of the river Szkło (old bed) and the canal leading to the San oxbow, currently the channel of the Motwica – stretches III and IV of the Motwica

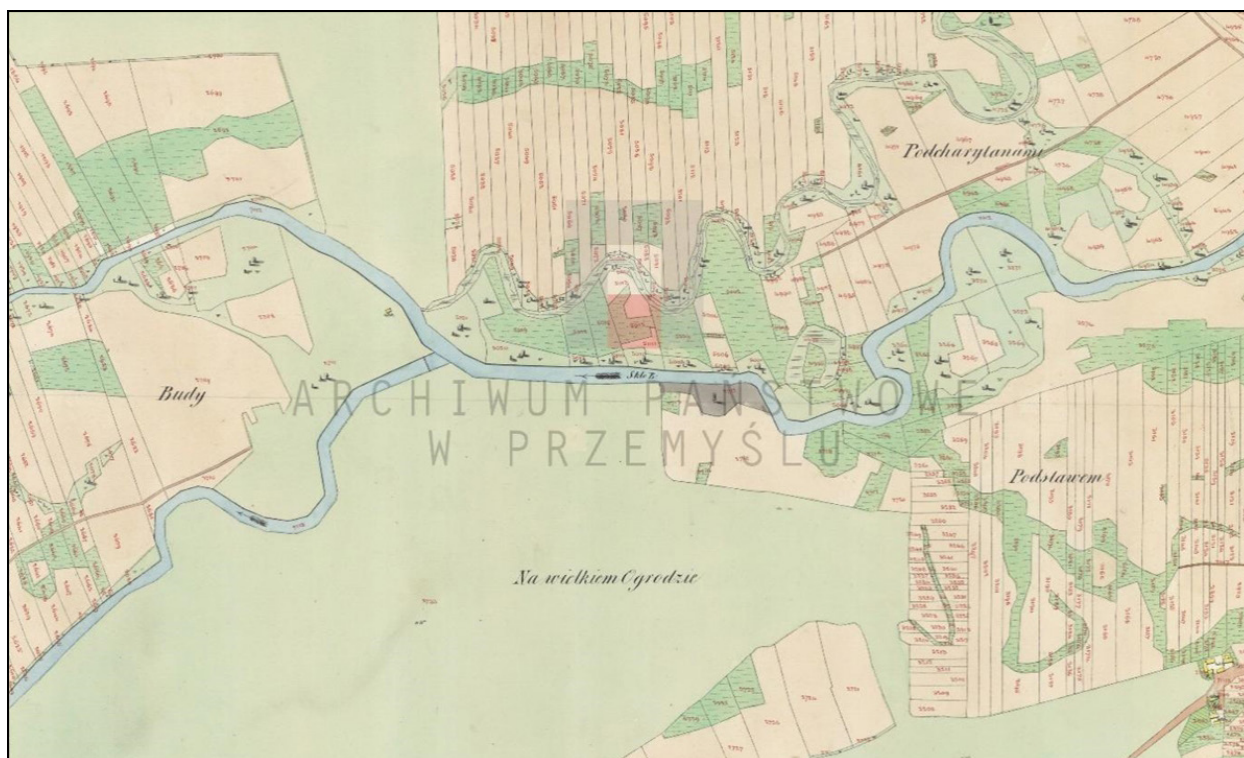
Fig. 9. Fragment of the 1851 Austrian cadastral map – area around the town of Podcharytany – depicting a bifurcation of the Szkło in the direction of what is currently the Wisznia

Additionally, at the village of Podcharytany Fig. 9 shows a clear bifurcation of the szkło (formerly the Krakowska and Wisznia) in the direction of what is currently the Wisznia, which is also shown on other maps of this period (compare Fig. 5). It may therefore be assumed that the river today known as the Szkło went by other names (Krakowska, Wisznia) and had a longer course even as late as the 19th century. It was shortened by repeated engineering works, resulting in the stretches of oxbow currently functioning as drainage for the cut off catchment.
