Świątkowski Wojciech, Rahnama Mansur, Wieczorek Katarzyna, Jastrzębska Jamrogiewicz Izabela, Jamrogiewicz Rafał. The displacement of a broken root canal instrument in the space of floor of the mouth. *Journal of Education, Health and Sport*. 2018;8(3):193-199. eISSN 2391-8306. DOI <http://dx.doi.org/10.5281/zenodo.1190983>
<http://ojs.ukw.edu.pl/index.php/johs/article/view/5342>
<https://pbn.nauka.gov.pl/sedno-webapp/works/859041>

The displacement of a broken root canal instrument in the space of floor of the mouth

The Chair and Department of Oral Surgery Medical University of Lublin

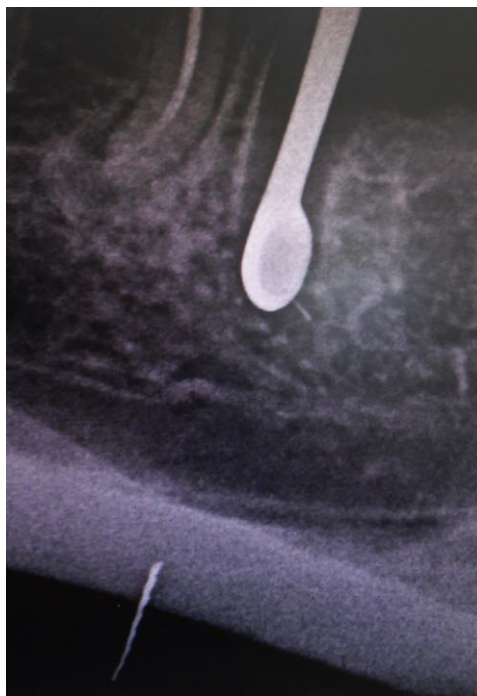
Fig. 3. Intraoral X-ray, confirmation of position of the instrument, before flap elevation.

After presentation of treatment plan to the patient and obtaining written consent for the procedure the surgical part of treatment was started. Just before the surgery X-ray was performed to make sure that there was no further displacement of the tool instrument within the soft tissues. [Figure 3].

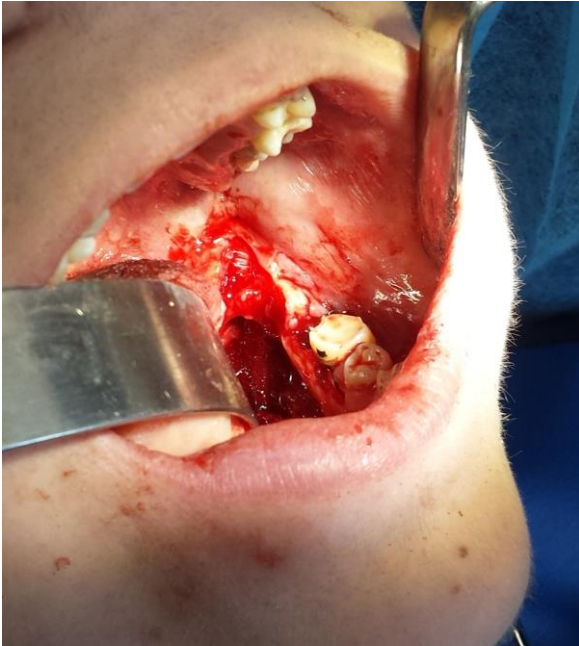
Fig. 4. Intraoral clinical view, surgical approach.

was made in the area from the retromolar triangle to the area of first premolar from the lingual site. The flap was elevated from bone to the attachment of mylo-hyoid muscle [Figure 4].

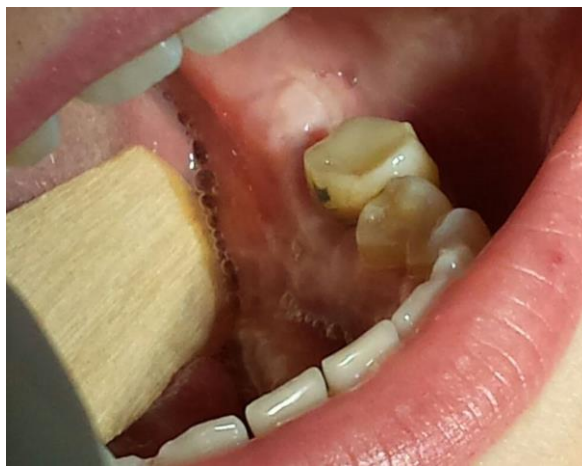
Fig. 6. Intraoral clinical view in 7 days follow-up after surgery.

A 6-day course of antibiotics clindamycin (600 mg every 12 hours) was recommended. Immediately after the surgical procedure intramuscular injection of 75 mg of diclofenac and intravenous injection of 8 mg of dexamethasone were made. Patient endured surgical treatment well. The patient reported daily for control visits for 5 days. After 7 days the sutures were removed. No complications in follow-up were found [Figure 6].
