## Comprehensive prosthetic treatment of a patient after removal of an impacted fragment of an orthodontic wire in the area of tooth 13 – review & case report

**Purpose of work:** The aim of this paper is to present a comprehensive surgical and prosthetic treatment of a patient after unsuccessful orthodontic treatment, which resulted in a piece of wire remaining in the area of tooth 13. The paper discusses the procedure for removing the foreign body, the stages of prosthetic reconstruction, and the evaluation of treatment results after three months of observation.

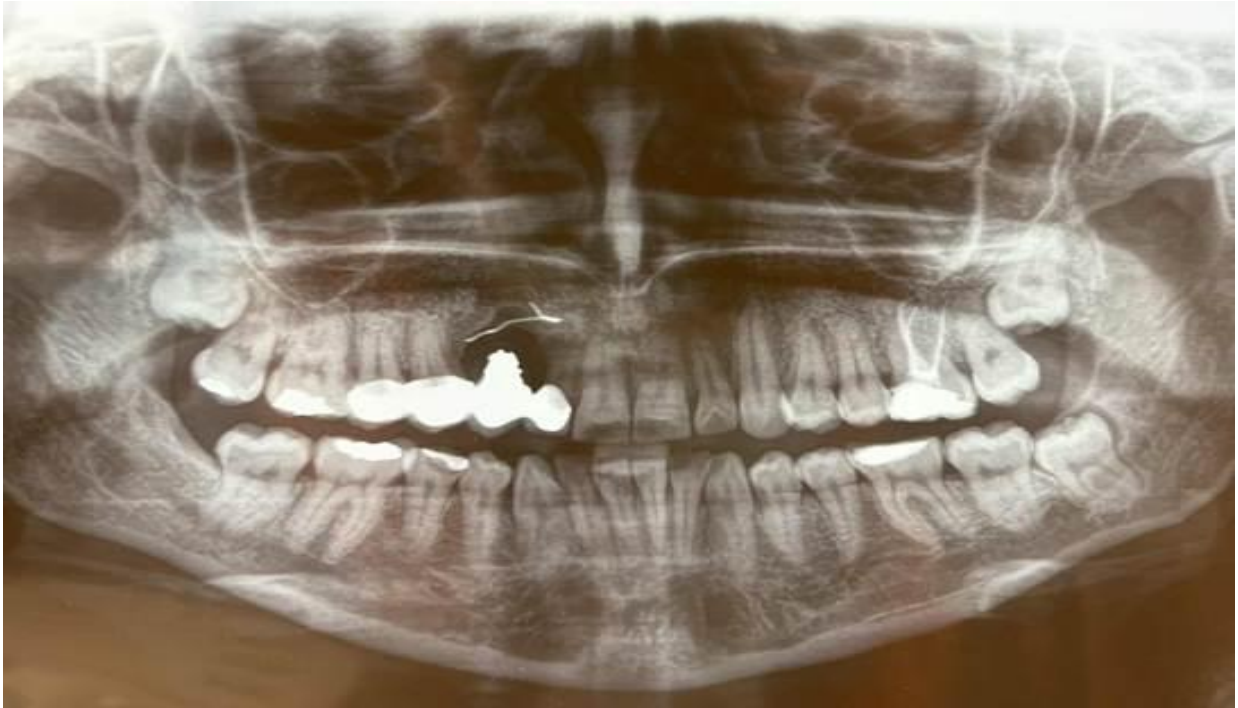
The patient's history included an unsuccessful attempt to orthodontically reposition the impacted tooth 13 ten years earlier. Following orthodontic treatment, a fragment of a steel wire remained in the bone. The patient reported no pain or chronic illness. An OPG was then taken, capturing the wire fragment and canal filling after endodontic treatment on tooth 26, the impacted teeth 18, 28, and 38, and significant bone loss in the maxillary alveolar process surrounding tooth 13. The mobility of the remaining teeth was normal. The patient was thoroughly examined and proposed a two-stage procedure: surgical and prosthetic. She was informed about treatment options, all possible complications, and the possibility of failure.

Fig. 1. OPG photo with a fragment of steel wire and visible bone loss in the maxillary alveolar process in this area.

After obtaining written consent, a detailed treatment plan was established. The surgical portion included infiltration anesthesia with Citocartin 200, removal of the old prosthetic bridge, incision of an envelope flap, osteotomy of the bone surrounding the steel wire fragment from the area of tooth 13, and its subsequent removal. Subsequently, extraction of tooth 12. The procedure was uneventful, and no intraoperative complications were observed.

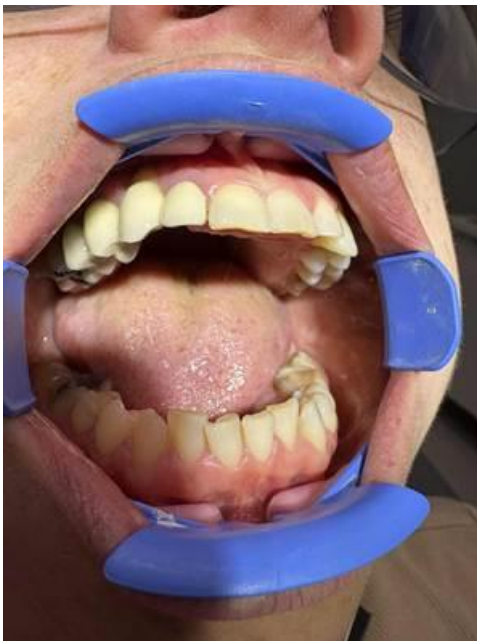
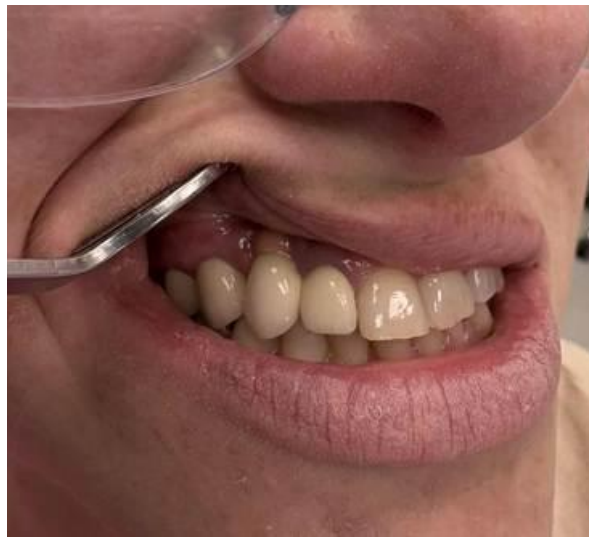
Fig. 2, 3. Photos of the initial prosthetic work on the day of surgery.

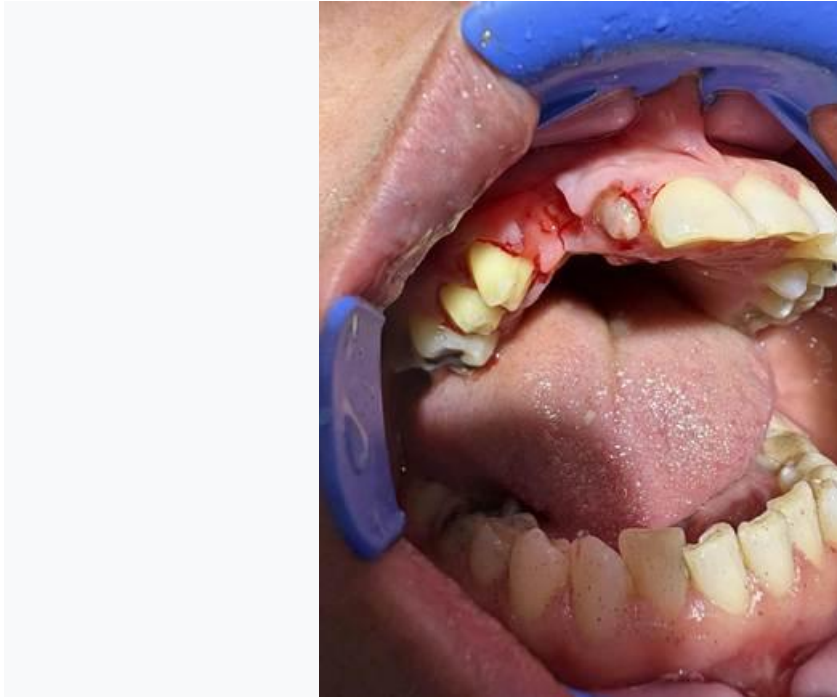
Fig. 4. Photo after removal of the primary bridge with a visible large loss of soft tissue in the vestibule area of tooth 13.

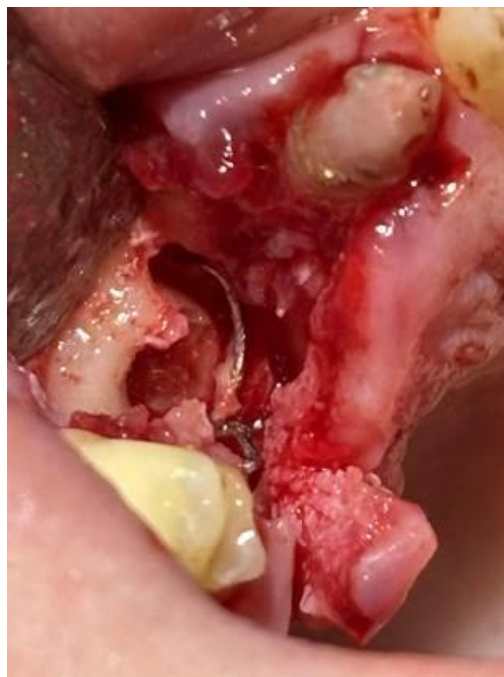
Fig. 5. Photo after flap detachment and partial osteotomy with steel wire visible.

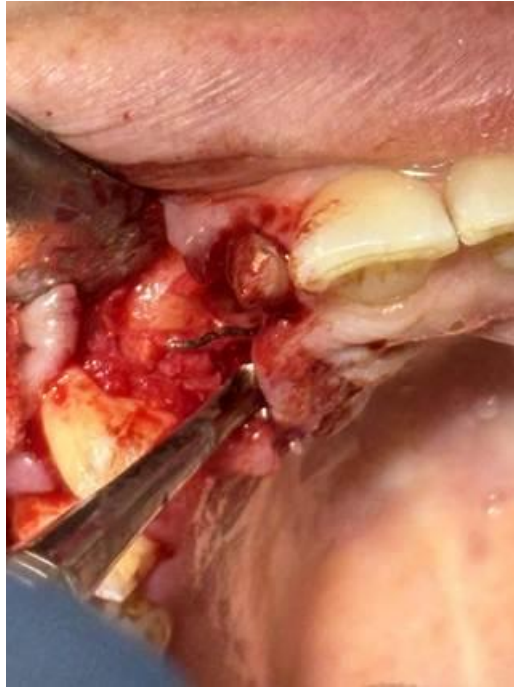
Fig. 6. Photo with partially removed steel wire and extraction of tooth 12.

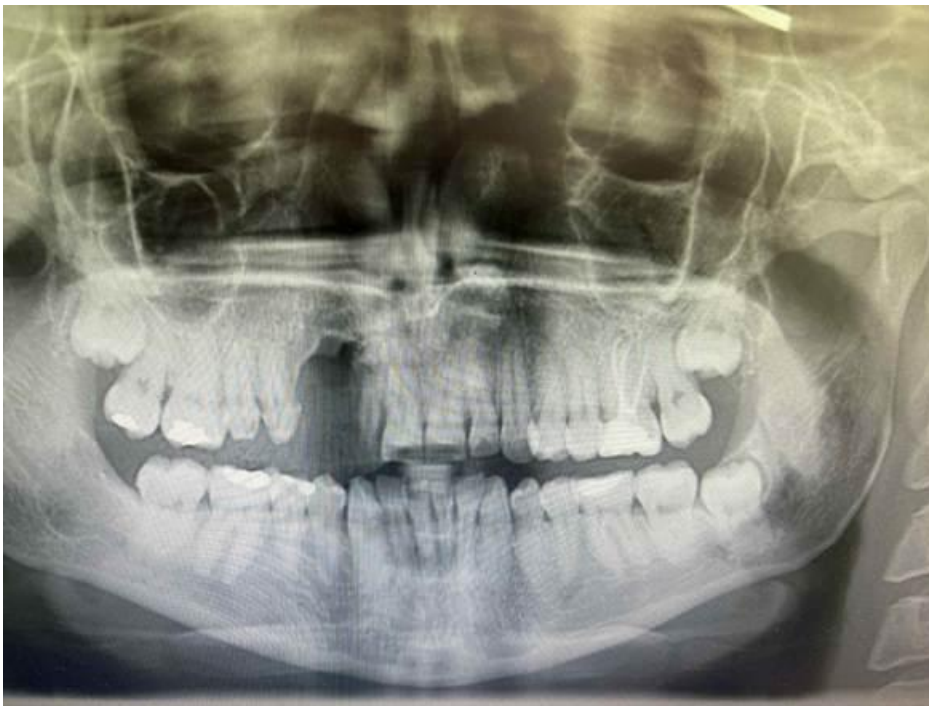
Fig. 7. Control OPG image after the procedure.

After the procedure, i.e. surgical tissue treatment, the patient was referred for a control OPG image to confirm the complete removal of the foreign body.

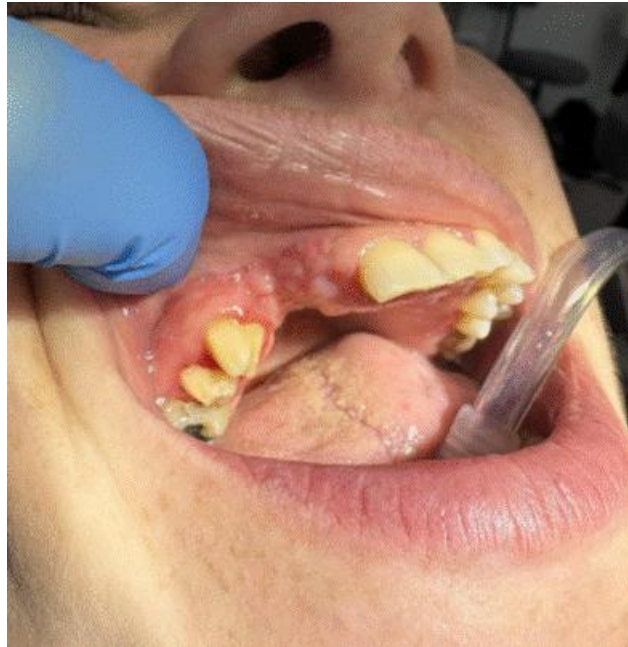
Fig. 8. Photograph of the patient 7 days after the procedure. Post-operative follow-up. Healing is normal.

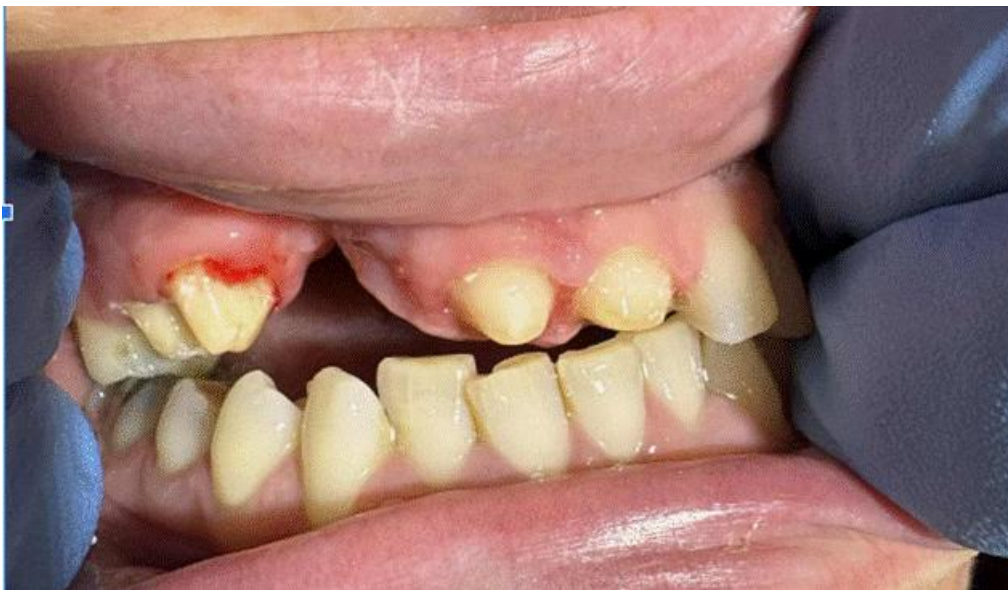
Fig. 9. Photo of the completed crown grinding of teeth 11 and 21.

The labial surface of the incisor was prepared in two separate planes. The cervical section was ground parallel to the tooth's long axis, while the section closer to the incisal edge was modeled at a different angle, depending on the natural crown convexity. The incisal edge was reduced by approximately 2 mm, while maintaining its physiological inclination.

The palatal surface was prepared to a depth of approximately 0.7 mm, with the instrument angled 3–6° to the vestibular aspect. It was also necessary to create approximately 1.5 mm of space between the tooth being prepared and the opposing tooth to allow for the appropriate thickness of the future crown.

The labial gingival shoulder was created as a pronounced chamfer (heavy chamfer), or a rounded shoulder (radial shoulder) with a depth of approximately 1.2 mm could also be used. A light chamfer (approximately 0.7 mm deep) was created on the lingual and proximal surfaces. Less preparation of the oral surface allows for the preservation of more hard tooth tissue. This approach is acceptable provided that the palatal crown is not covered with ceramic. The edge of the shoulder should run smoothly and harmoniously along the gingival line. After preparation, all sharp edges should be smoothed and rounded.

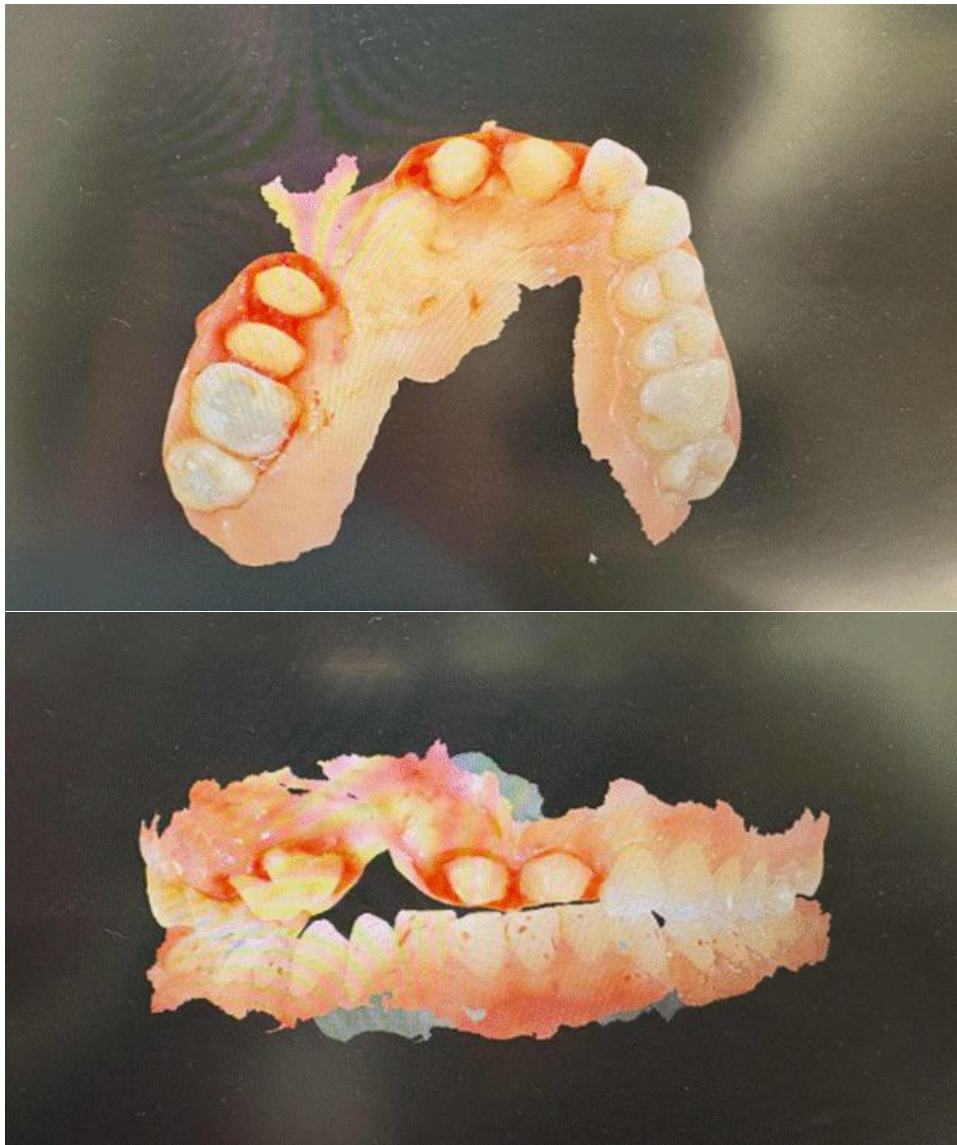
Fig. 10, 11. Scans of the upper and lower arch.

In the next stage, scans of both the upper and lower arches were made in order to design the future restoration. The continuous development of computer technology and advanced data processing methods in dentistry contributes to the emergence of new diagnostic and therapeutic possibilities in the field of fixed prosthetics. [7] Traditionally, standard therapeutic procedures were based on conventional impression techniques and the production of plaster models, which were used to manufacture acrylic and porcelain reconstructions fired onto metal using the lost wax technique. In contrast to these methods, modern computer-aided design technologies ensure high, repeatable precision and predictable production results, while streamlining the work process and reducing manual labor. [8,9]

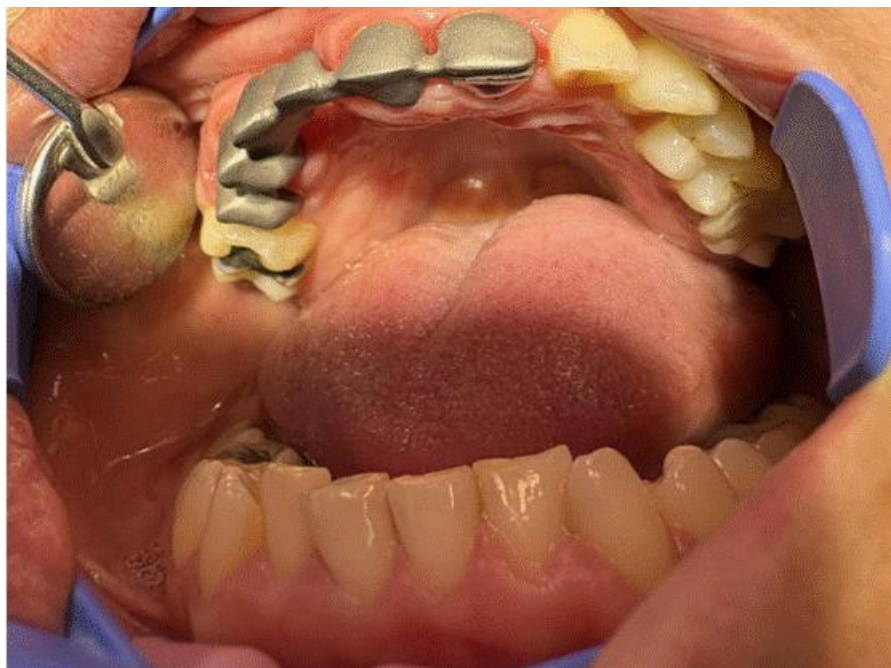
Fig. 12. Intraoral situation, fitting of the future prosthetic restoration in the oral cavity.

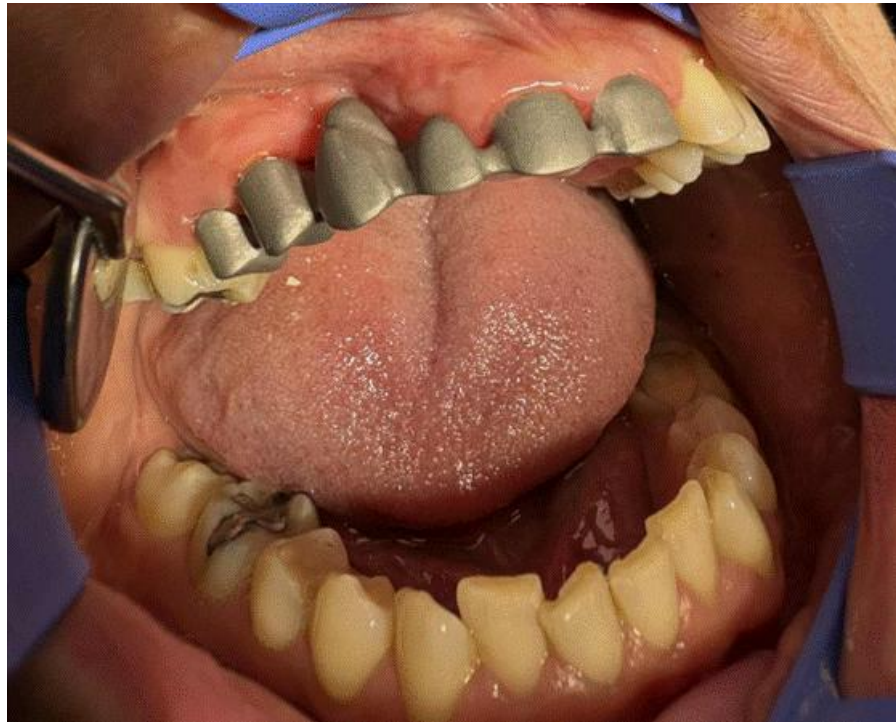
Fig. 13. Try-in of the framework for the future prosthetic restoration in the oral cavity. View from the right.

The substructure was made using selective laser melting (SLM/DMLS) technology. It is an additive, incremental method in which the device used in selective laser melting technology consists of a laser, a laser guidance system, and a working platform placed in a chamber filled with inert gas. A computer-controlled laser beam is directed onto the surface of the platform, onto which a layer of powdered metal is evenly applied. Under the influence of the high temperature generated by the laser, the powder particles undergo local melting and bonding into a layer approximately 20–200  $\mu\text{m}$  thick. The platform is then lowered and another portion of powder is applied to the resulting layer, which is again fused by the laser. In this way, the laser successively sinter individual sections of the model, creating the entire structure layer by layer. After the process is complete, the finished metal component is heat treated in an argon atmosphere to reduce internal stresses in the material. This technique produces restorations with a homogeneous and compact structure, free of voids, shrinkage pores, and impurities typical of traditional casting. Components made in this way are characterized by high hardness and high resistance to loads. The thickness of the metal crown substructure made using this method is usually in the range of 0.3–0.5 mm.

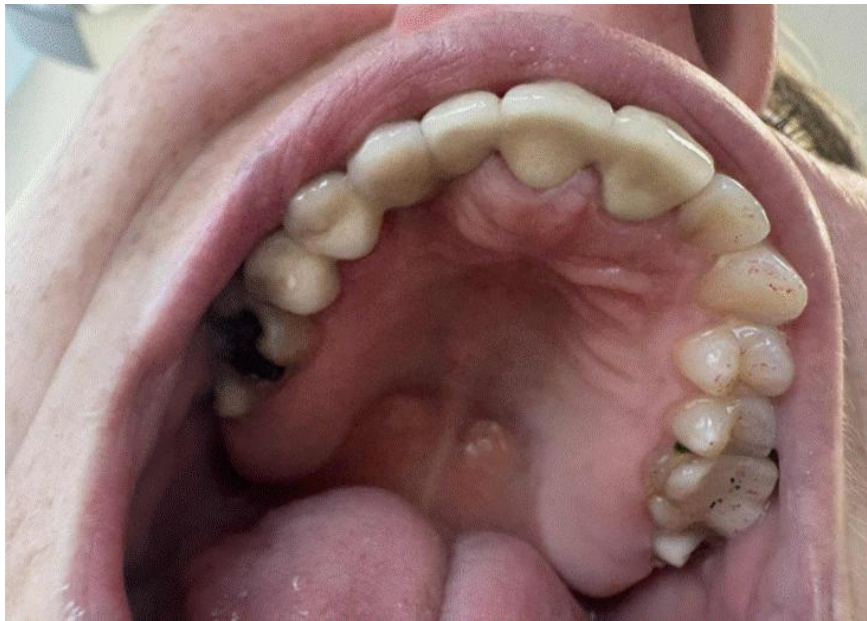
Fig. 14. Intraoral situation after final cementation of the work, view of the upper arch.

Ten weeks after the procedure, the final restoration was cemented in place. The veneering ceramic was the aforementioned leucite ceramic. The restoration was cemented with glass ionomer cement (Ketac CEM). Glass ionomer is made from finely ground aluminosilicate glass combined with an aqueous solution of polycarboxylic acids. [10] This material is characterized by high tensile and compressive strength, low thermal expansion coefficient, and anti-caries properties that promote remineralization of tooth tissue. The latter feature results from the gradual release of ions in the aqueous environment of the oral cavity. [10,11]. Glass ionomer cements are also semi-transparent and less soluble than zinc phosphate cement. [13] However, one of the significant disadvantages of these materials is their low pH (approximately 3.5), which may cause clinical problems, including hypersensitivity in patients with a low pain threshold. In addition, the strength of glass ionomer cements is reduced if they are exposed to moisture too early, due to cation leaching and progressive erosion. This phenomenon increases the risk of cracking, so the material requires adequate protection, e.g., with a protective varnish or petroleum jelly, in the initial stage of setting. [14] The choice of the right cement is very important, as there have been cases of permanent works being aspirated into the respiratory tract. [18] Cementing with this type of cement requires the substructure to be prepared for the process. This is done as follows:

The interior of the restoration is sandblasted with aluminum oxide with a grain size of 50–110  $\mu\text{m}$ , at a pressure of approximately 2.5 bar, from a distance of approximately 1 cm for 10–20 seconds. Next, the structure is cleaned with alcohol, rinsed with distilled water, and thoroughly dried. The abutment tooth is isolated, washed with distilled water, and dried. Glass ionomer cement is prepared by mixing it with a spatula on a plate or paper according to the manufacturer's instructions.

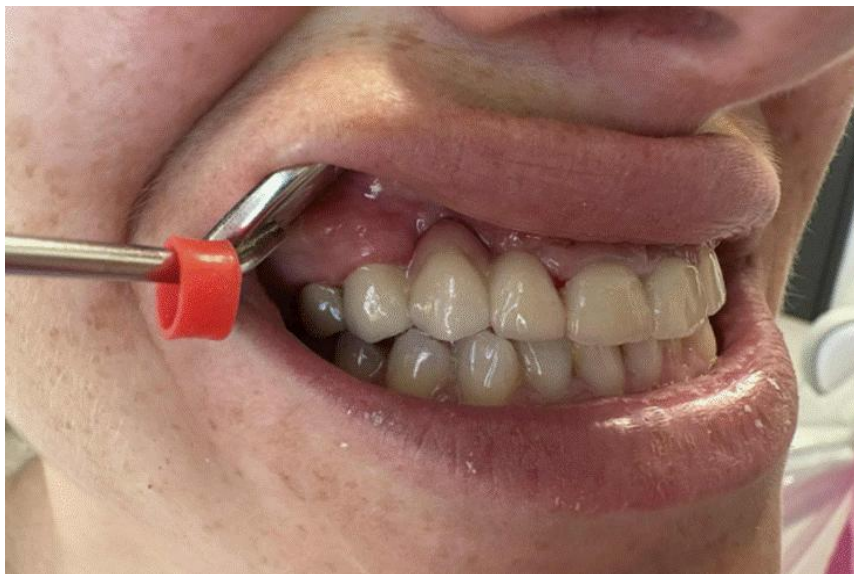
Fig. 15. Intraoral situation after final cementation of the work, view from the right side of the upper arch.

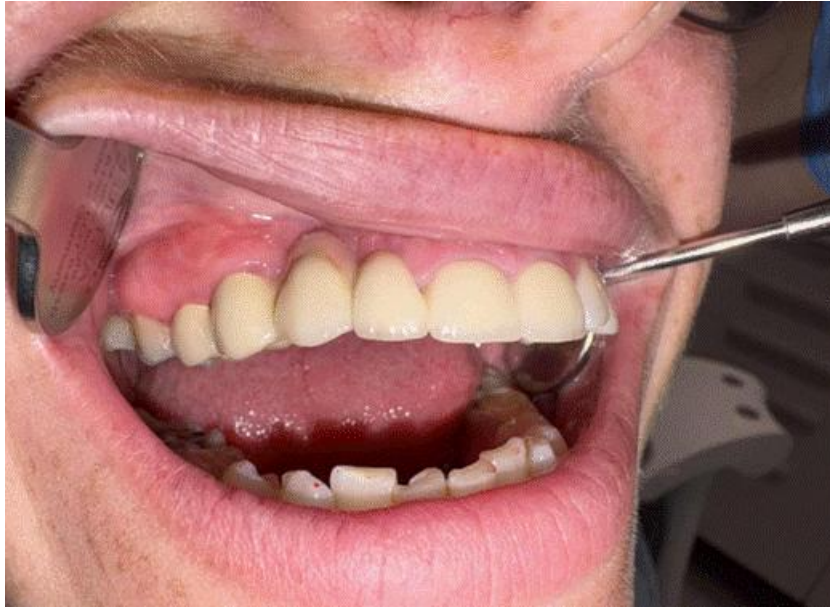
Fig. 16. Intraoral situation, control 30 days after cementation, view from the right side of the upper dental arch.

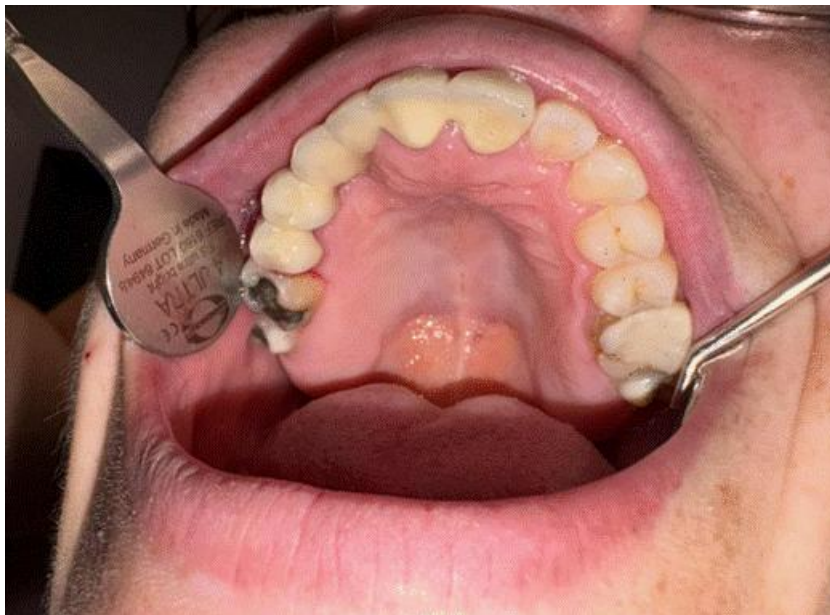
Fig. 17. Intraoral situation, control 30 days after cementation, view of the upper dental arch.

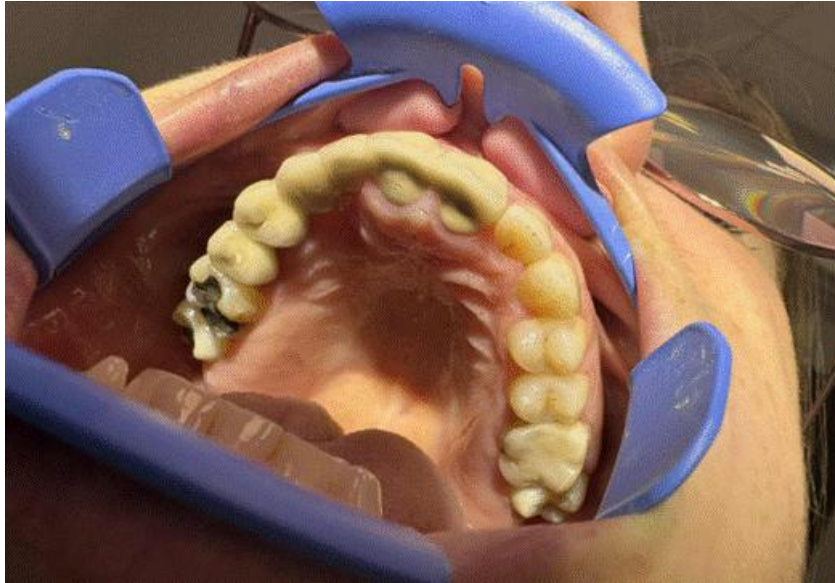
Fig. 18. Intraoral situation of the work 3 months after cementation.

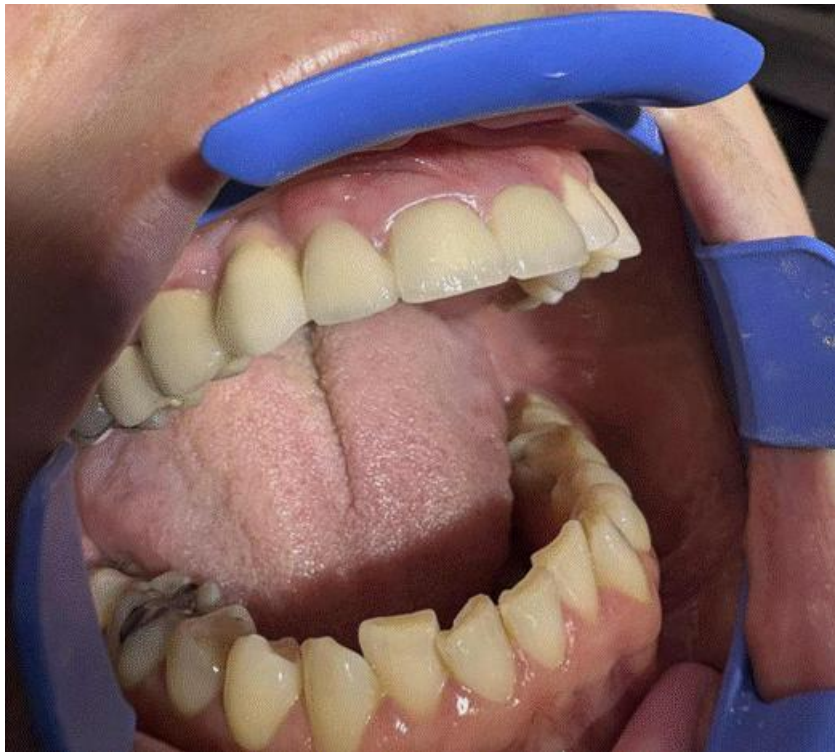
Fig. 19. Intraoral situation of the work 3 months after cementation. View from the right.

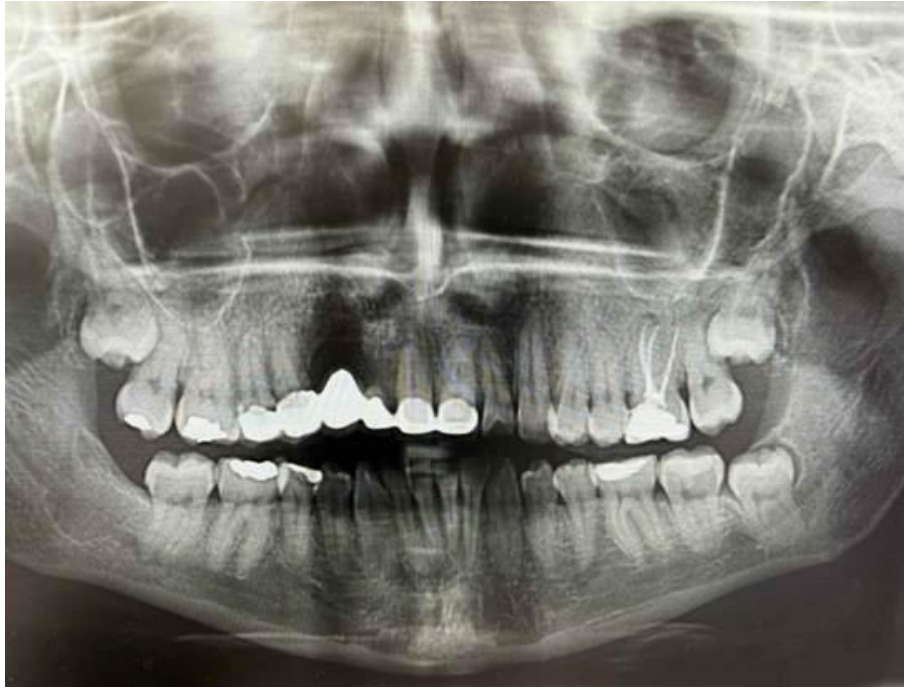
Fig. 20. OPG photo of the final prosthetic work, taken 3 months after final cementation.

The next follow-up visit was carried out 3 months after cementation, and a control OPG image was taken.
