# An attempt to reconstruct selected elements of the original site topography of the Teutonic castles at Unisław and Starogród (Chełmno Land, Northern Poland) based on archaeological and cartographic data

Paweł Molewski<sup>a</sup>, Bogusz Wasik<sup>b</sup>, Marcin Wiewióra<sup>c</sup>

Nicolaus Copernicus University, Poland

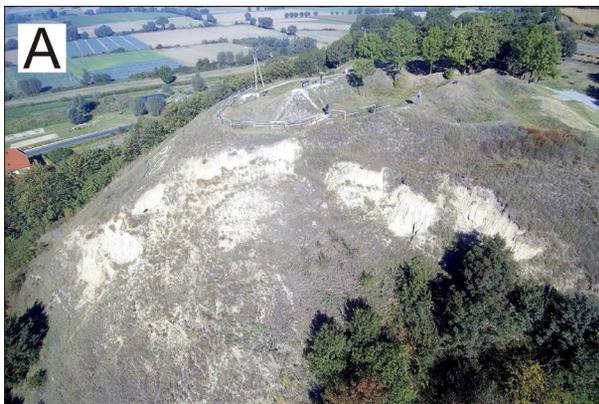
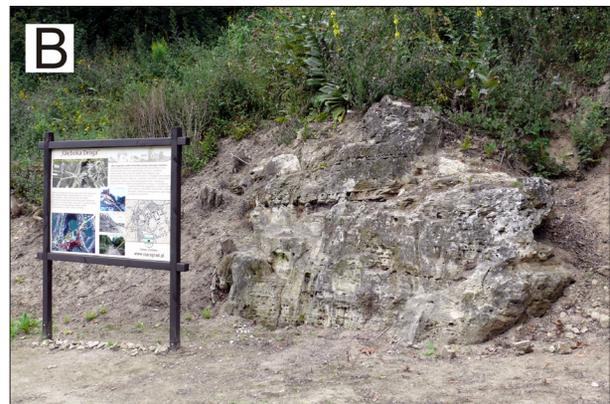
Fig. 11. Plateau quasi-peninsula in Starogród: A – castle site with landslide slumps on the south slope; B – uncovering of Pleistocene sandstones at the foot of the south slope

Similarly to Unisław, the still-active landslide processes are conditioned by the height and steepness of the slopes, and by their geological structure (Fig. 10 and Fig. 11A). The moraine plateau around Starogród is made of two surface till layers overlying sandy deposits (Kozłowska and Kozłowski 1990). The combined thickness of the tills is near-

The sediments under the till are uncovered in several places in the lower slopes of the plateau quasi-peninsula (Fig. 11B) as fine sands, strongly cemented with calcium carbonate (calcium carbonate

contents reach 50%). These are Pleistocene sandstones, which are known in the lower Vistula valley (Drozdowski and Krażewski 1978) but also in other places in the Polish Lowlands (Urban 2000) and so, in this case, they are fluvioglacial deposits cemented with calcite. Therefore, in the case of Starogród, the undermining of the slope's stability and the occurrence of landslides may be the result of chemical suffosion (Kowalski 1988) by the calcareous binding being washed from the Pleistocene sandstones. Additionally, the natural retreat of the slope edge, combined with landslide processes to the south of the southern wing of the high castle, may have been a catalyst to the remains of the castle walls burdening the slope.
