The role of geological conditions in the disintegration of historical structures on the escarpment of the Lower Vistula Valley, on the example of Chełmno (Poland)

Ewa Labak-Mechowska*, Michał Dąbrowski

Nicolaus Copernicus University in Toruń, Poland

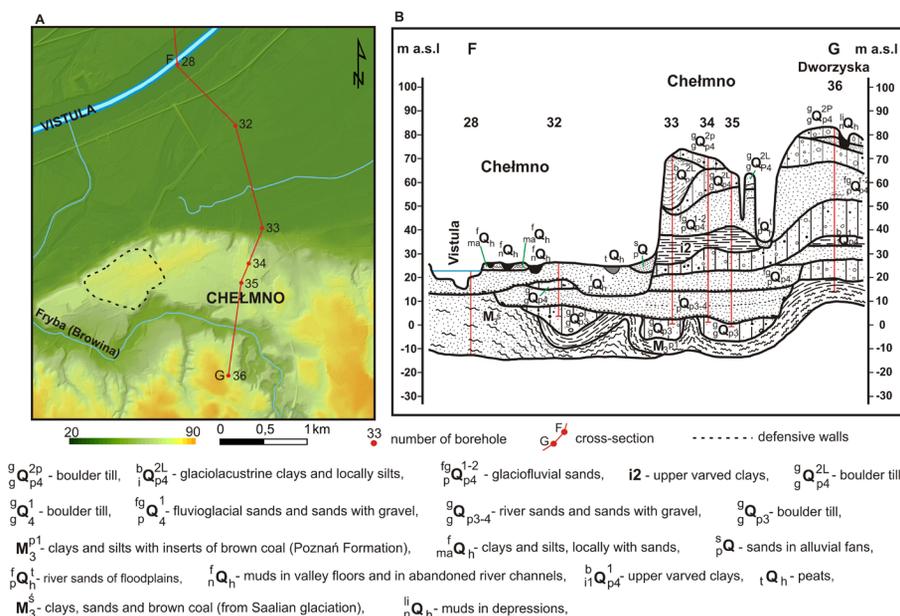
Fig. 3. Surface relief of the study area (A) and geological-engineering cross-section (B) (Butrymowicz 1981)

The escarpment in Chełmno is located at a height of 75 a.s.l. The full geological structure was presented on an archaeological geological cross-section (Fig. 3) and described based on an explanatory map (Butrymowicz 1981). On the surface of the till plains there are boulder tills whose occurrence is probably related to the maximum extent and recessive moraines of the Poznań phase of the last glaciation (gQ_{p4}^{2p}). The thickness of these sediments varies from 2 to 12 m. Directly below these deposits there are deposits from the Leszno phase. There are grey, grey-black or grey-brown varved sediments. These consist of layers of dark clay and lighter silt or fine sand (bQ_{p4}^{2L}). The varved sediments' thickness ranges from 1 to several metres. Next to these sediments are grey and grey-brown sandy till, clayey till or silty till (gQ_{p4}^{2L}). Under the layers of clay from different phases of the main stadial of the Weichselian glaciation are glaciofluvial sands (fgQ_{p4}^{1-2} ; f_pQ_{p3-4} ; fgQ_{p4}^1) They are fine-grained, and somewhat silty. In places, thin interbeddings of silts and clays occur, up to a few centimetres thick. After the layer of glaciofluvial sediments, there are varved deposits, boulder till, sand and gravels. Below clays and mud with inserts of brown coal (Poznań Formation M_3^{p1}) there are lenses of boulder tills (gQ_{p3}). These clays are the lowest level of glacial sediments that occur below the fluvial sediments from the Eemian interglacial.

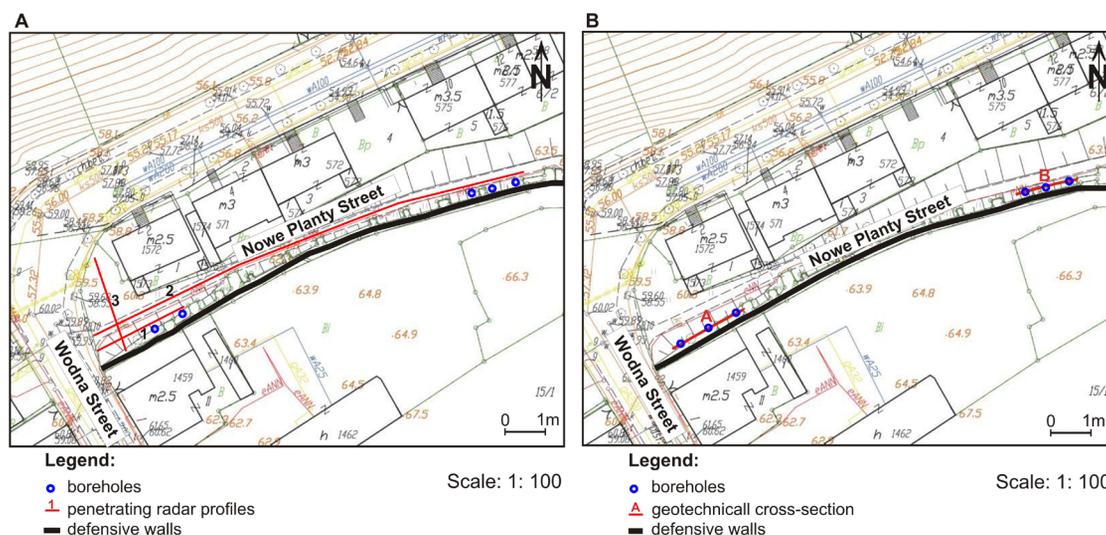
Fig. 4. Location of boreholes, line of geological cross-section and geo-radar profiles

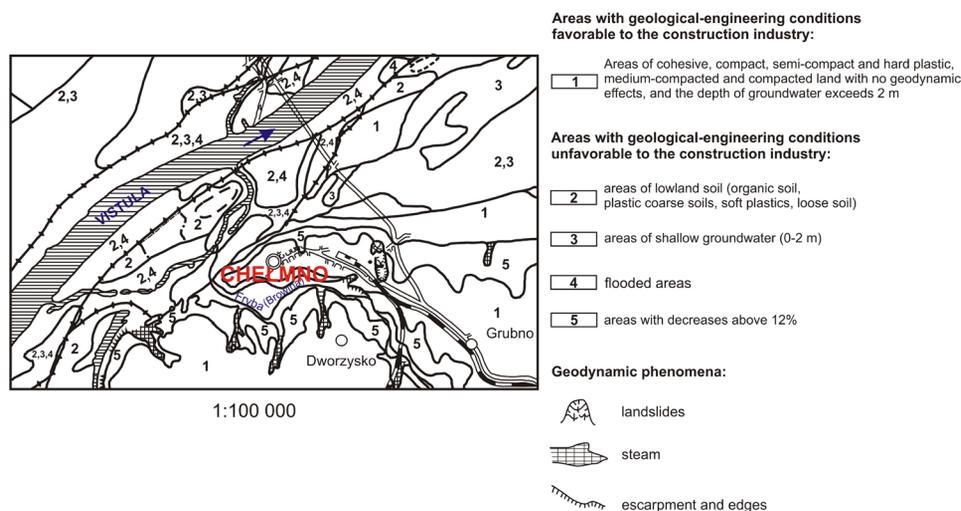
Chełmno has 2 main geological-engineering divisions. The first is a region with favourable geological-engineering conditions, and the other is a region that impedes construction. The analyzed area in which the medieval defensive walls are located lies in both the first and the second division (Fig. 6). Land areas favourable to construction include areas of loose, compact, semi-hard and hard plastics, medium-density ground with no geodynamic phenomena, and groundwater table depth of the water is more than 2 m. The defensive walls were built on the till plain.

Fig. 6. Archival geological-engineering sketch (Butrymowicz 1981)
